2009 Condition Report for Northeast Plaza and Northwest Plaza and Barrier Wall Repair Options

**Milwaukee State Office Building
819 North 6th Street
Milwaukee, Wisconsin**

DSF Project No. 08C1A

November 2, 2009

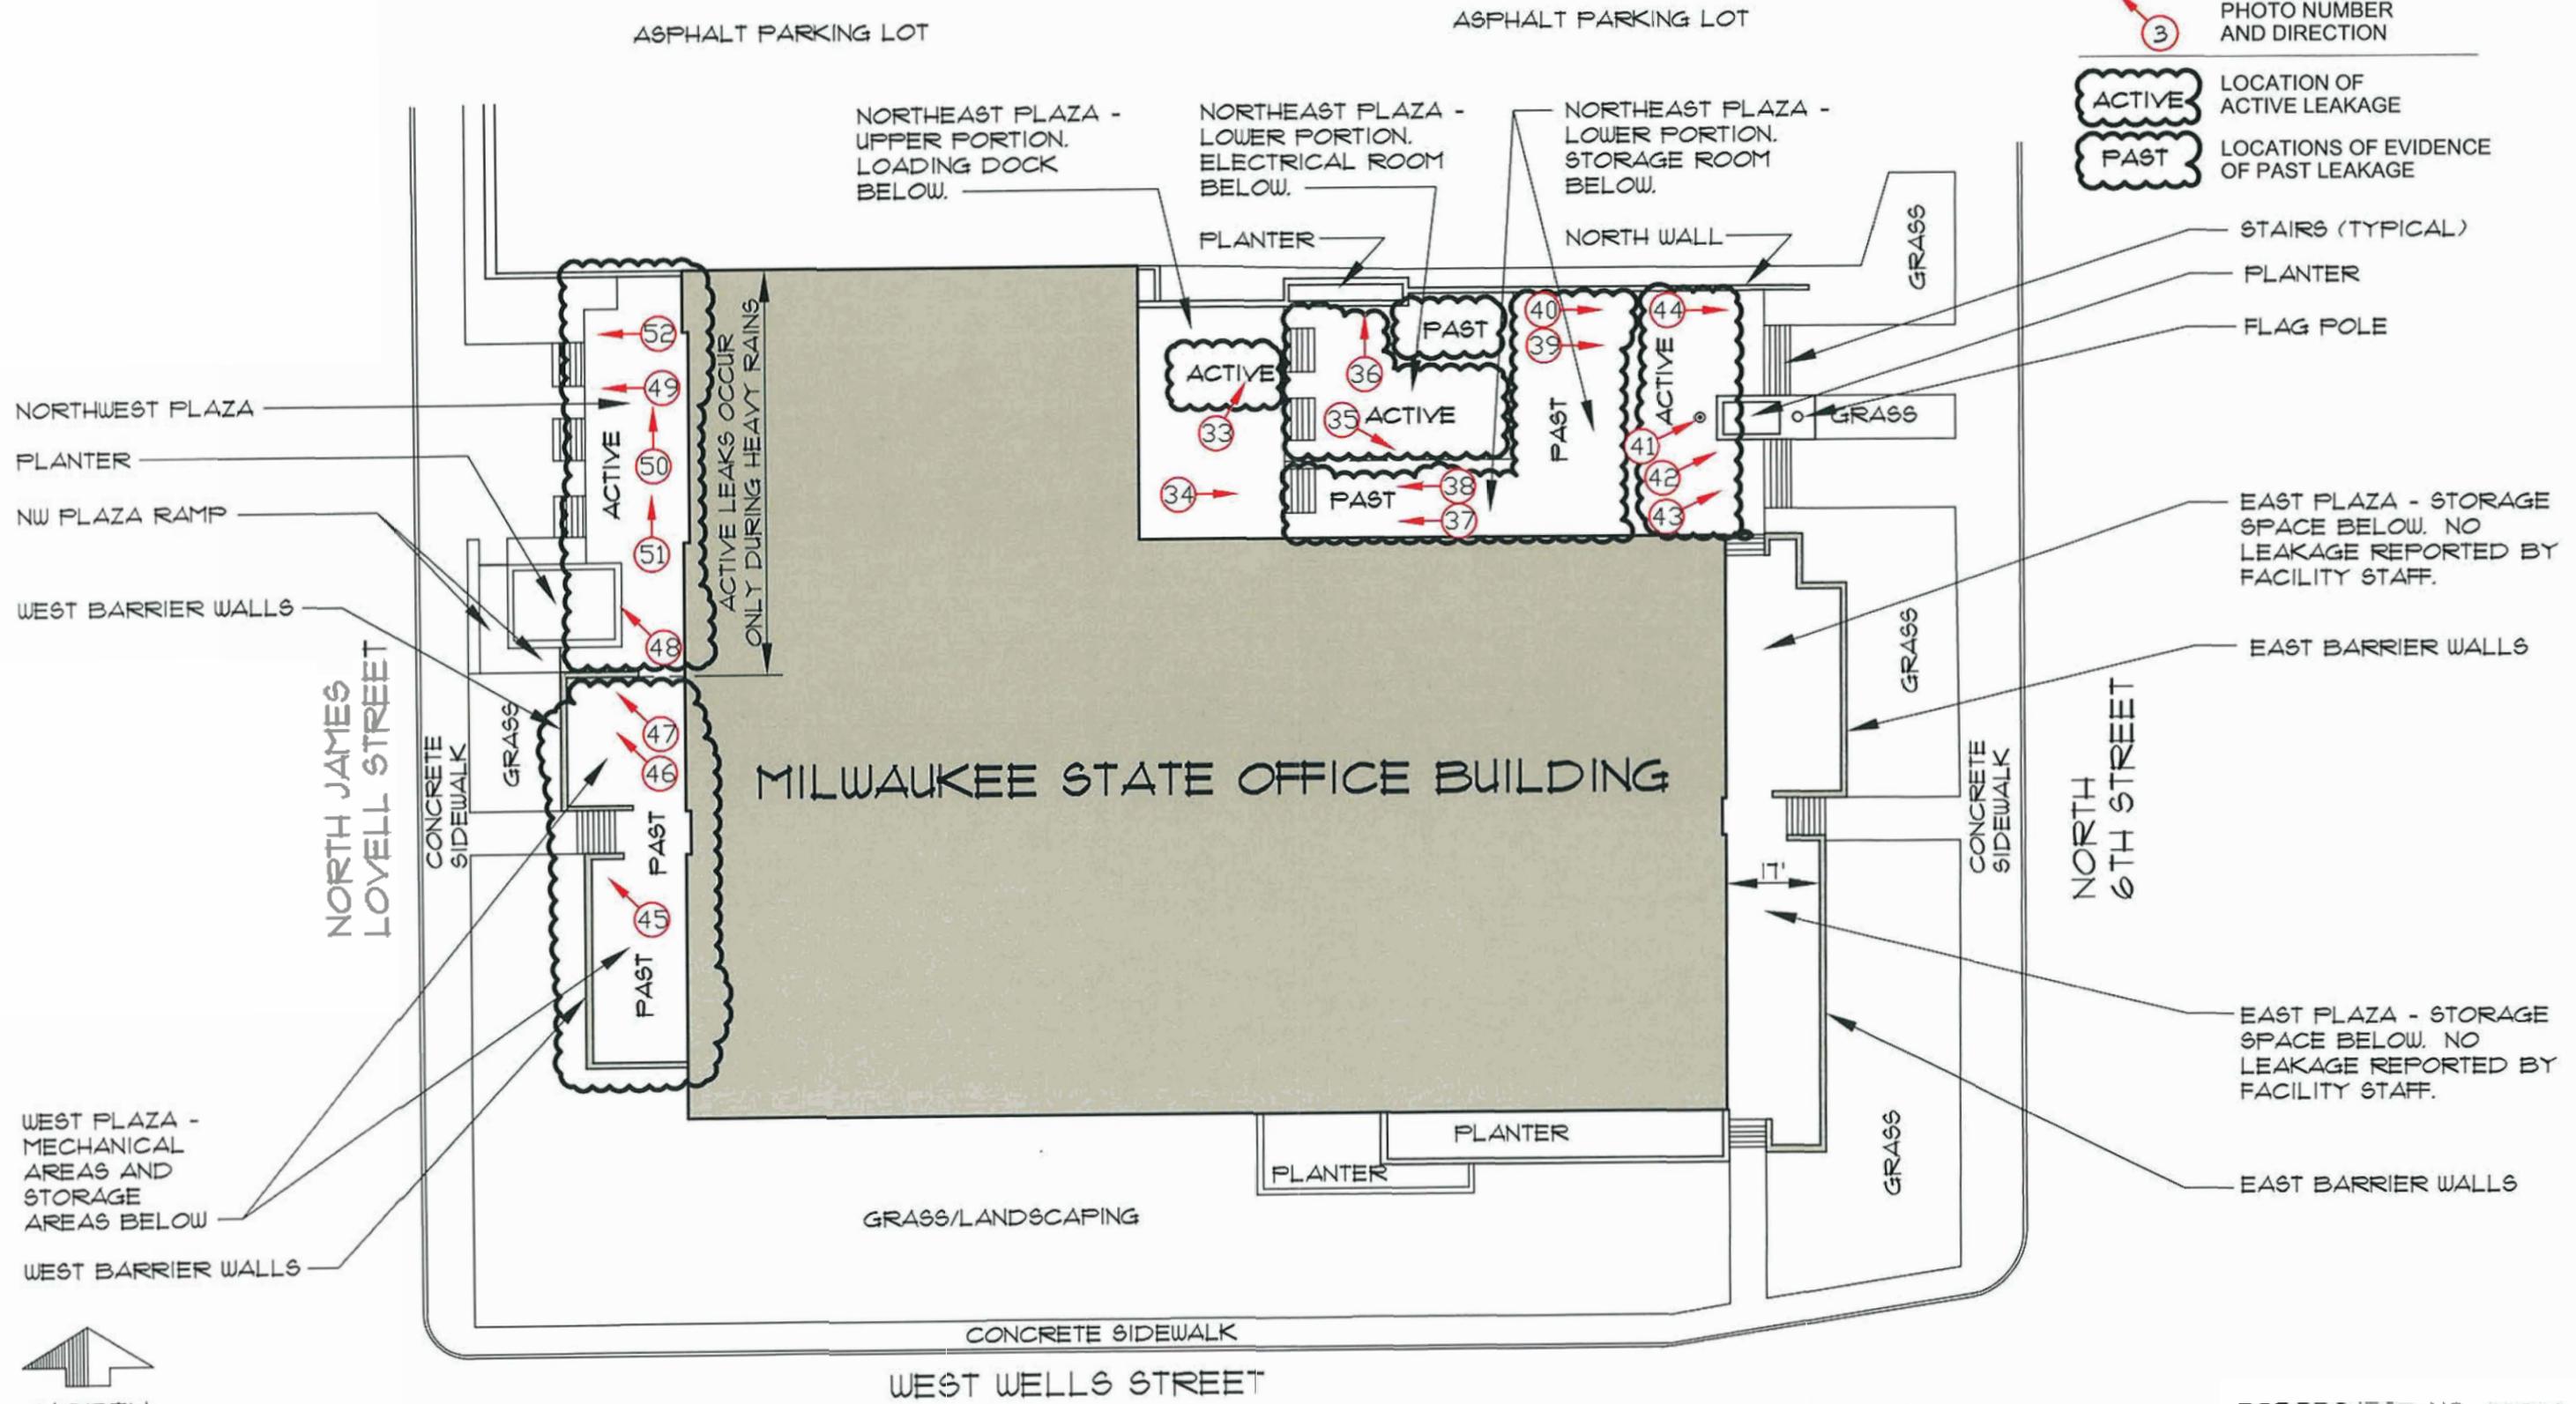
2 LEAK LOCATION SKETCH
1" = 30'-0" APPROXIMATE

Presently, water is infiltrating the occupied space below the northeast plaza and the northwest plaza. Extensive active leakage is present in the northeast plaza and active leakage in the northwest plaza occurs only during heavy rainfalls. Evidence of past leakage is present below the northeast and northwest plazas as well. Active leakage was not reported under the east and west plazas. However, evidence of past leakage was observed under the west plaza. See Sketch 2 – Leak Location Sketch and photos 33 through 52.

1. We reviewed existing construction documents from the original building construction in 1962 and the maintenance/repair drawings from 1988 and 1991. These documents were given to us by facility personnel.
2. We interviewed site personnel and visually surveyed and inspected the occupied space below the northeast, northwest, and west plazas regarding previous and present water infiltration. The locations of active water infiltration and locations of evidence of past water infiltration documented (see sketch 2). Leakage under the east plaza was not reported by facility staff.

PAST LOCATIONS OF EVIDENCE OF PAST LEAKAGE

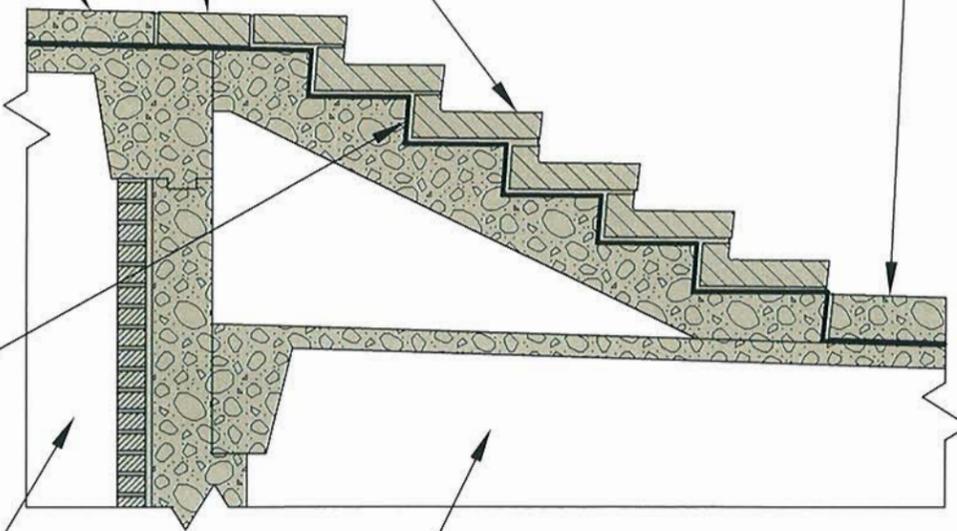
EXISTING DETAIL

- ✓ At staircases: The waterproofing membrane runs under the stone stair treads and then across lower structural deck or turns down onto the frost walls. See existing detail on Sketch 5 – Schematic Detail of Northeast Plaza Transition at Stairs.

EXISTING PLAZA SYSTEM:
CONCRETE WEARING SLAB OVER RUBBER WATERPROOFING MEMBRANE OVER CAST-IN-PLACE STRUCTURAL CONCRETE DECK

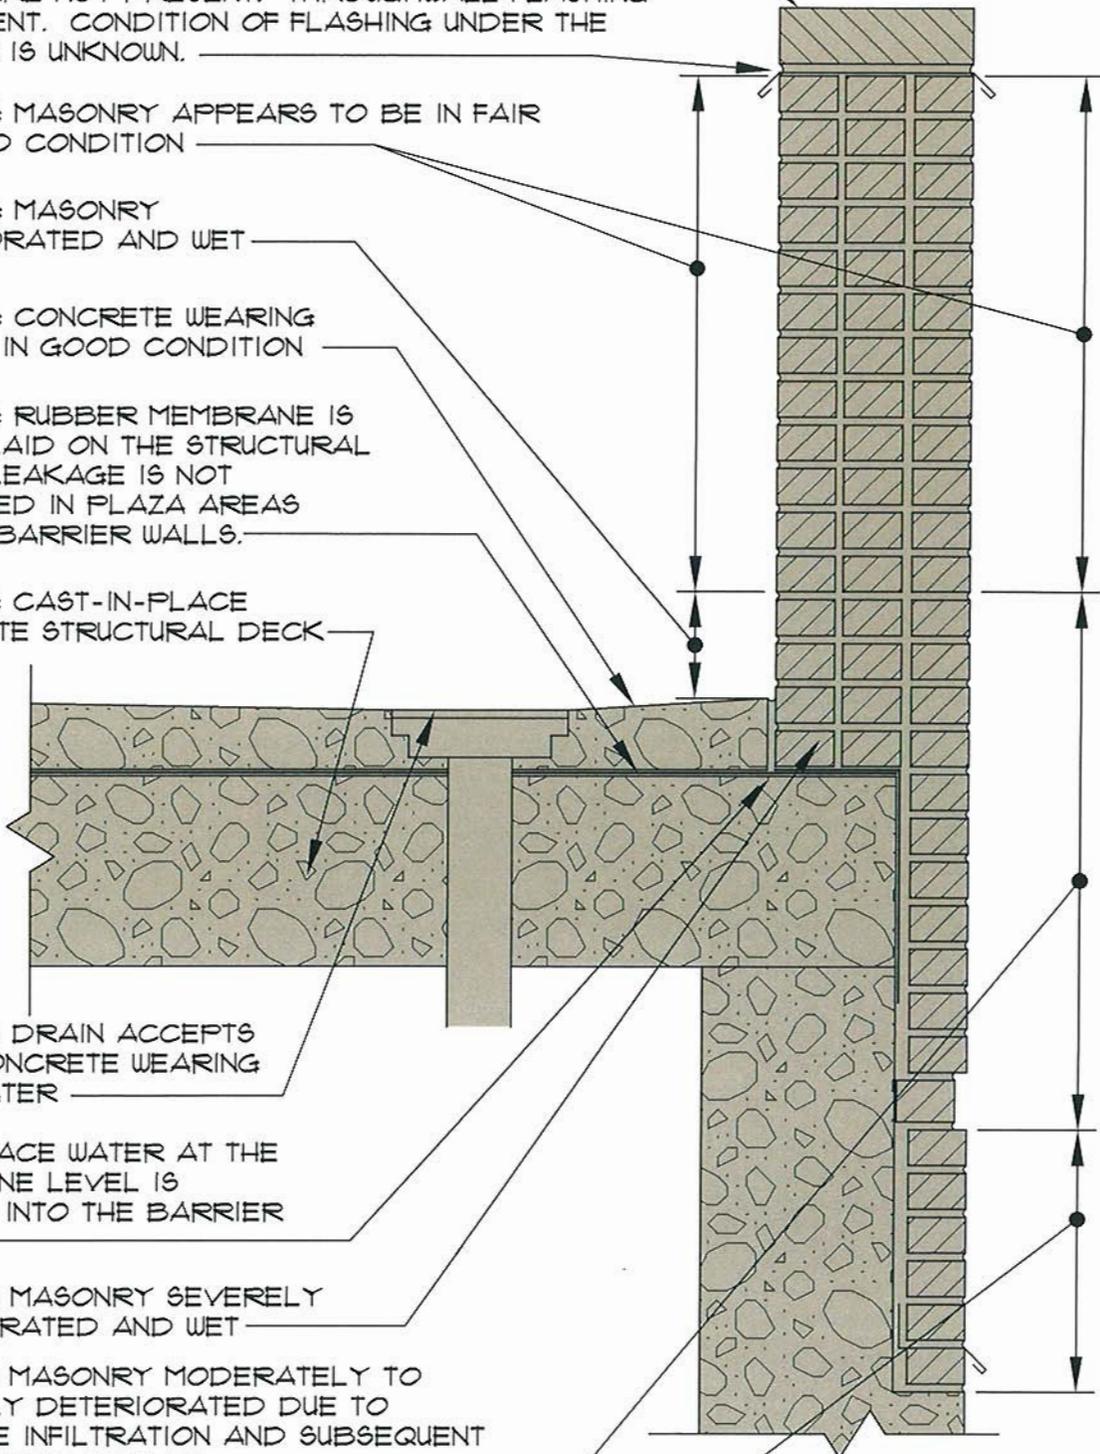
SCHEMATIC DETAIL OF EXIST. BARRIER WALL

- ✓ At barrier walls: The waterproofing membrane runs under the barrier wall and then turns down the foundation wall and runs between the concrete foundation wall (back-up wall) and masonry face brick. See Sketch 7 – Schematic Detail of Existing Barrier Wall.

We were able to verify the cause of the deteriorated brick at the barrier walls adjacent to the east and west plazas. Water is infiltrating the barrier walls due to inadequate detailing of the waterproofing membrane. The waterproofing membrane extends into the barrier wall and is turned down the foundation walls and runs behind the face brick (see sketch 7). Since the masonry is placed directly against the membrane without an air cavity, subsurface water is absorbed by the brick and mortar. Saturated bricks deteriorate quickly especially with the numerous freeze/thaw cycles that the walls are subjected to in this climate. The location of the worst deterioration of bricks is at the bottom of the interior face of the wall. The location of the worst deterioration of bricks for the exterior face of the wall is at the level of the waterproofing membrane and down several brick courses from there.

EXISTING MASONRY MODERATELY TO
SEVERELY DETERIORATED DUE TO
MOISTURE INFILTRATION AND SUBSEQUENT
FREEZE-THAW CYCLING

EXISTING MASONRY AND THROUGHWALL FLASHING
APPEARS TO BE IN FAIR CONDITION
