POWER PLANT

LORENZ HALL LOADING DOCK

**JSD PROFESSIONAL SERVICES, INC
POWER PLANT-COAL STORAGE BIN BUILDING (CSB)
OPINION OF PROBABLE RESTORATION COSTS**

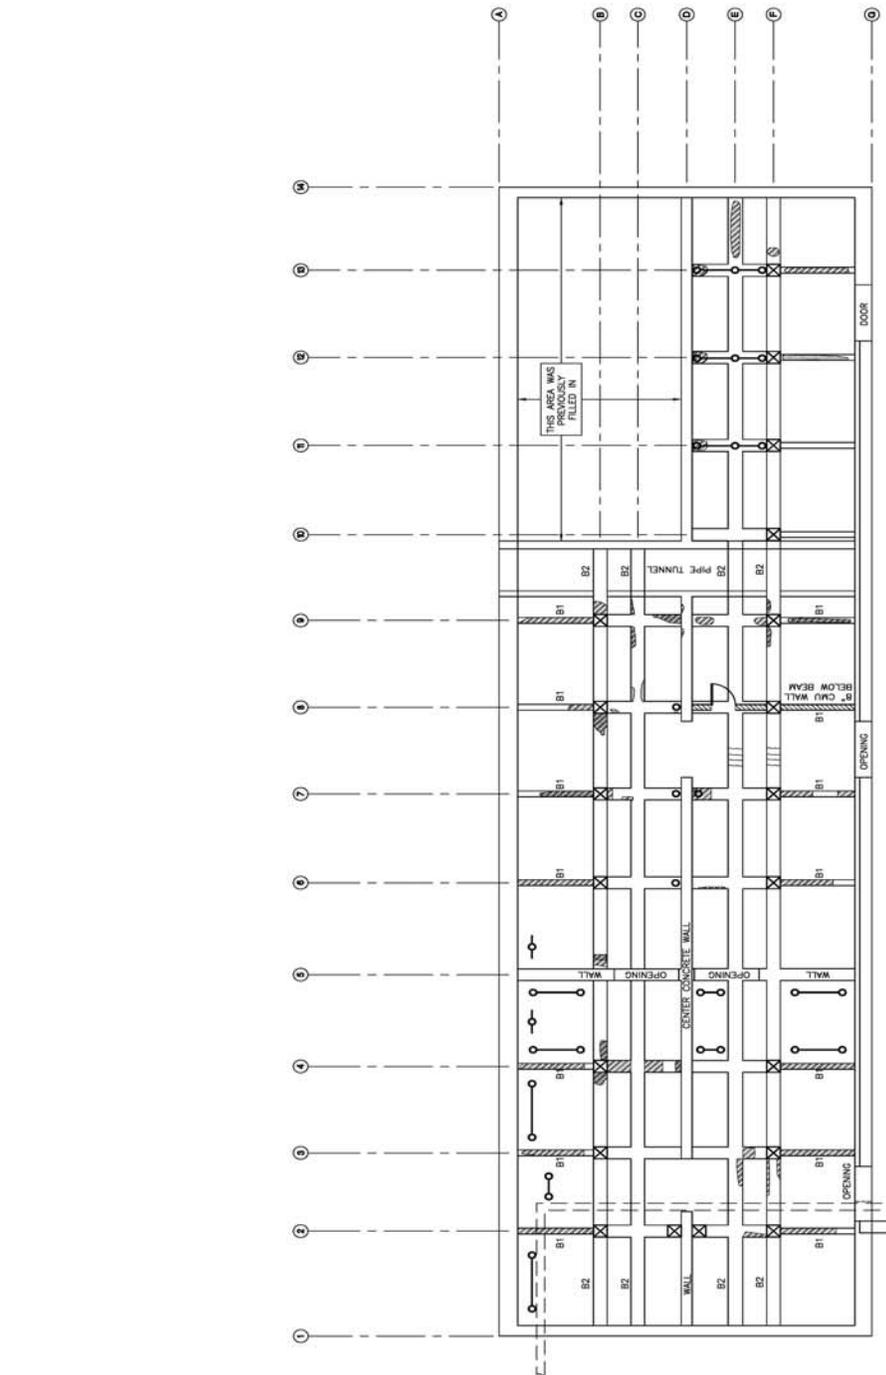
UNDERSIDE BEAM PLAN
 SCALE: 1/8" = 1'-0"

The concrete beams which span from the exterior walls at the North and South side of the CSB to the first interior beam lines are all severely spalled. These beams are 10" wide; all other beams are 20" wide. The slabs between these beams are also badly deteriorated. Lesser amounts of concrete spalling were present on the other beams. There are concrete spalls around many of the in-filled coal chutes and signs of leaking. There is some cracking and spalling on concrete columns and walls. Cracks and spalls at the interface of some beams and concrete walls seem to indicate that there was a lateral shift in the structure at some time. The concrete beams look like they are pulling out of the walls into which they are bearing. This could have occurred as a result of the dynamic loading from the rail cars and the coal dumping process. It was observed that there is some cracking and spalling within the concrete patching from the previous restoration.

Concrete restoration to the underside of the CSB structure will include removal and replacement of deteriorated concrete on the underside of concrete beams, and on columns and walls. Cracks on interior walls that are non-bearing or not posing any structure concerns can remain as they are. Aesthetics are not a key concern.
