Specialty Engineering Group LLC

Re: Chapman Hall Roof Replacement
University of Wisconsin – Milwaukee
Milwaukee, Wisconsin
DSF Project No. 00000
SEG Project No. 11806

This letter represents the Design Development (Designer – Drafter Report) phase for the above referenced project.

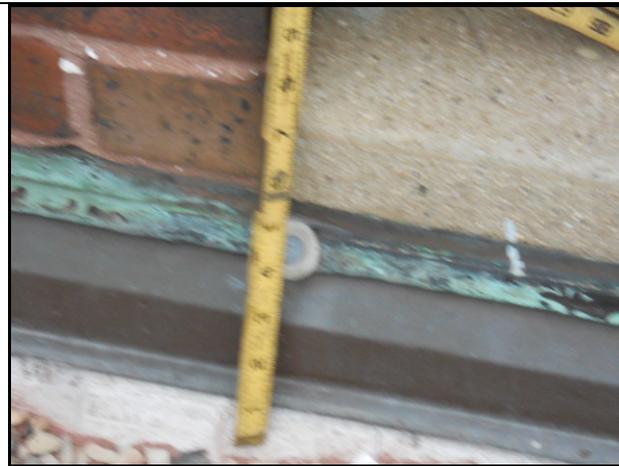
The flashing heights will be below minimums required by the manufacturer to issue a warranty on all portions of the roof.

Low Flashing Height on Low Sloped Roof Area

Reuse existing built-in receiver, provide new copper counter flashing

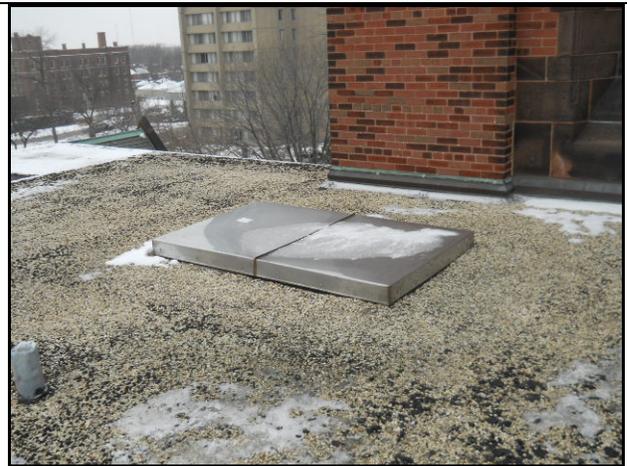
Curb to Be Removed on Low Sloped Area

Two (2) unused vents to be removed and new decking installed

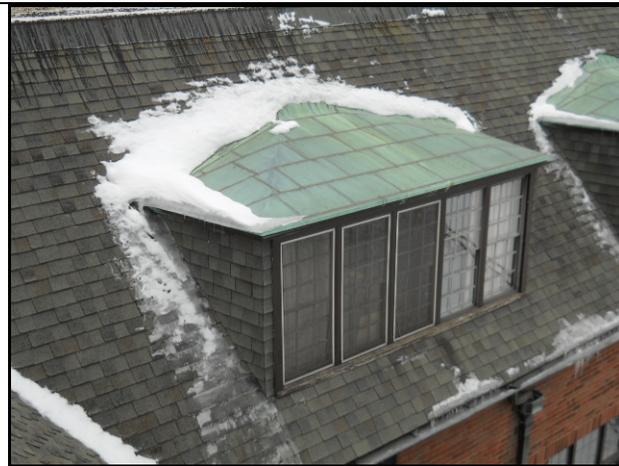
Dormer with Copper Roofing and Shingle Sidewalls

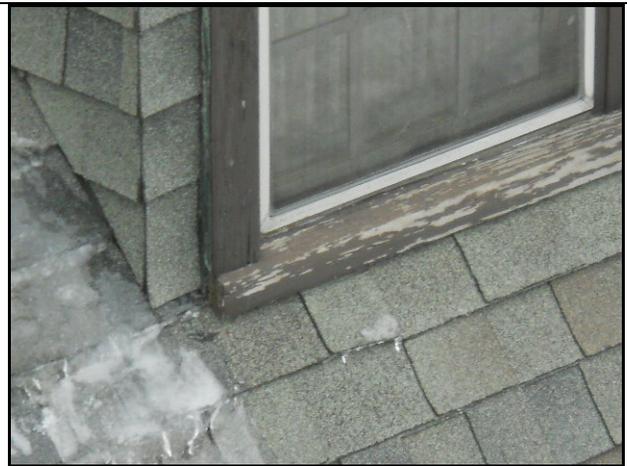
Deteriorated Wood Windows

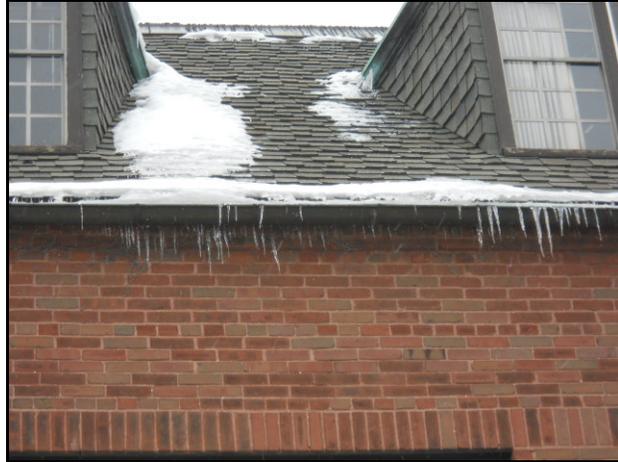
Existing gutters are deteriorated and displaced due to ice. Downspouts and conductor heads are in good condition. Counter flashings and flashings will require replacement

Ice Behind Existing Gutters

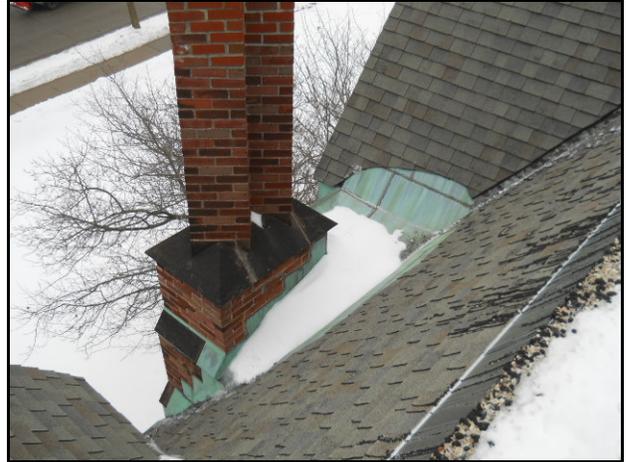
Large Copper Flashing

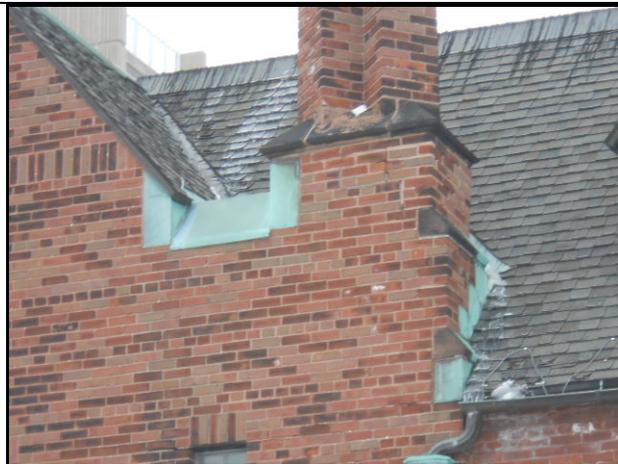
Large Copper Flashing
