Devil's Lake Sewer System Evaluation

Devil's Lake State Park

DSF Project No.: 10B30

March 11, 2011

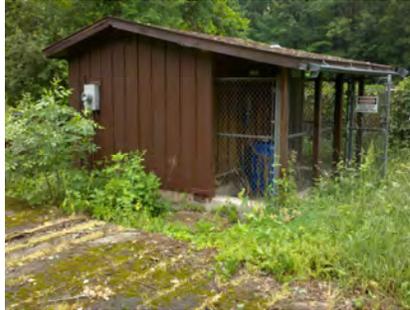
North Shore Wastewater Pumping Station Exterior

The present configuration of the pumping station is composed of head works, a concrete wet well, a concrete sub-grade dry well housing two dry pit centrifugal pumps. A control room above the dry well houses the pump motors and controls. The control room is enclosed in a wood framed structure with wood siding and a shingled roof that extends over the headworks and wetwell (see pictures following). The pumping station is located adjacent to a concrete septic tank that is currently used as an overflow tank for pumping station wetwell.

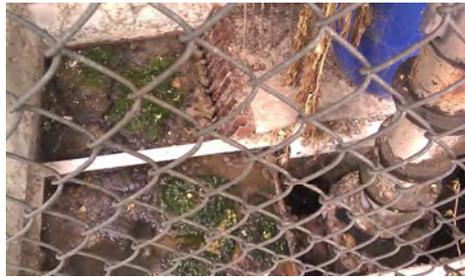
Head Works Channel (Comminutor & Bar Screen)

The head works of the North Shore Pumping Station are enclosed with a chain link fence and are exposed to the elements. The head works include a comminutor and stationary bypass bar screen above a concrete wet well. The comminutor is operated by a 1/3 hp 230 volt single phase motor manufactured by General Electric. Almost all of the paint on comminutor and motor has peeled away leaving a rusting metal exterior. The intended function of the comminutor is to grind and shred solids in the wastewater so that they may pass through the pumps. However, the comminutor clogs on a regular basis and a grabbing tool is used to remove solids that are stuck in the open top of the comminutor. A thick layer of solids, debris and algae was observed in the channel upstream of the comminutor and on bypass bar screen which impeded flow through the head works. Below the head works is a 9' x 4' x 12' deep concrete wet well.

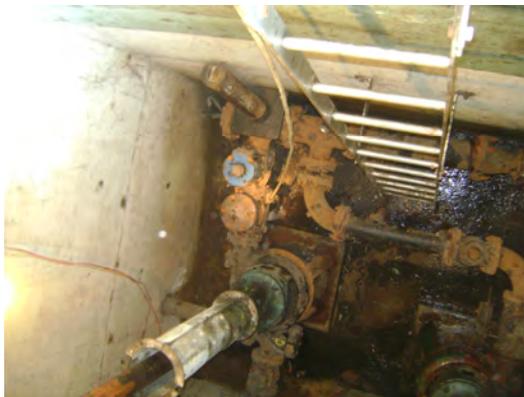
Drywell (west side)

An aluminum access ladder is used to enter the dry well. The floor of the dry well was moist, and wastewater appeared to be leaking from the seal of Pump #2. There is a ventilation fan in the control room with an intake in the dry well and exhaust duct through the side wall of the control room. However, there was a noticeable sewage smell coming through the access opening to the dry well. A rope is connected to the lever of the check valve on Pump #1 to back flush the pump when clogging occurs. The dry well was lacking an automatic heater, dehumidifier and sump pump as required by paragraph NR110.14(3)(b) & (d) of the Wisconsin Administrative Code.

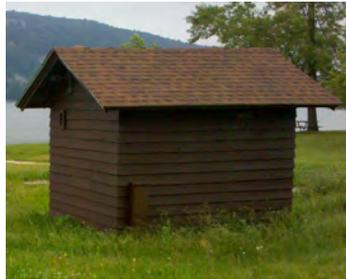
South Shore Wastewater Pumping Station Exterior

The South Shore Pumping Station is composed of head works, a concrete wet well, a concrete sub-grade dry well housing two dry pit centrifugal pumps. A control room is located above the dry well housing the pump motors and controls. The control room is enclosed in a wood framed structure with wood siding and a shingled roof.

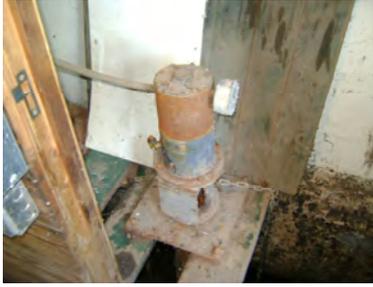
Head Works Room/Comminutor

The head works of the South Shore Pumping Station are enclosed in a room adjacent to the control room and are 6 feet lower than the floor of the control room. The head works include a comminutor and stationary bypass bar screen above a concrete wet well. The comminutor is operated by a 1/3 hp 230 volt single phase motor manufactured by General Electric. Almost all of the paint on comminutor and motor has peeled away leaving a rusting metal exterior. The function of the comminutor is to grind and shred solids in the wastewater so that they may pass through the pumps. However, a large amount of debris was observed in the head works channel and bypass screen. There is a door frame, without a door, in the wall between the control room and the head works room. No caution sign, as required by Paragraph NR110.14(3)(b)4. of the Wisconsin Administrative Code, near the entrance to the head works room. The ceiling over the head works room, and the adjacent control room, is open to the roof trusses. Since the head works room (and entire structure) is open to the wet well below, hazardous and potentially explosive gases could be present in the head works room. Current code requires the wet well to be completely separated from the control room, common walls to be a gas tight, and a separate exterior entrance for the head works and/or wet well.

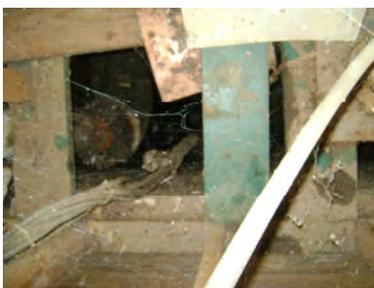
Wetwell (below wood framing)

Below the head works is a 20' x 11' x 11' deep concrete wet well. The head works channel, comminutor and bypass screen sit 6 feet below the top of the wet well. Two gravity pipes (Pipe 106 & Pipe 107 on the **South Shore Sanitary System Map** found in the **Appendix**) discharge into the head works channel. One pipe is from the west and one from the east. There is a 4' tall wall in the wet well which vertically aligns with the outside edge of the head works room. This wall separates the part of the wet well below the head works room from the part that is buried outside. Based on sketches provided by Park staff, normal operating pump on liquid level is set at of 3.95' which provides an approximate wet well operating volume of 6,500 gallons. This operating volume provides a detention time in excess of 30 minutes which is the maximum allowed by current code. There is a ventilation fan in the head works room with an intake in the wet well and exhaust duct through the side wall of the head works room. The exposed top portions of the wet well concrete appeared to be pitted and crumbling. There was a deteriorated permanent fixed ladder into the wet well from the head works room which is not currently allowed per Paragraph NR 110.14((3)(b)3. of the Wisconsin Administrative Code. The interior of the wet well beyond the head works room was not observed as it was not dewatered for observation at the time of the site visit. However, based on conditions of the portions of the wet well visible in the head works room, it is reasonable to assume that the rest of the wet well may be of the same deteriorating condition also in need of repair or replacement.

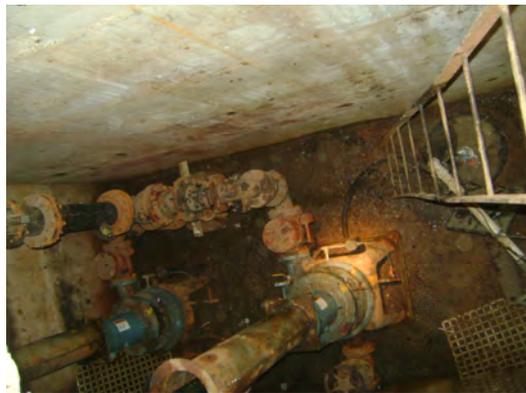
Drywell

An aluminum ladder is used for access into the dry well, is not secured to the wall, and has one bent side rail. The floor of the dry well was moist, and there appeared to be a thin mat of rust. The dry well is lacking an automatic heater and dehumidifier as required by paragraph NR110.14(3)(d) of the Wisconsin Administrative Code.

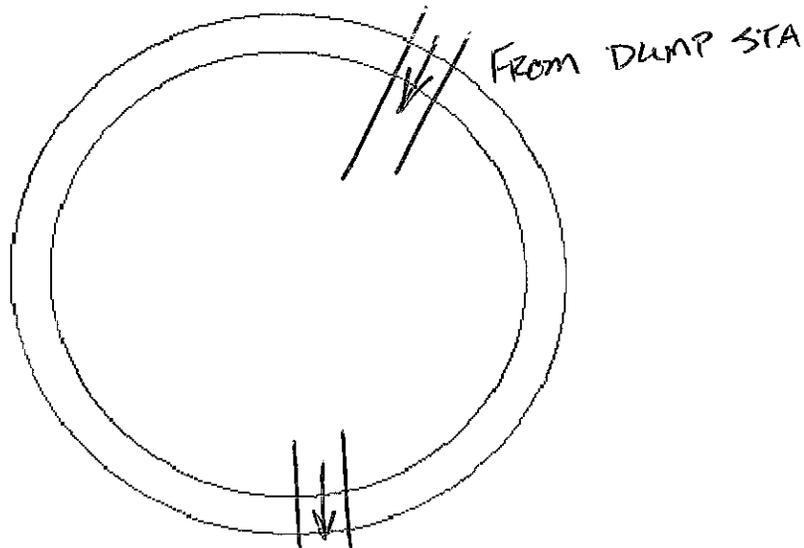
CASTING LOOSE

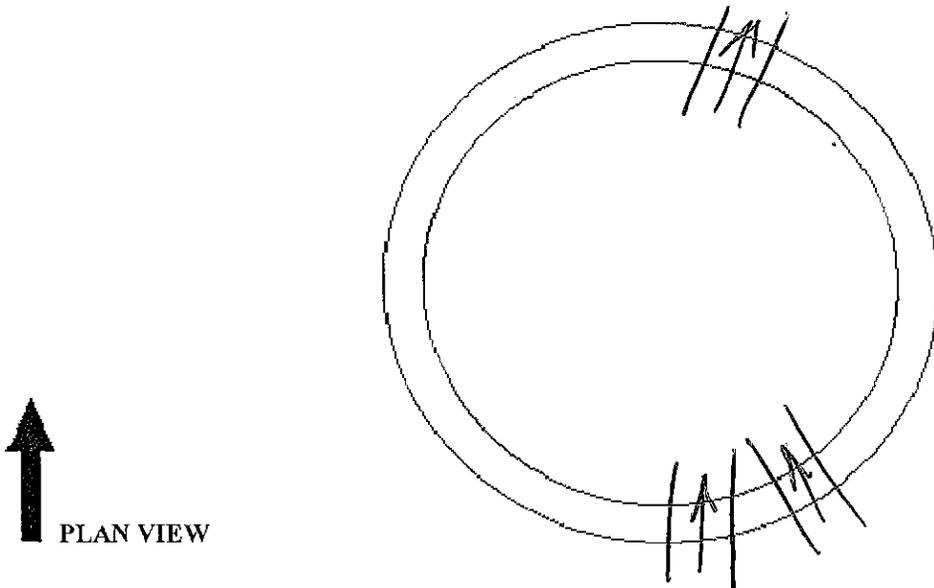
3" BELOW SURFACE
INFILTRATION

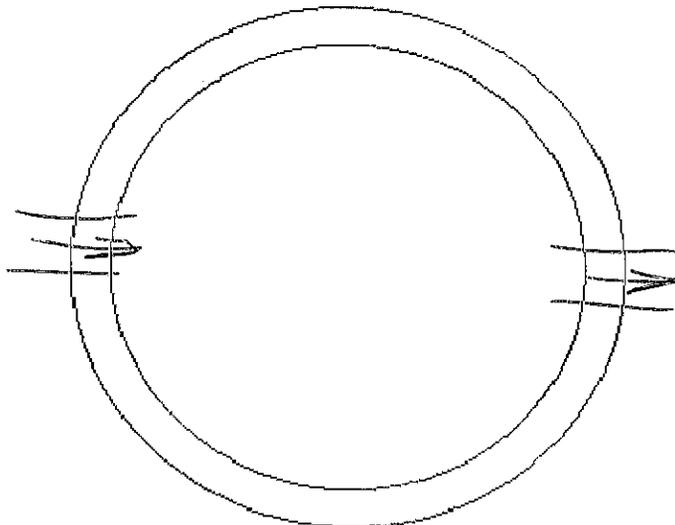
INFILTRATION
SOLIDS BUILD UP

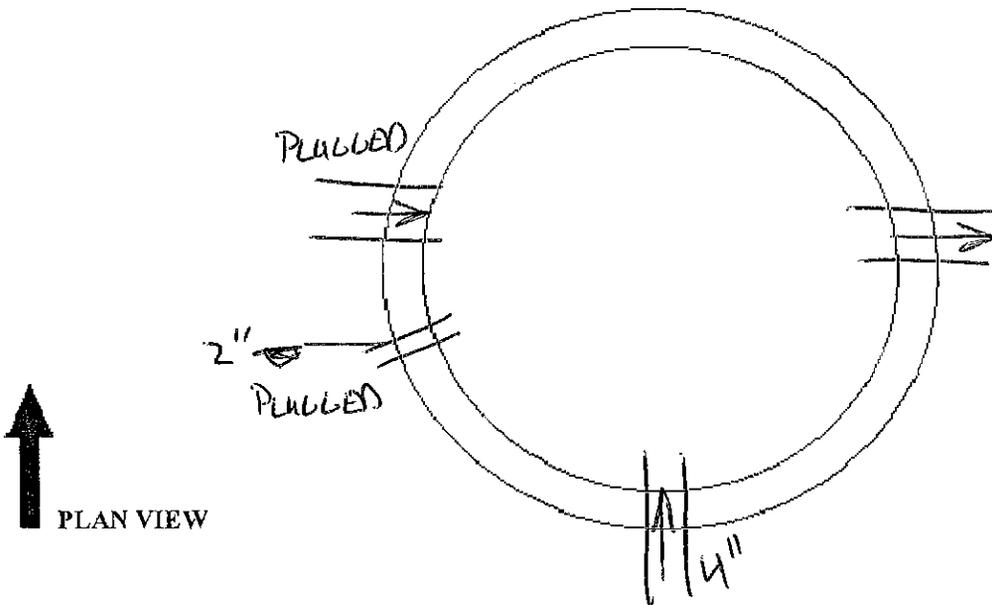
INFILTRATION FROM 2"
SOLID BUILD UP

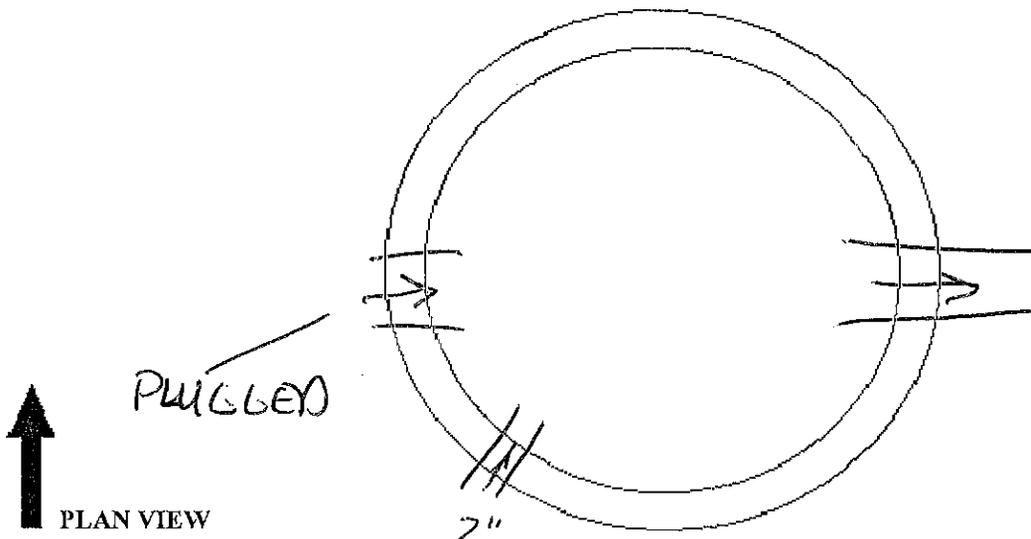
6" BELOW SURFACE
INFILTRATION
SAND

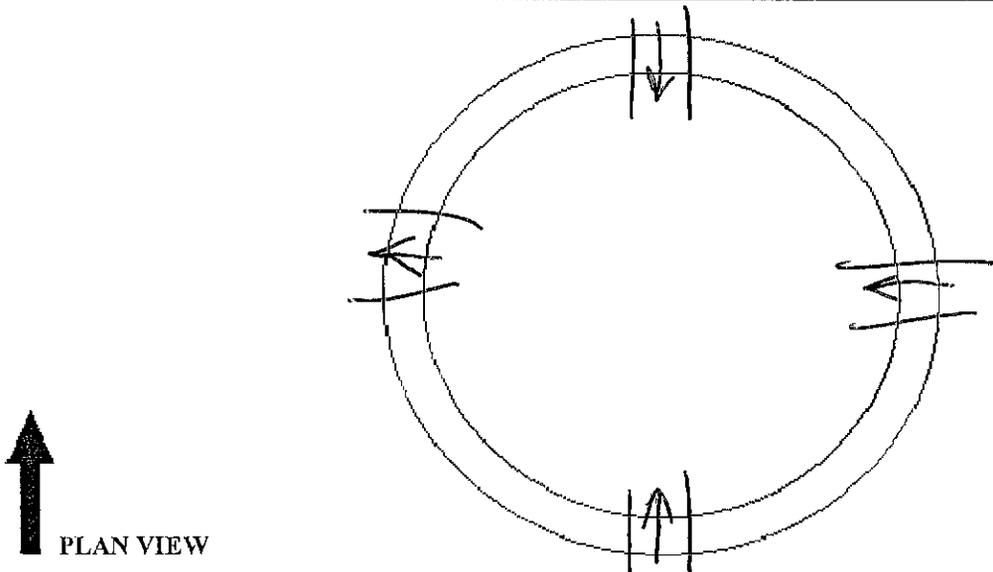
CRACKED LID
 ROCK & GRAVEL IN PIPES
 NO FLOW

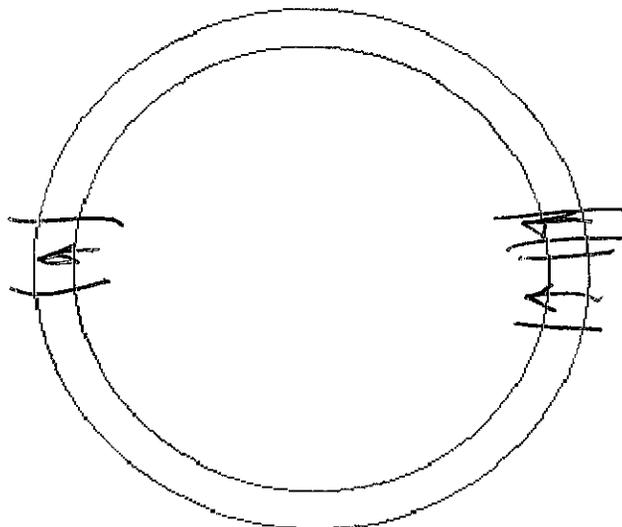
CRACKED LID
DROP MH

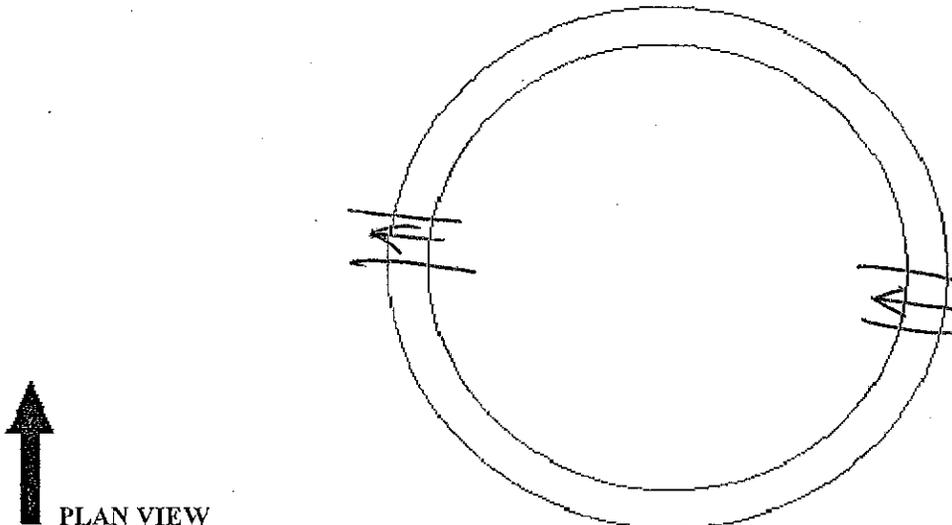
SOLIDS BUILD UP
OLD CONCRETE RIM BROKEN IN BOTTOM

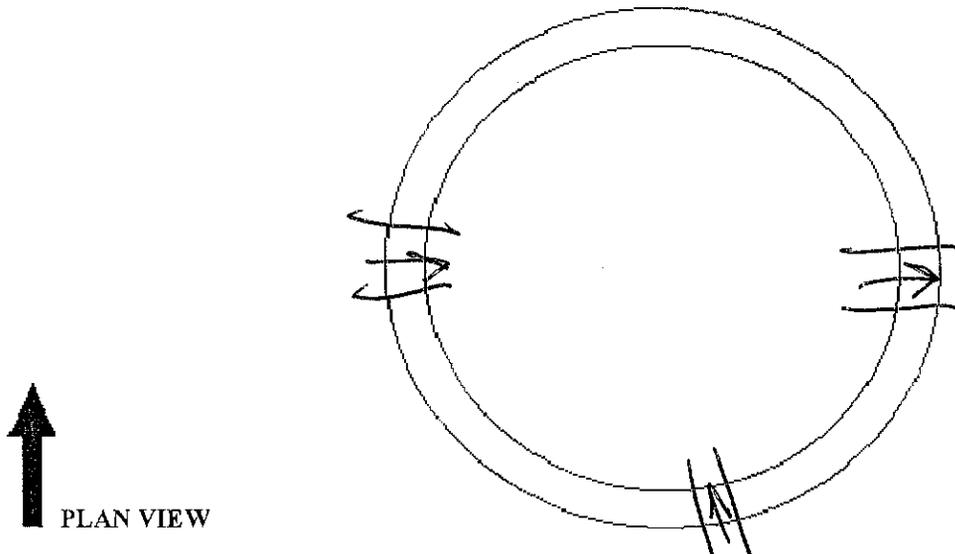
SOLIDS BUILD UP
CRACKING OF STONE NEAR TOP
