November 2012

KETTLE MORaine CORRECTIONAL INSTITUTION

WATER SYSTEM EVALUATION

WISCONSIN DEPARTMENT OF ADMINISTRATION
PROJECT NO. 11L11

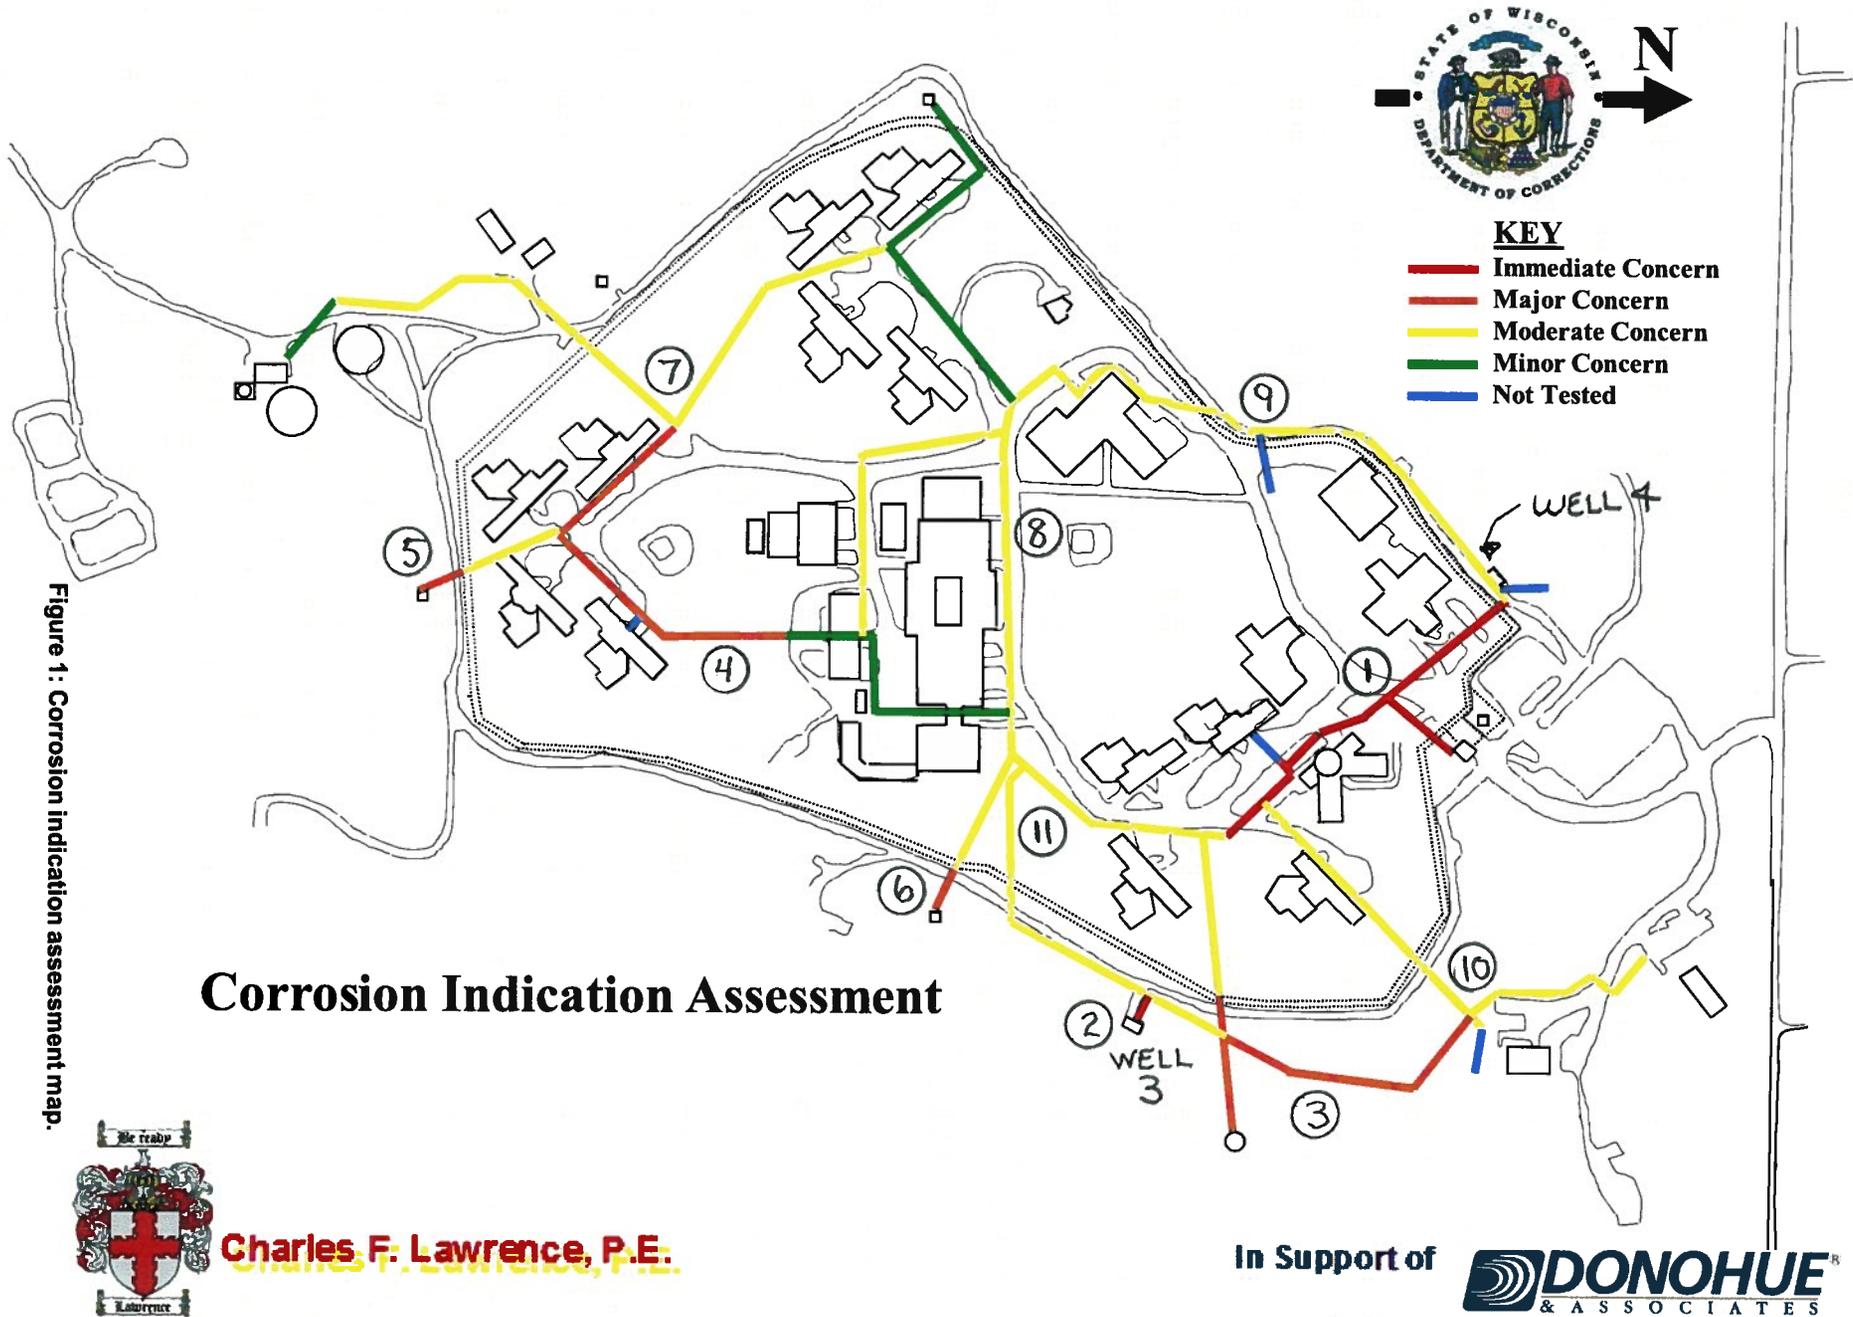
Figure 1: Summary of Corrosion Indication Assessment

The report showed that approximately 8 percent of the distribution system is highly likely to experience an increasing rate of near-term pipe failure. 16 percent is likely to begin to experience failures in the near future. The corrosion and reduced service life for the piping is likely attributed to soil conditions which are not favorable to ductile iron pipe.

Figure 1 is a summary of the corrosion indication survey. The survey identified the following piping classifications:

- Immediate Concern
- Major Concern
- Moderate Concern
- Minor Concern

The Immediate Concern piping identified as Segment 1 is the line that runs across the site between Well Nos. 3 and 4. This is the same line that experienced numerous failures in 2011.

The line running to the elevated storage tower was rated as a Major Concern. This line experienced a break in December 2011.

Figure 1: Corrosion indication assessment map.

- Piping that was found to be highly likely to experience near-term failure (Immediate Concern) should be replaced.
- Piping that was found likely to begin to experience failure (Major Concern) should be replaced as funding and schedule allow.
- The soil environment at KMCI is not favorable for ductile iron pipe. Non-metallic water main or cathodic protection for new metallic mains should be considered.

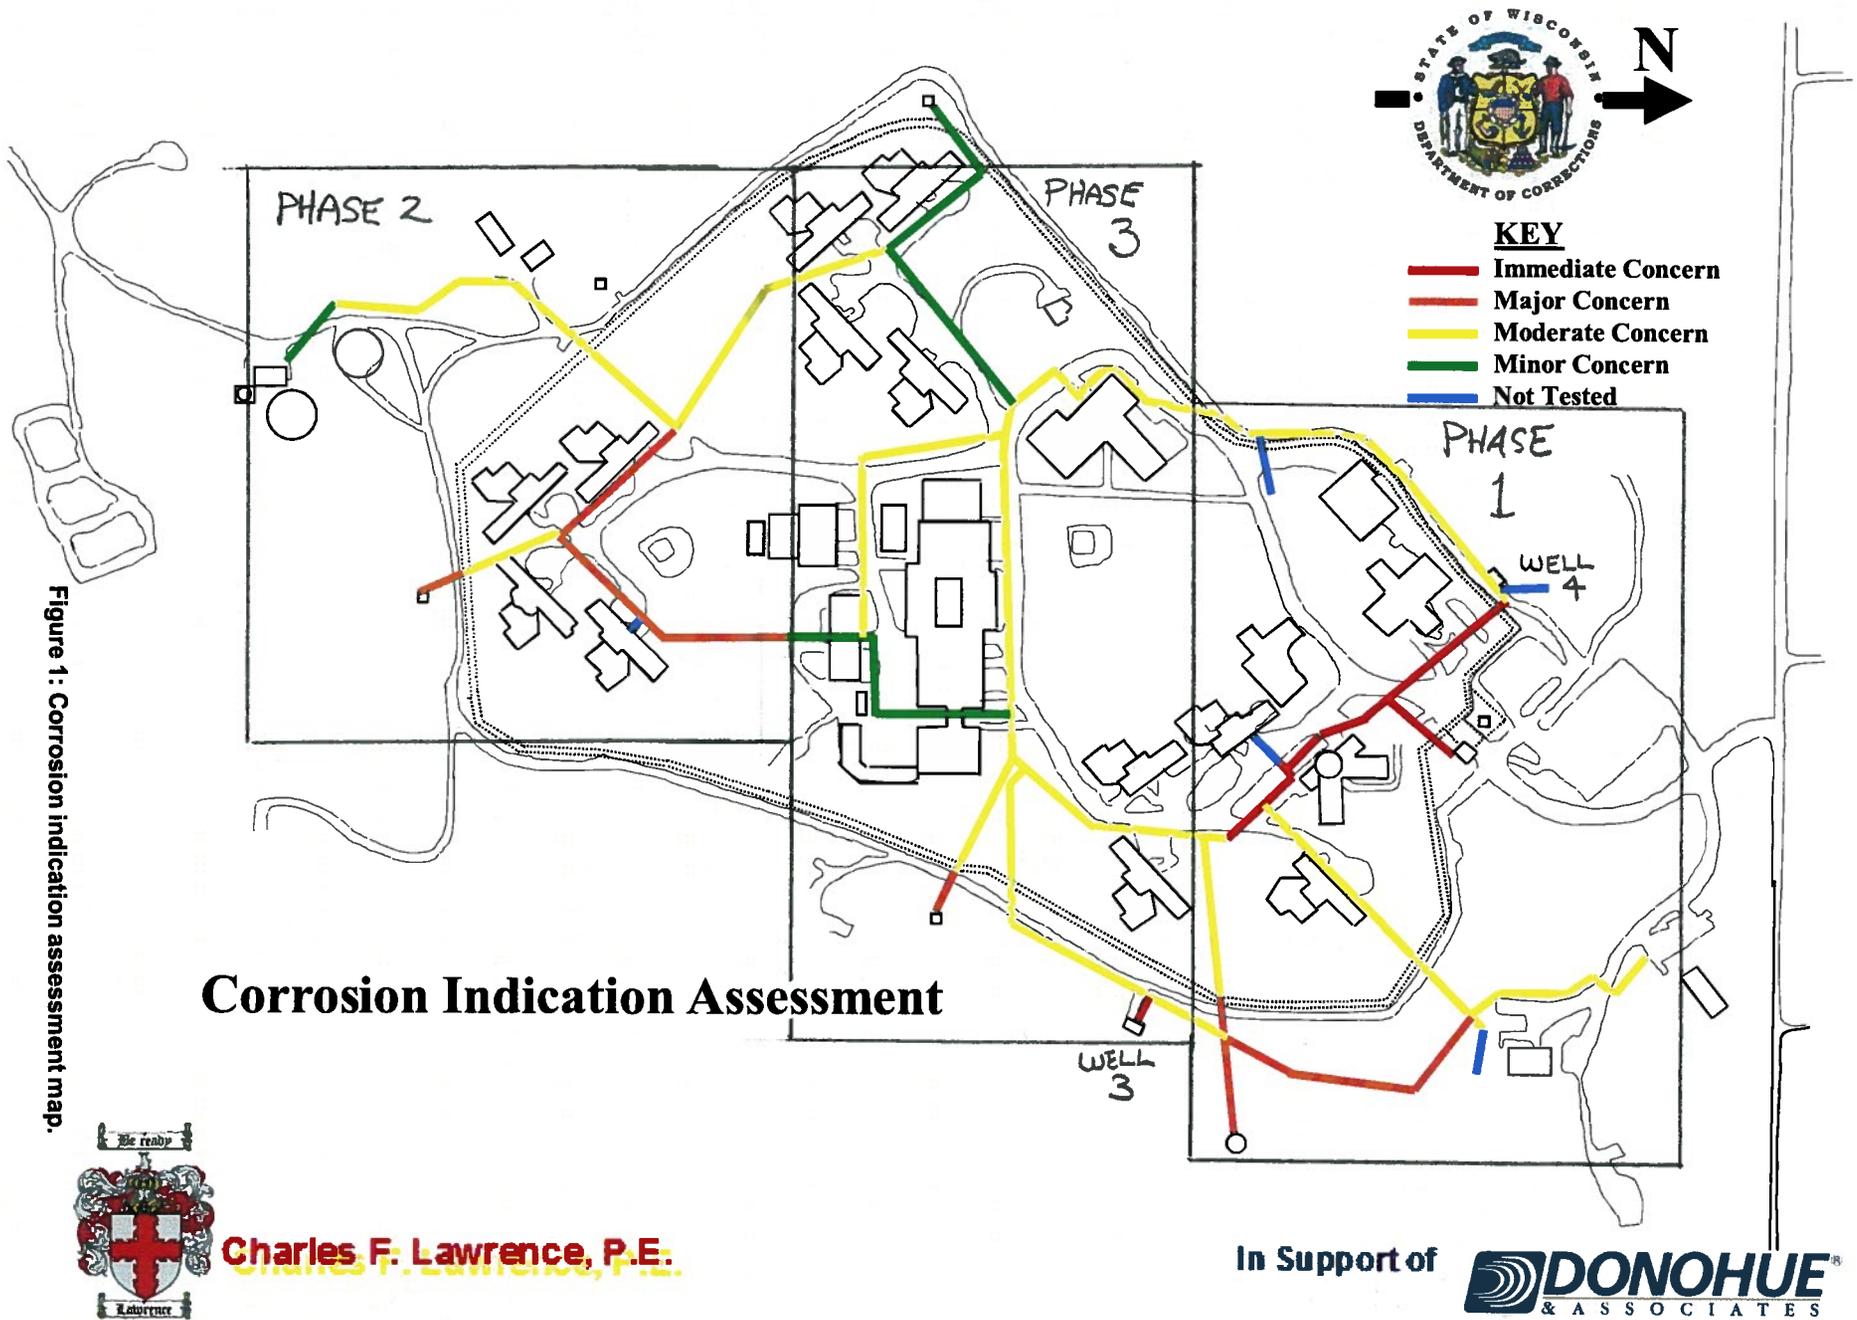
Figure 2: Recommended Distribution System Replacement Phasing

Three zones were identified and are shown in Figure 2. The first project would focus on the north side of the facility where most of the line breaks have been occurring. The second project

would focus on the south side of the facility where there is some Major Concern piping. The third project would focus on the center of the facility where most of the piping is of Moderate and Minor Concern.

Construction cost opinions were prepared for each zone, and are summarized in Tables 1-3. The following assumptions were made:

- Non-metallic C900 piping, 8-inch diameter (upsized from the existing 6-inch diameter)
- Replacement of fire hydrants (included in contingency)
- Replacement of existing valves, and additional valves to better isolate buildings and distribution piping segments for maintenance/repairs
