**DEPARTMENT OF VETERANS AFFAIRS
KING & UNION GROVE BUILDING EVALUATION**

EMPLOYEE DORM

Project No. 08F2B

Prepared by:
Berners-Schober Associates, Inc.
Architects/Engineers

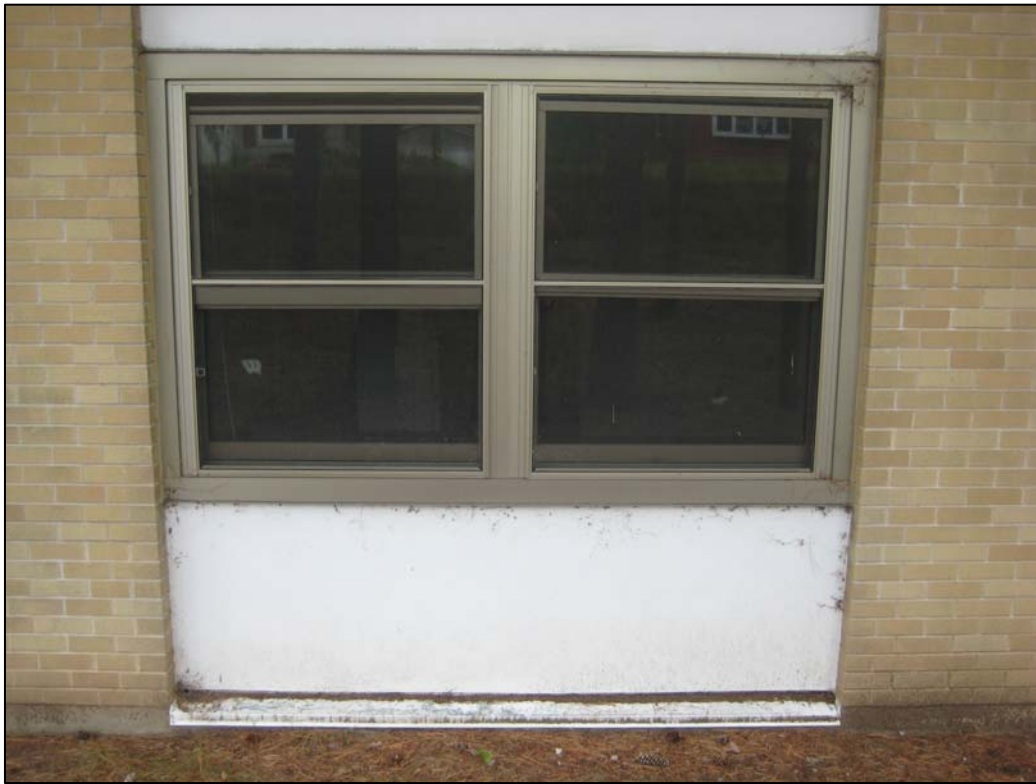
Original Aluminum Windows

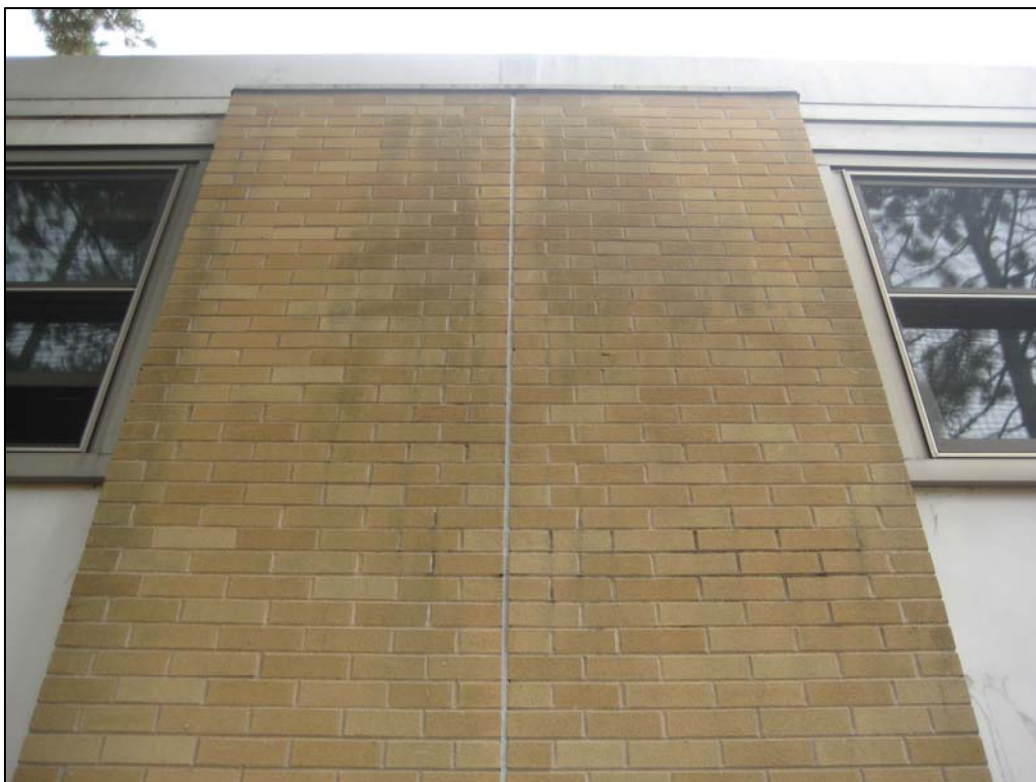
Typical Staining of Brick found around the Building's Exterior

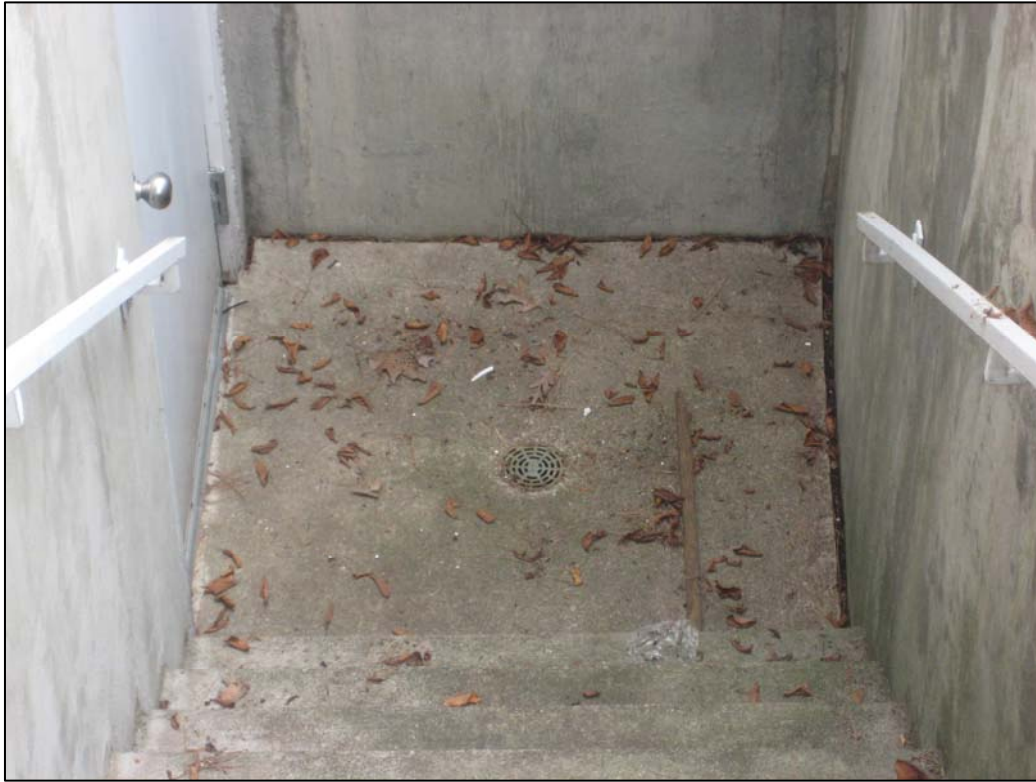
Drain at Bottom of Basement Exit Stair

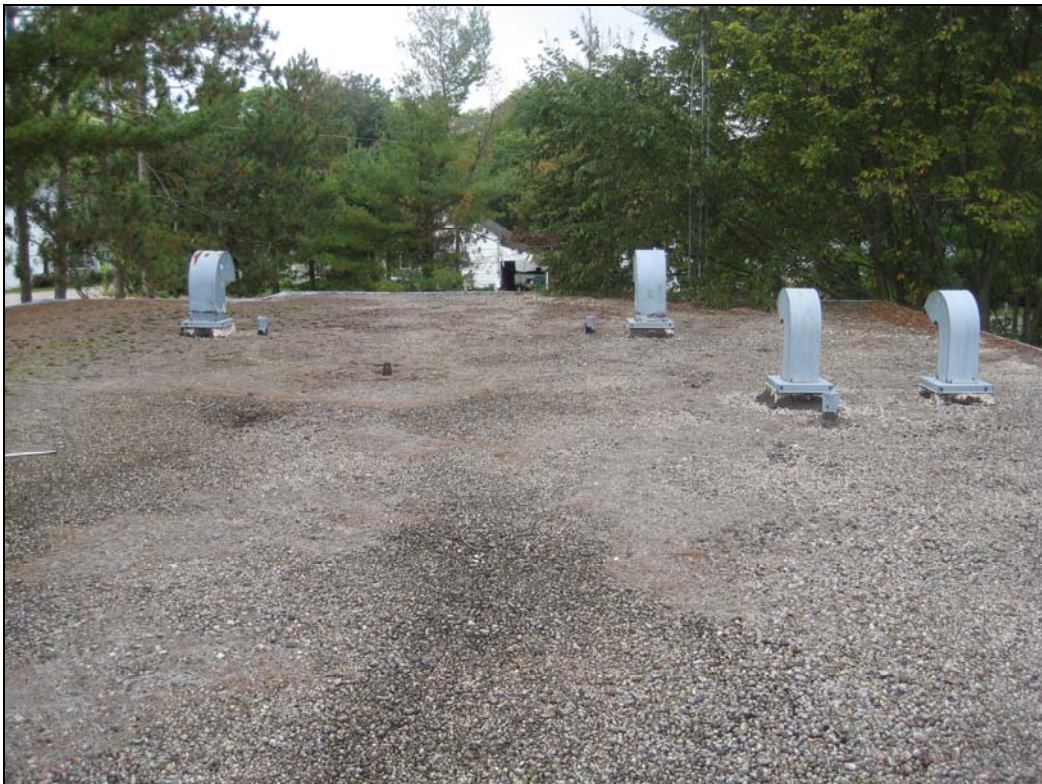
View of Roof and Vegetation Growth

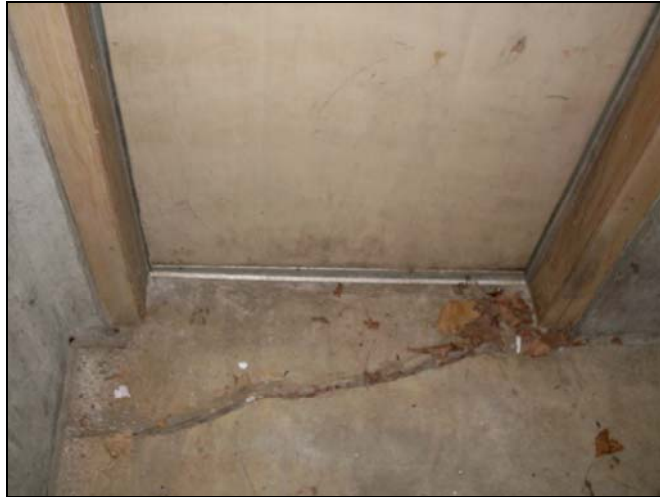
Cracks in Basement Concrete Floor Slab at Exit Door

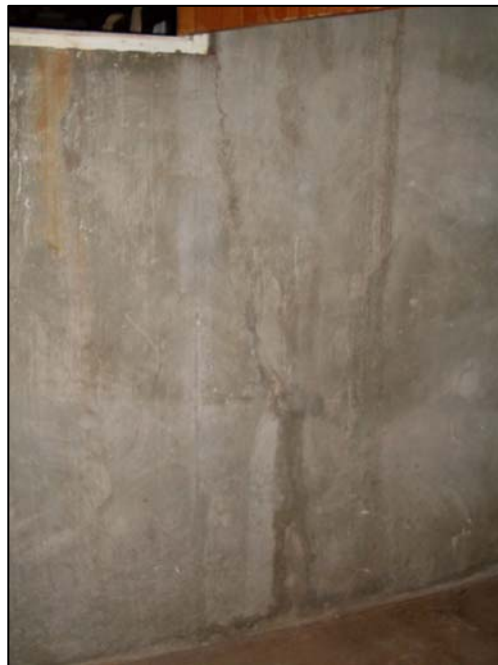
Cracks in Crawl Space Concrete Foundation Wall

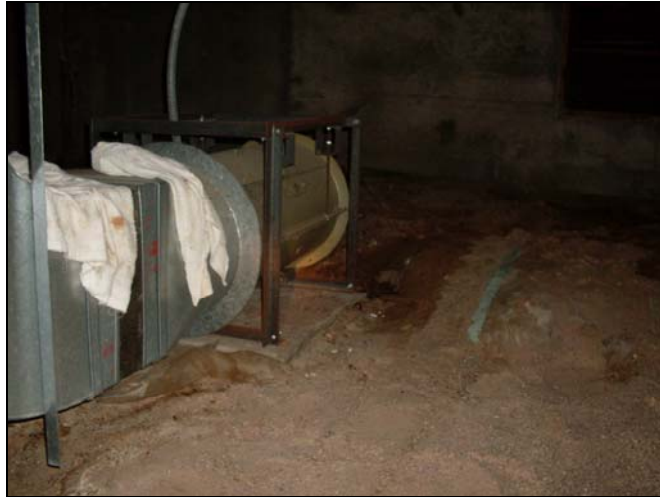
Soil Backfill at Crawl Space Appeared to be Moist during Site Visit due to Possible Pipe Leak(s)

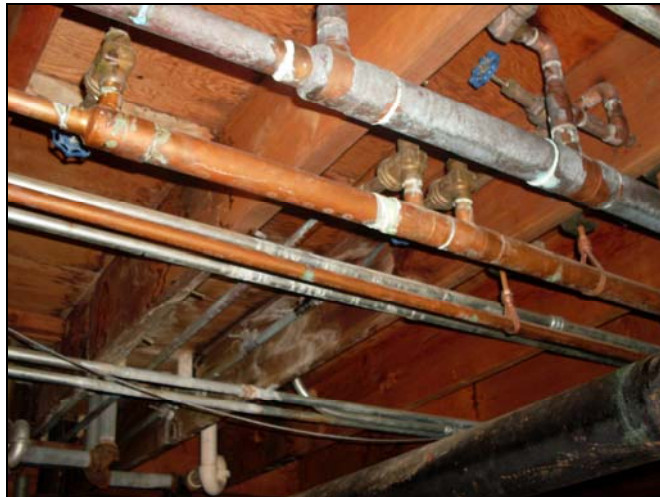
Severe Water Stains and Possible Rotting of Floor Joists above Crawl Space due to Possible Pipe Leak(s)

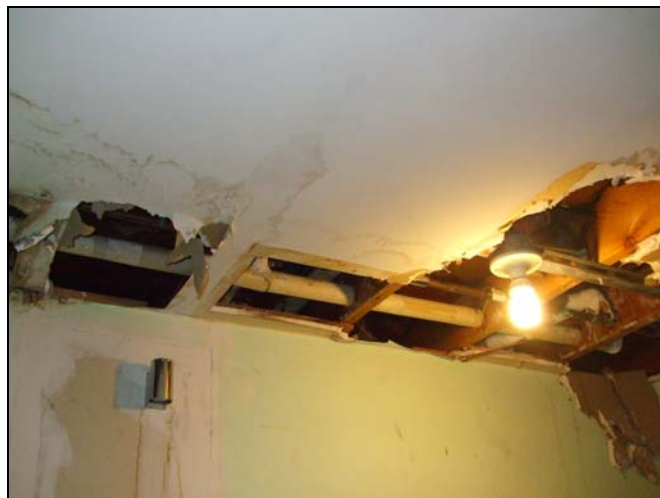
Deteriorating Drywall in Ceiling of Basement due to Possible Pipe Leak(s)

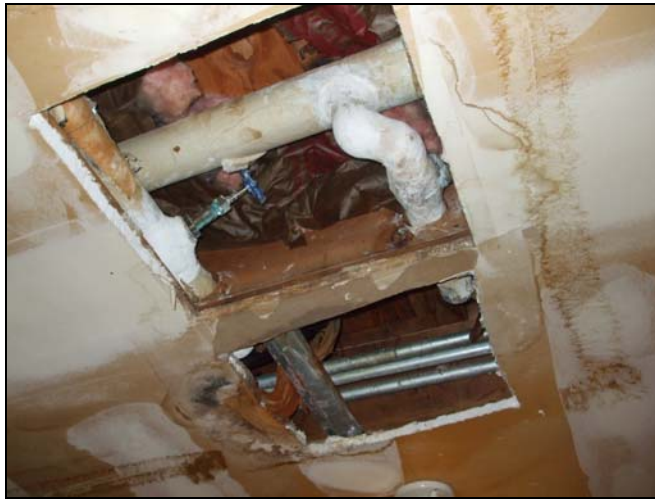
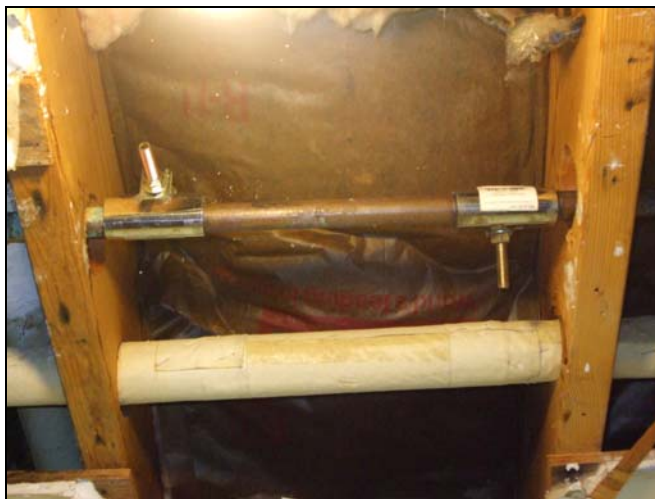
Holes in Floor Joists are not in a suitable Location from Bottom Edge of Members and are close Together

Same as above

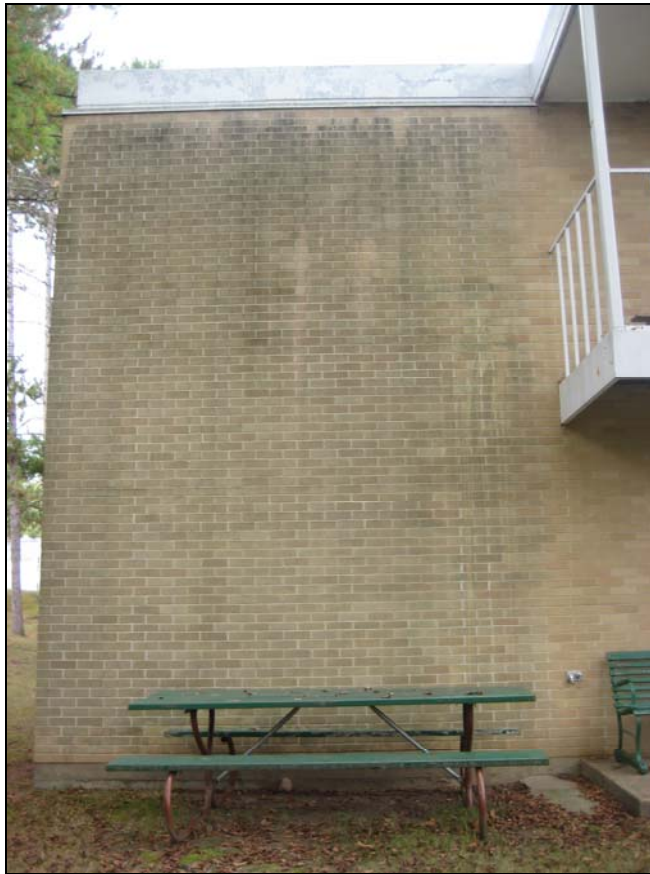
Roof Drainage Problem causing Staining on Brick Veneer

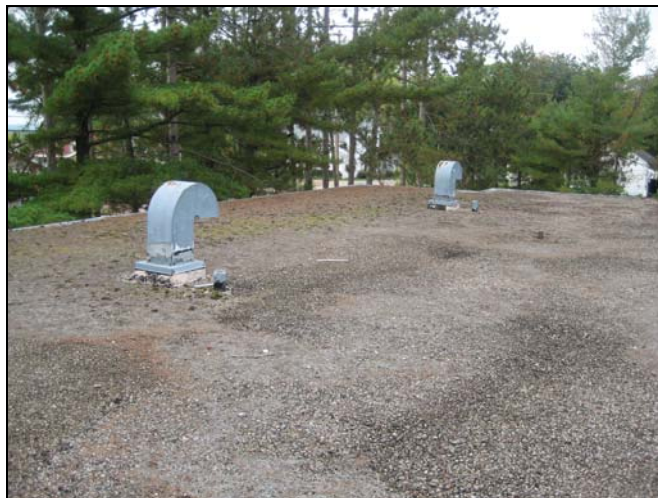
Plant Growth and Standing Water on Roof

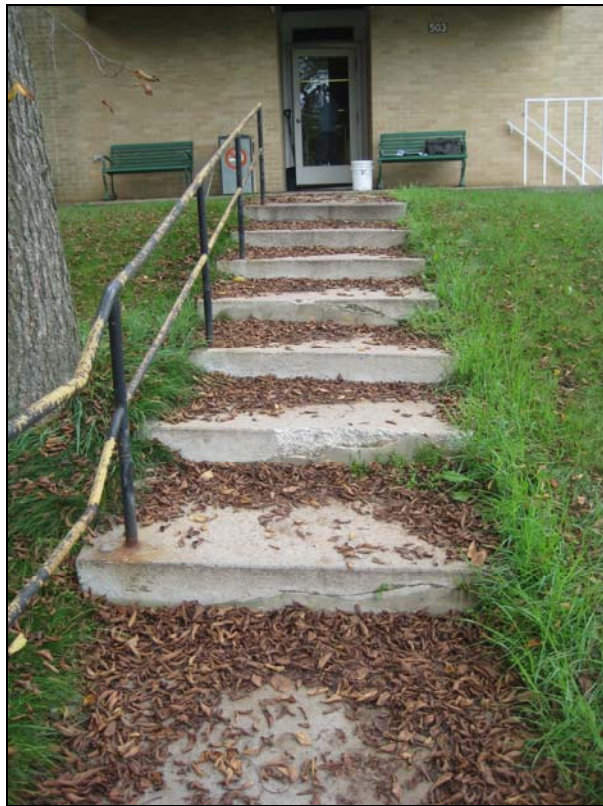
Cracks and deterioration at Concrete Stair and Paint lifting off of Steel Railing

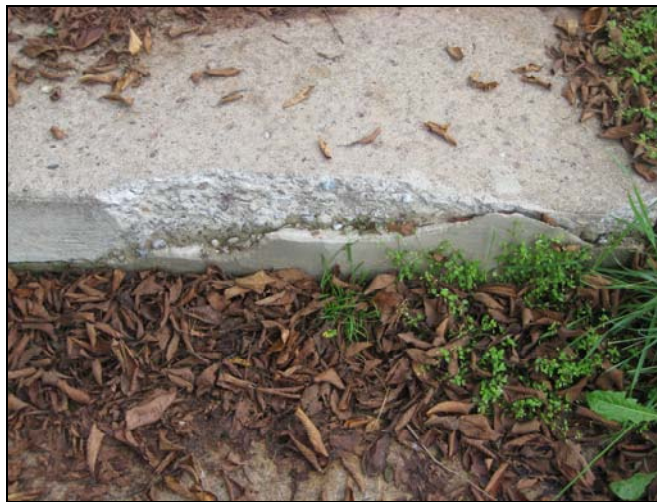
Concrete Deterioration and Cracking are occurring at this Stair Step

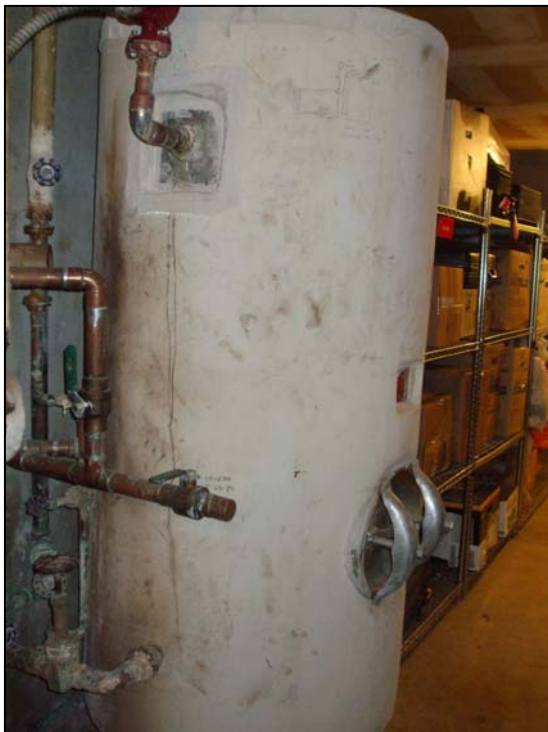
Hot Water Storage Tank in Basement

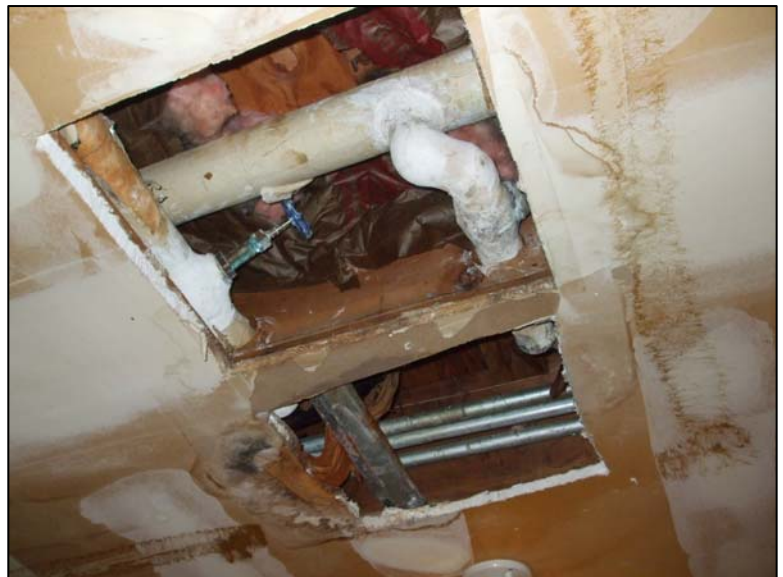
Piping in Basement Ceiling

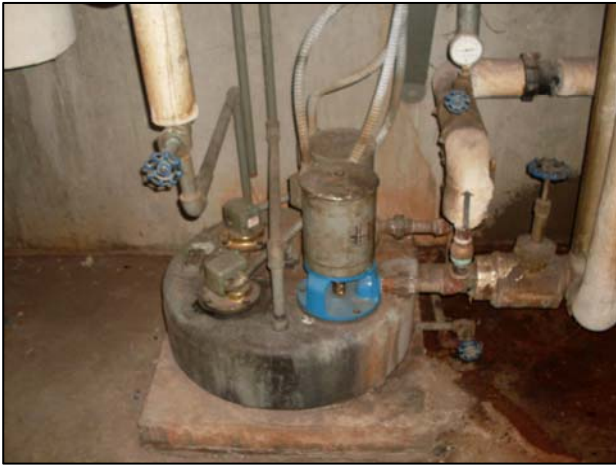
Condensate Pump

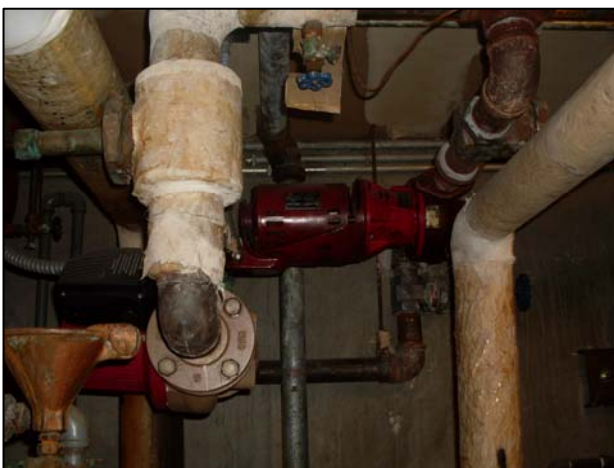
Pump and Uninsulated Steam Piping

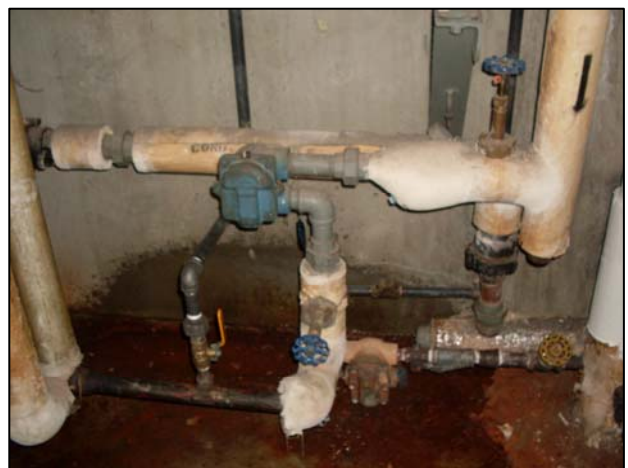
Uninsulated leaking Pipes
