UNIVERSITY OF WISCONSIN – LA CROSSE RESIDENCE LIFE FACILITY ASSESSMENT

DFD Project No. 15A1H

Date: April 25, 2016

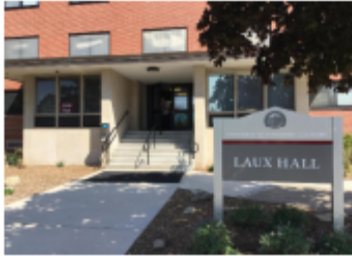
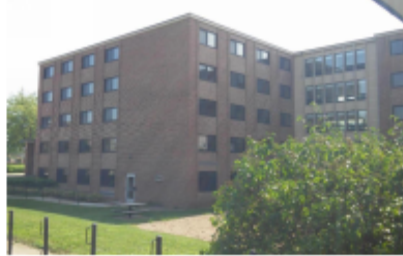
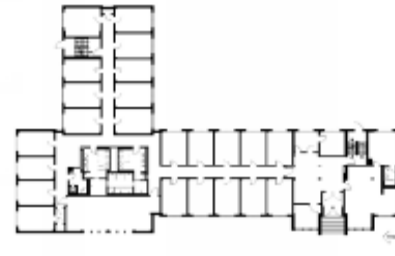
1.i Laux HALL – SUMMARY

No fire suppression system
 Inadequate ventilation

Provide fire sprinklers; replace electrical power systems; refurbish bathroom exhaust systems; gut remodel showers, add ADA/Gender Neutral bathrooms, add elevator.

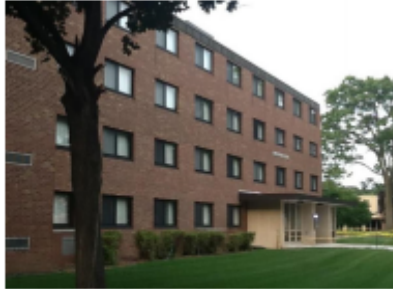
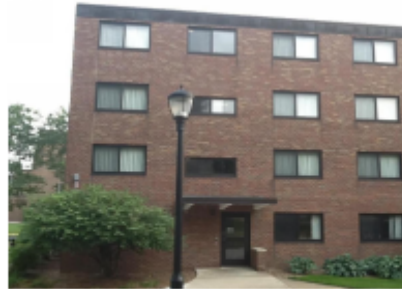
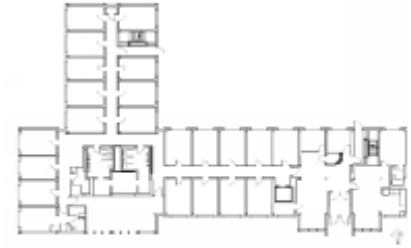
1.i Wentz Hall – Summary

No fire suppression system
 Inadequate ventilation
 28 year old elevator

Provide fire sprinklers;
 refurbish elevator; replace
 electrical power systems;
 refurbish bathroom exhaust
 systems; gut remodel showers,
 add ADA/Gender Neutral
 bathrooms, add elevator.

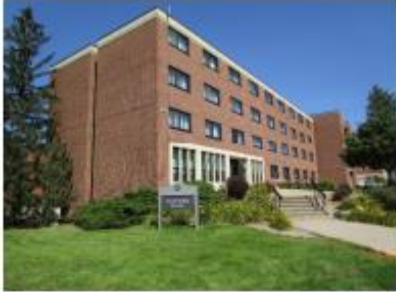
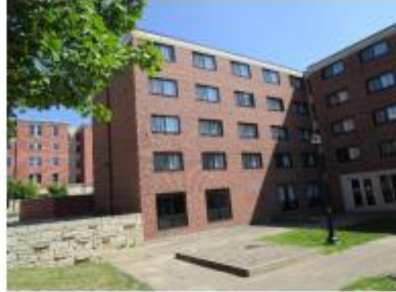
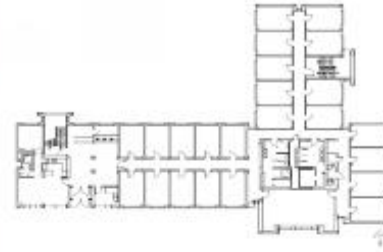
1.i Sanford HALL – SUMMARY

No fire suppression system
 Inadequate ventilation

Provide fire sprinklers; replace electrical power systems; refurbish bathroom exhaust systems; gut remodel showers, add ADA/Gender Neutral bathrooms, add elevator.

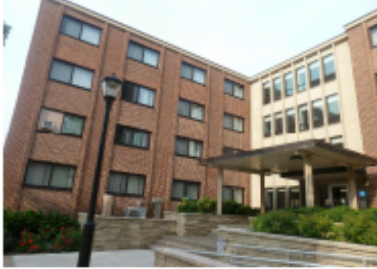
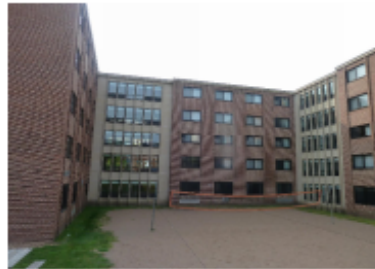
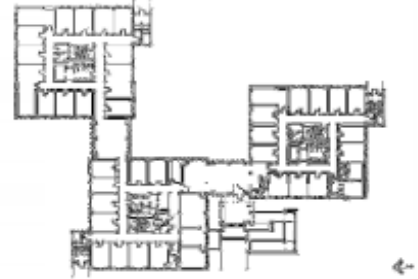
1.i Coate HALL – SUMMARY

No fire suppression system
 No code compliant fire alarm system
 Inadequate ventilation

Provide fire sprinklers; provide compliant fire alarm system; replace electrical power systems; refurbish bathroom exhaust systems; gut remodel showers, add ADA/Gender ADA/Gender Neutral bathrooms, add elevator.

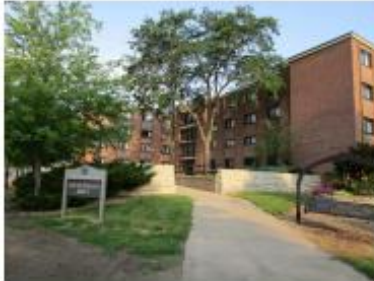
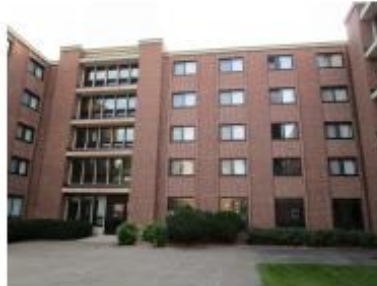
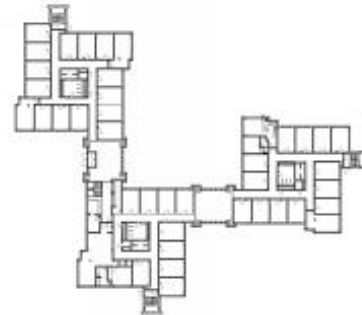
1.i Hutchison HALL – SUMMARY

No fire suppression system
 Inadequate ventilation

Provide fire sprinklers; provide compliant fire alarm system; replace electrical power systems; refurbish bathroom exhaust systems; gut remodel showers, add ADA/Gender Neutral bathrooms, add elevator.

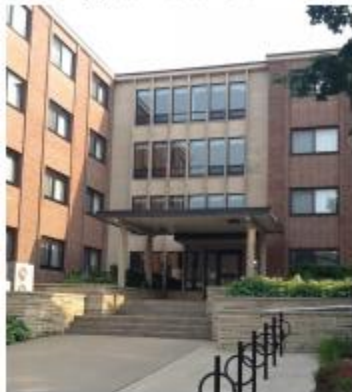
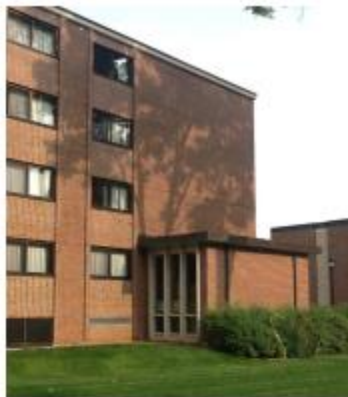
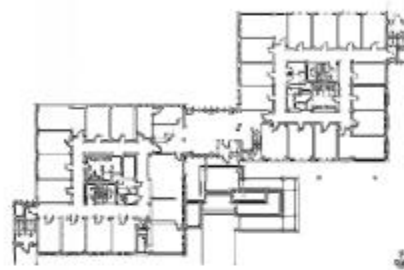
1.i Drake HALL – SUMMARY

No fire suppression system
 Inadequate ventilation

Provide fire sprinklers; replace electrical power systems; refurbish bathroom exhaust systems; gut remodel showers, add ADA/Gender Neutral bathrooms, add elevator.

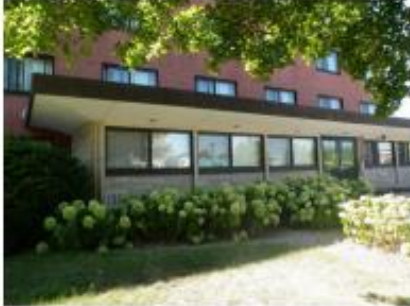
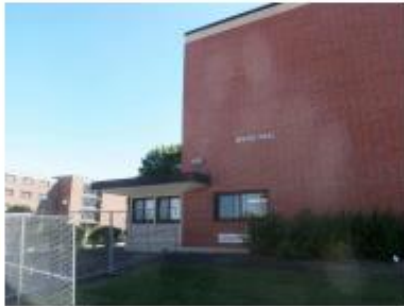
1.i White Hall – SUMMARY

No fire suppression system
 Inadequate ventilation

Provide fire sprinklers;
 refurbish elevator; replace electrical power systems;
 refurbish bathroom exhaust systems; gut remodel showers, add ADA/Gender Neutral bathrooms, add
