# Black Point Historic Preserve Historic Structures Report

## Table of Contents

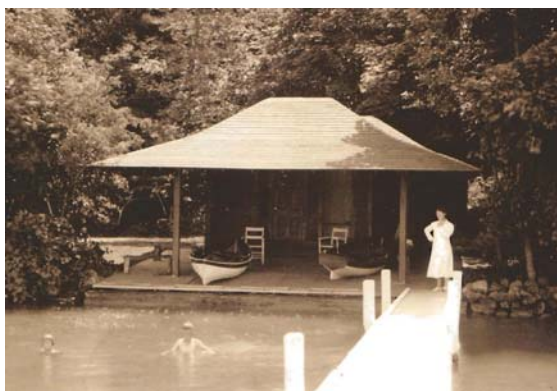
*The original bath house shown in this undated photo  
Photo: Black Point Preserve archives*

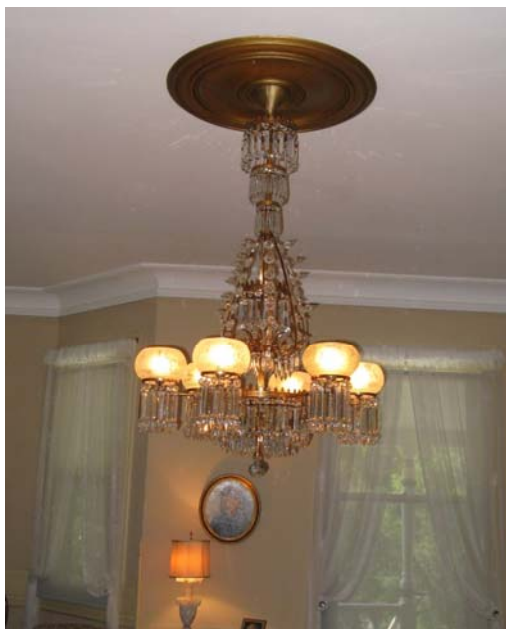
*The chandelier in the music room was once a gas burning fixture in a home in Chicago. It was brought to estate in 1970 and wired for electrical use.*

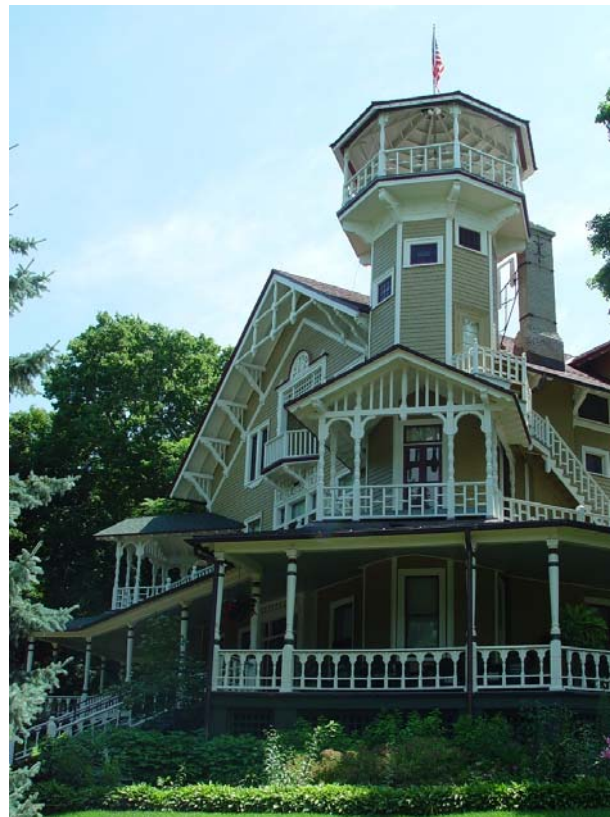
*View showing the four-story tower on the northwest corner of the house. Much of the “stick work” is visible, including eave brackets, posts, railings, spindles and angle braces.*

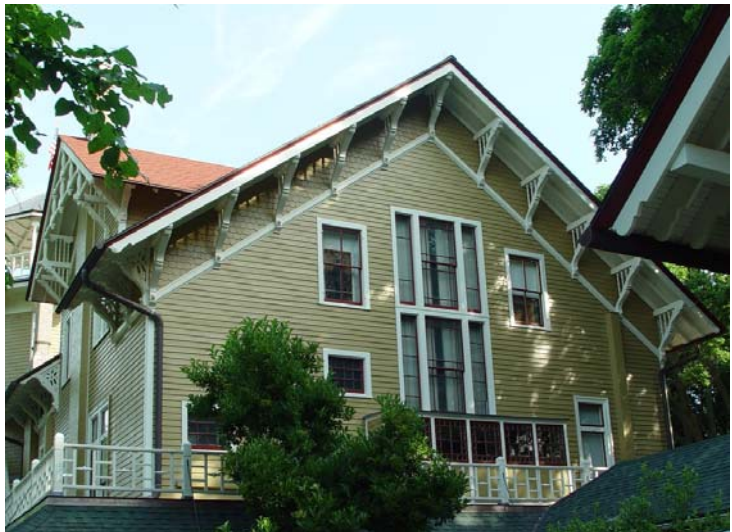
*The south elevation has some unique features, including a large window wall in the main staircase, and an absence of the large gable brace found on the other elevations*

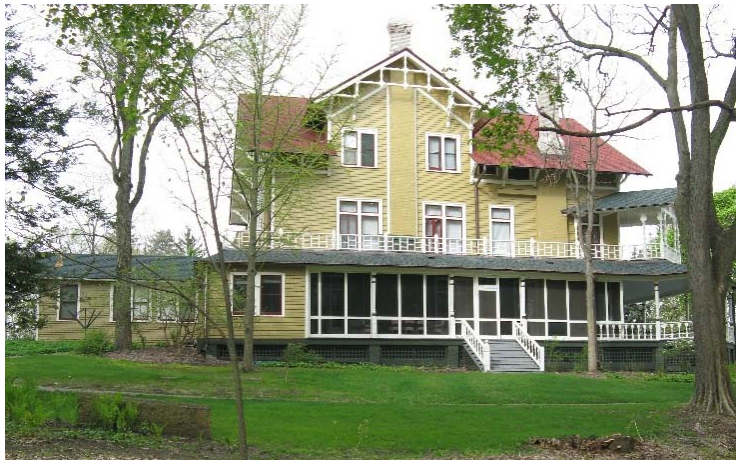
*The east elevation showing the non-original screened Dining Porch and the enclosed corner to its left. The southeast corner was enclosed at the same time the kitchen wing, on the left of photo, was added in 1946.*

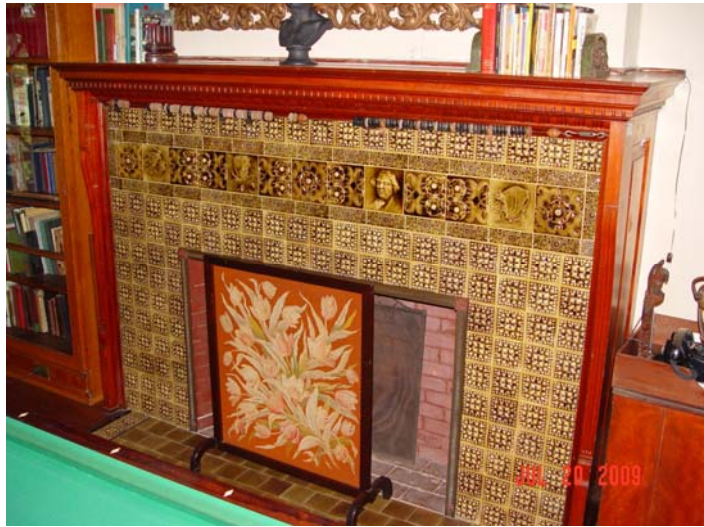
*The Billiards Room fireplace has a glazed tile front and a wood mantel and surround, similar to the other three large fireplaces.*

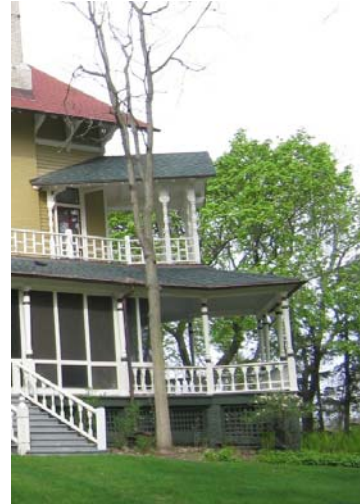
Current picture shows the widened first floor porch (see noted plan diagram pg. 51)

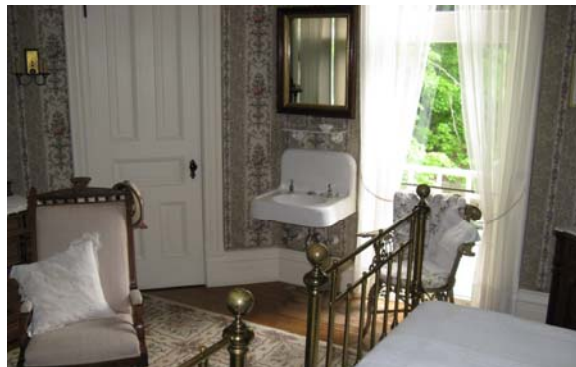
*Hand sink not original to floor plans (typical in bedrooms)*

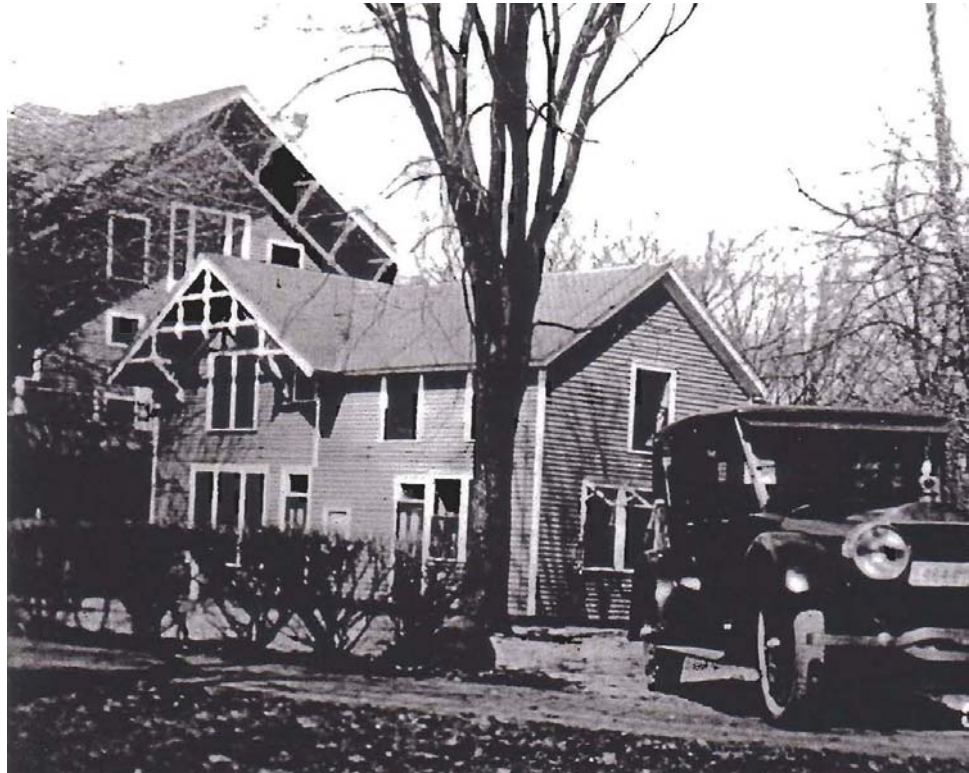
*Black Point's original Service Building, razed in 1946, as it appeared in this undated photo. Photo date estimated to be after 1925 based upon automobile, believed to be a 1925, or c. mid-20's, Locomobile.  
Photo: Black Point Preserve archives*

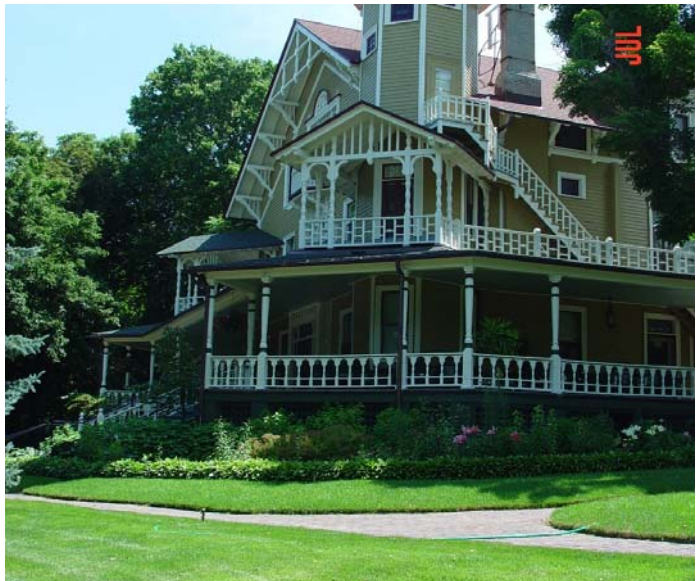
*The brick paved paths and drives are generally in good condition, especially considering their age, with occasional rough spots due to weathering.*

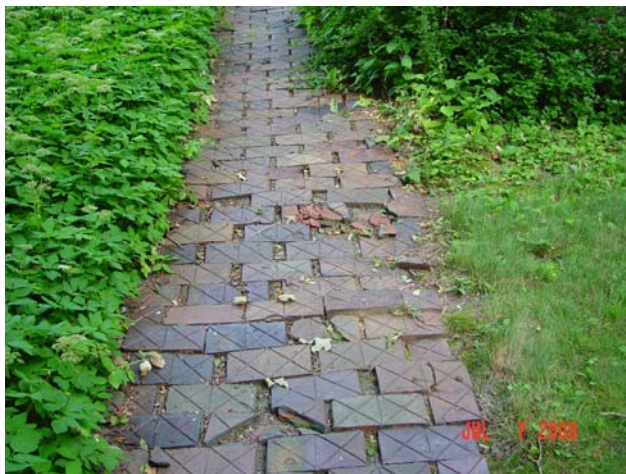
*This close-up of a walkway reveals bricks that are crumbling and uneven*

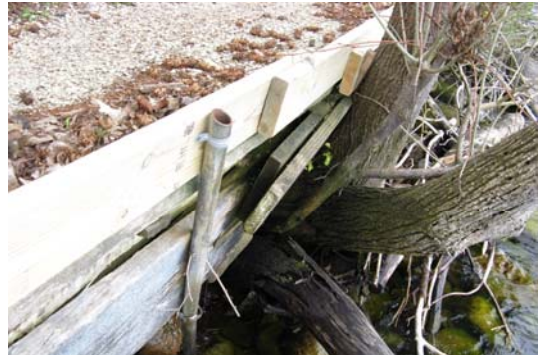
*Temporary repairs installed are not adequate to stop the lakeshore erosion that is damaging the path in some locations.*

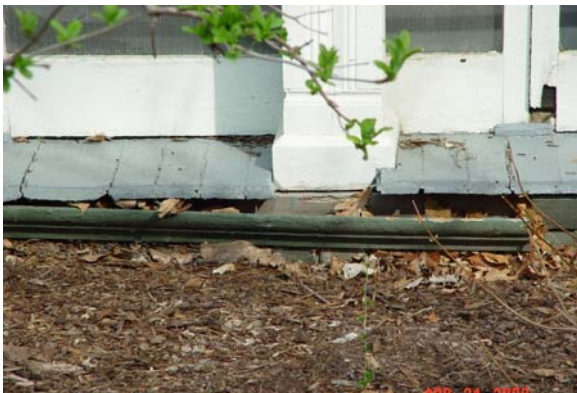
**Image 1:** *Example of trim piece that has detached from the porch*

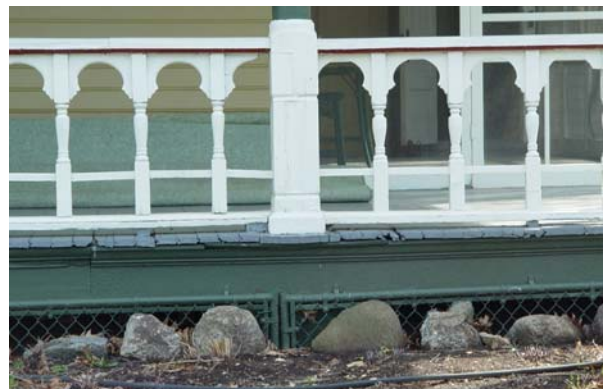
**Image 2:** *Porch decking shows signs of decay on the ends in several places*

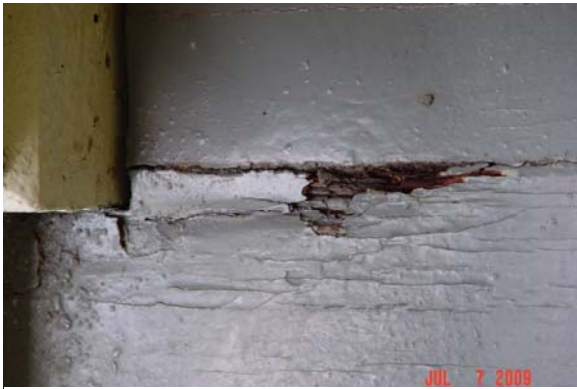
**Image 3:** *In some areas decay in the porch deck has resulted in soft spots (see diagram on p. 51 for locations)*

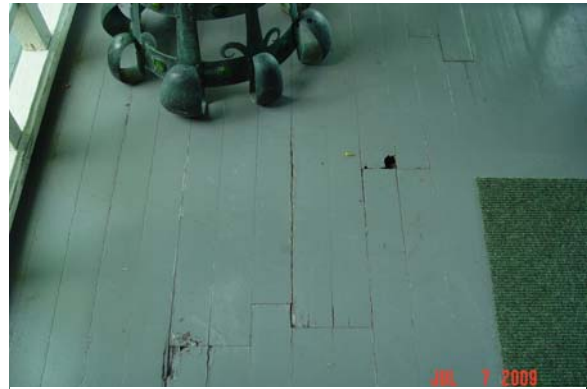
**Image 4:** *Another example of porch floor boards that show signs of decay*

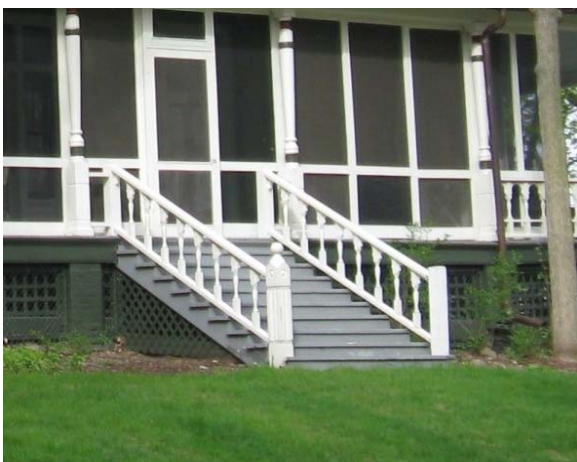
**Image 5:** *Original handrail baluster is missing and replaced by simple 6x6*

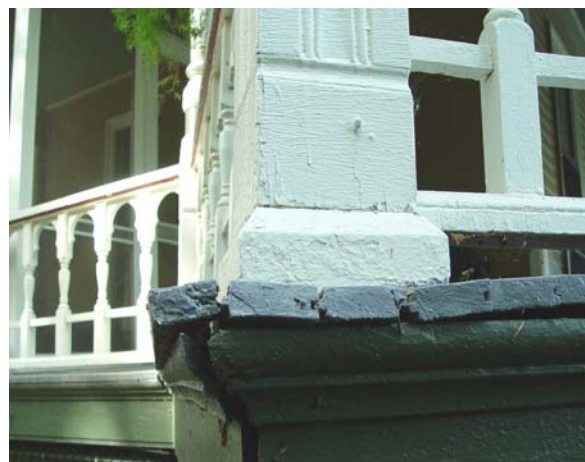
**Image 6:** *This area on the northeast corner of the porch shows deck boards and trim detaching from the structure*

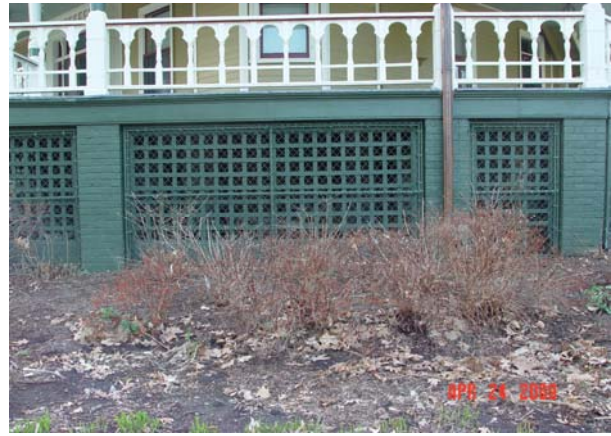
**Images 8:** Another view of lattice work covered by chain link fence

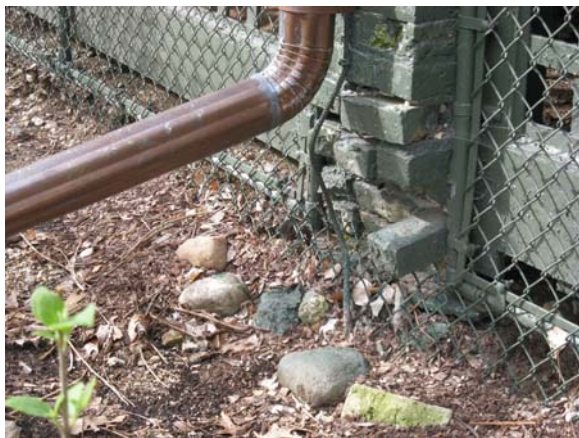
**Image 9:** This pier, located on the east side of the building, is one of the most severe examples of deteriorating brickwork.

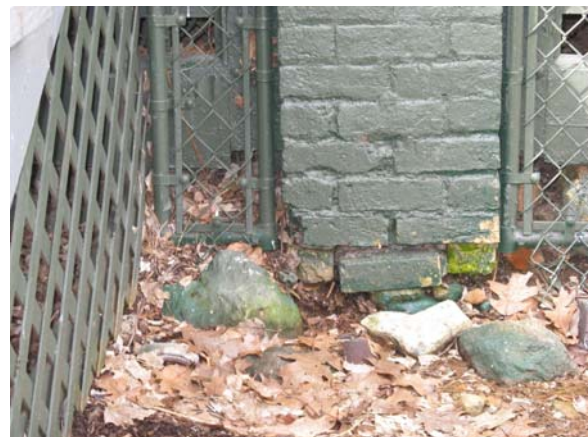
**Image 10:** Eroded mortar joints and dislocated bricks are a fairly typical condition found on the base of the exterior piers.

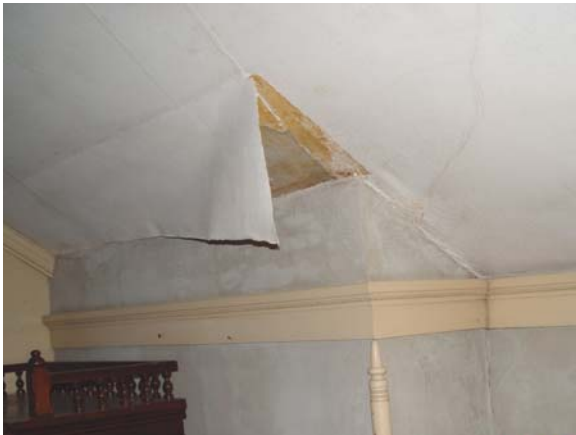
**Image 11:** *The original burlap wall covering is peeling in several areas, although typically not as severely as this example in the third floor Gray Room.*

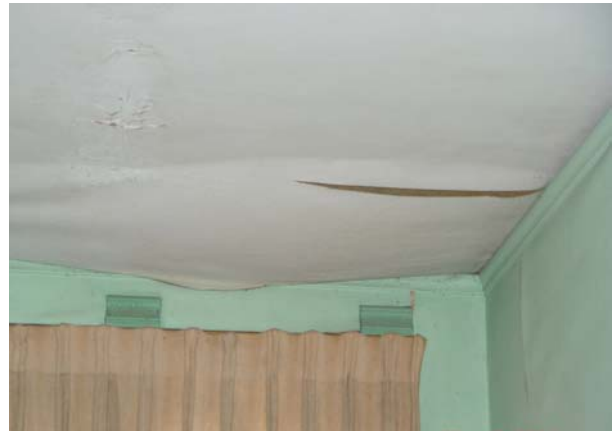
**Image 12:** *This spot on the ceiling above the main staircase also shows damage to the covering.*

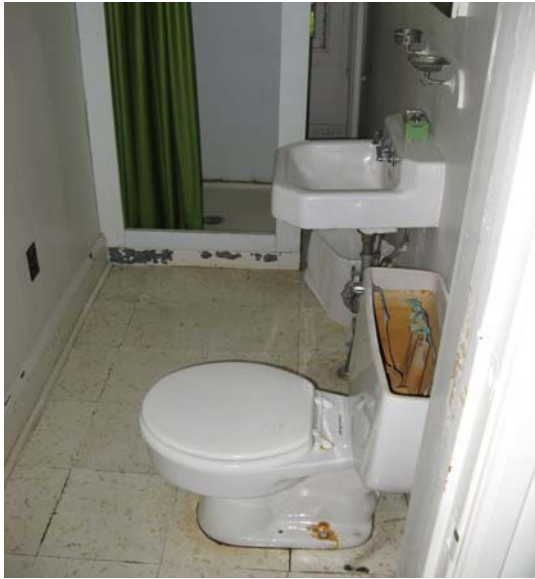
**Image 13:** Bathroom shows peeling tiles, incomplete fixtures, and changes made over time (note relatively modern toilet).

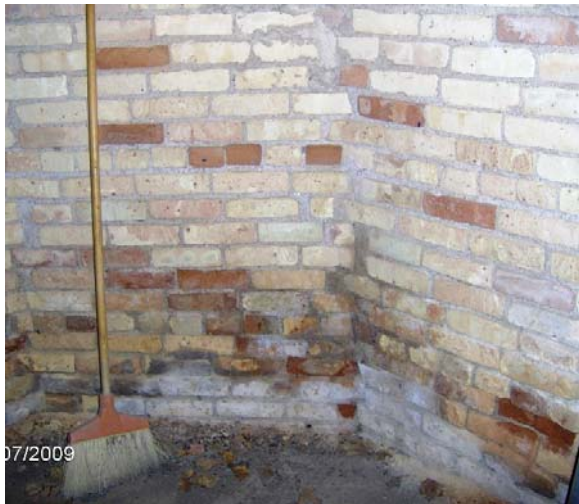
**Image 1:** Deteriorated basement wall (see noted plan diagram pg. 50)

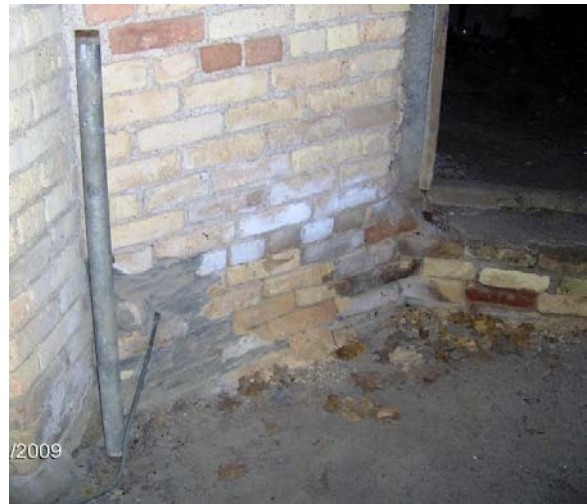
**Image 2:** Basement wall patched with cementitious material.

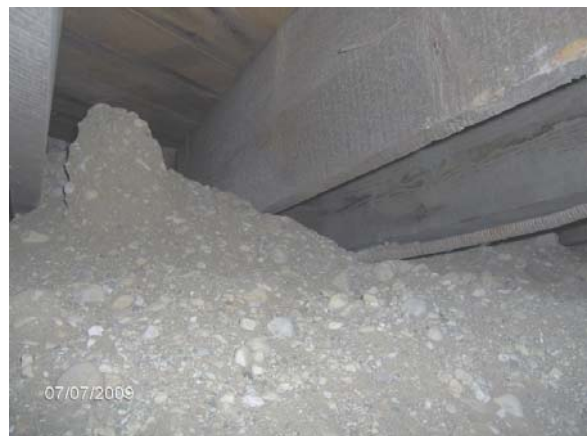
**Image 3:** Soil at the bottom of the floor joists in the crawlspace (see noted plan diagram pg. 50)

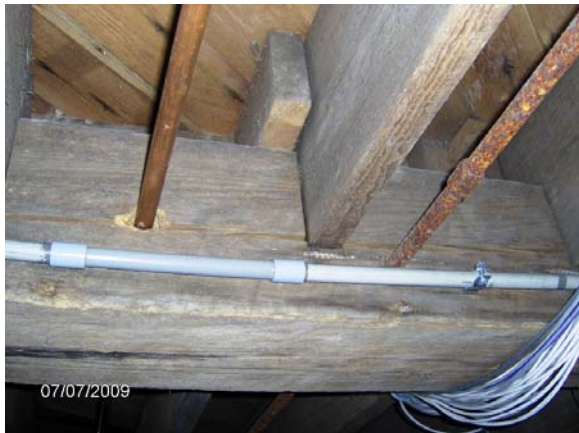
**Image 4:** *Notches, checks and holes are located at the same depth in the floor beams.*

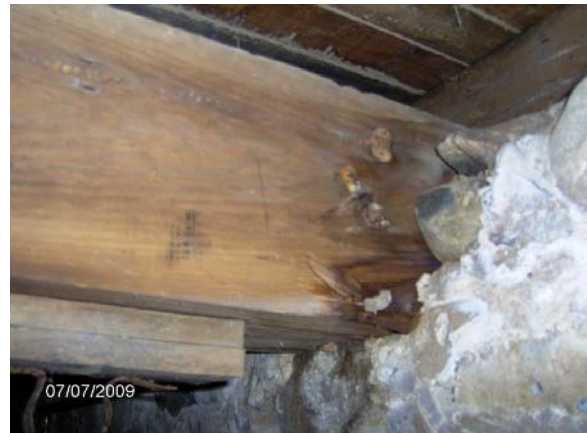
**Image 5:** *Deterioration at the end of floor beam where it is bearing into the masonry wall.*

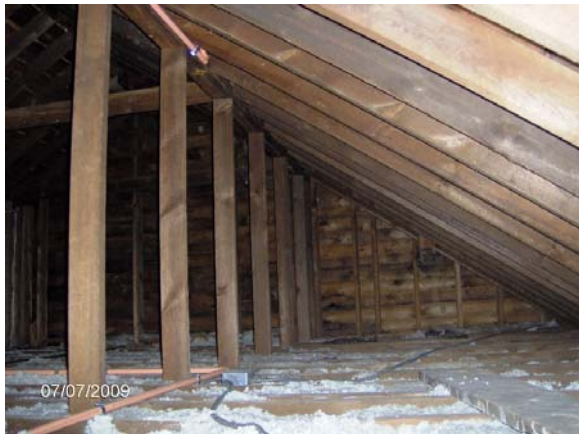
**Image 6:** Rafter and ceiling joist framing in roof

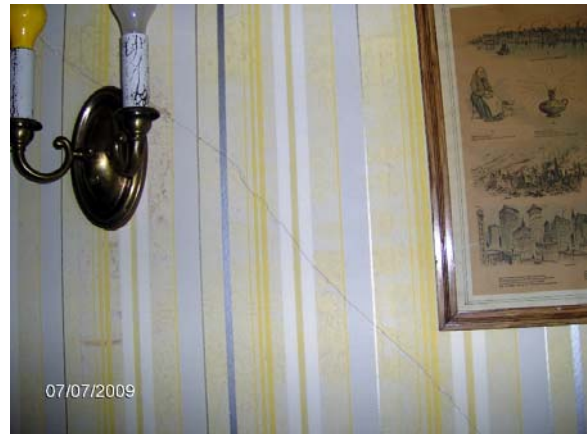
**Image 7:** Diagonal cracks in third story walls

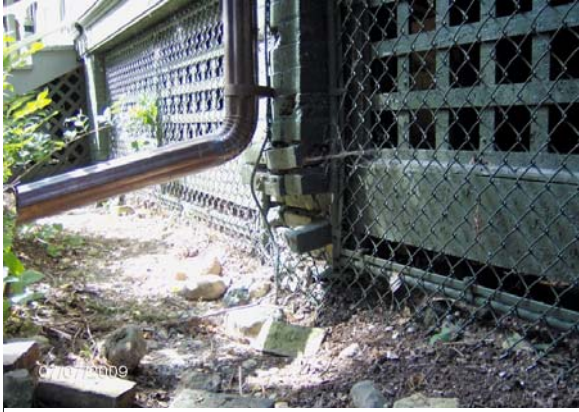
**Image 8:** *Damaged porch pier  
(see noted plan diagram p. 50)*

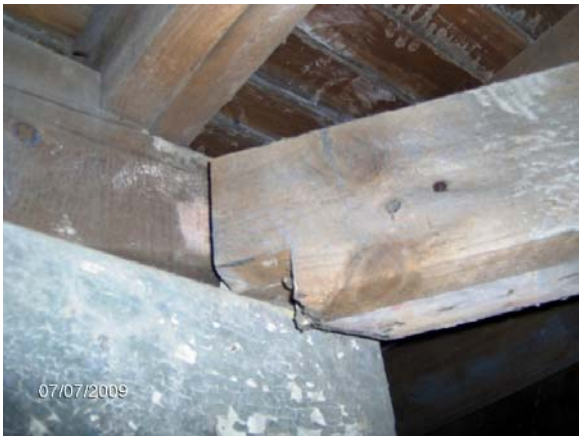
**Image 9:** *Insufficient porch beam bearing*

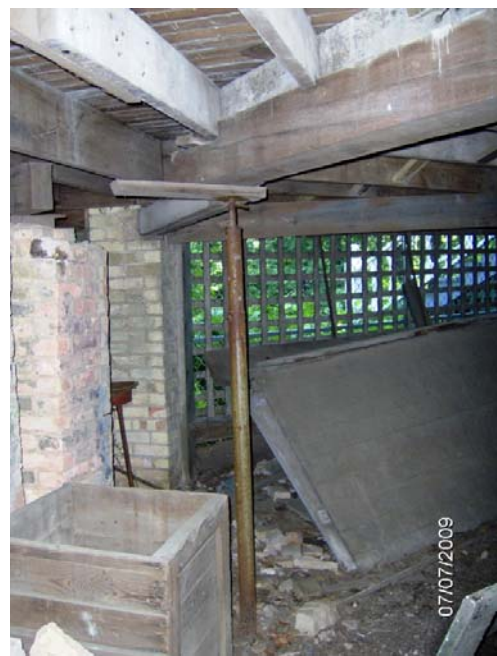
**Image 10:** *Adjustable pipe column  
supporting porch framing*

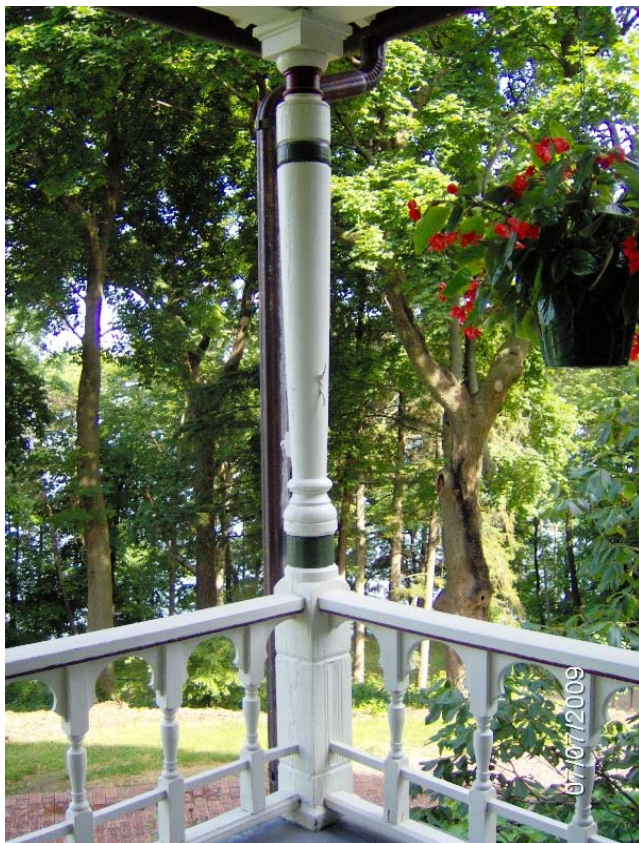
**Image 11:** Typical porch column

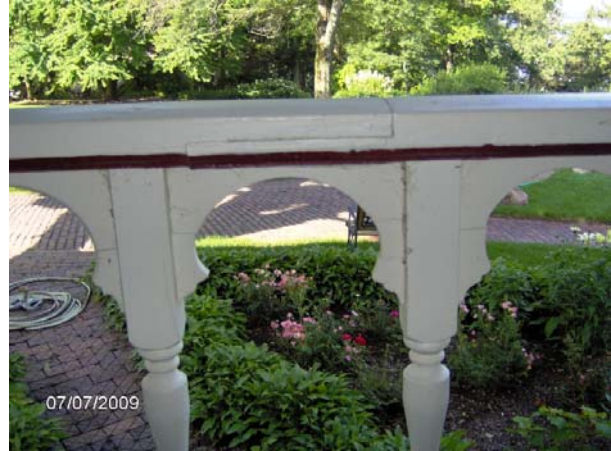
*Image 13: Splice in porch railing*

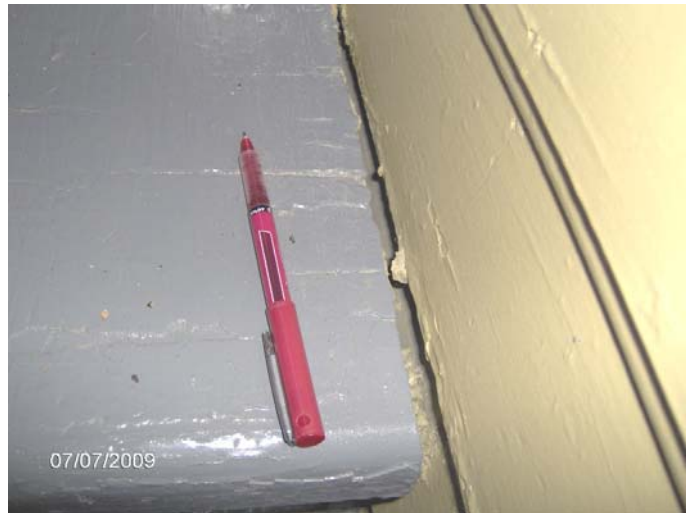
**Image 15:** Gap created between stair and building wall due to stair rotation.

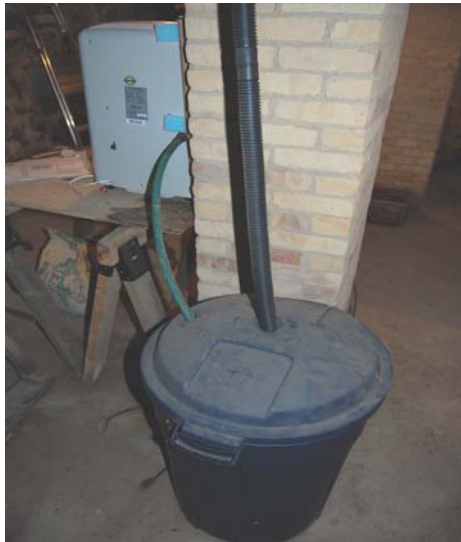
*Sump pump located on floor in basement*

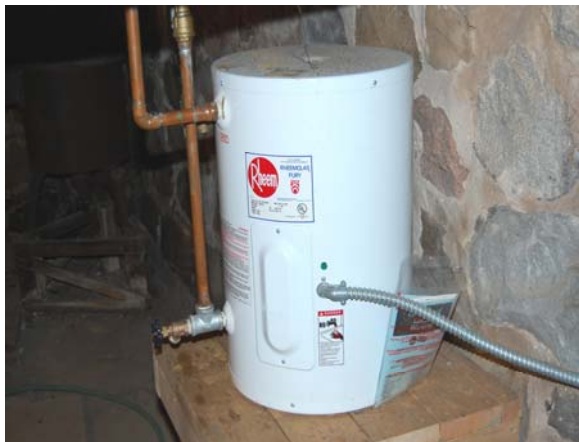
*Water heater serving kitchen sink*

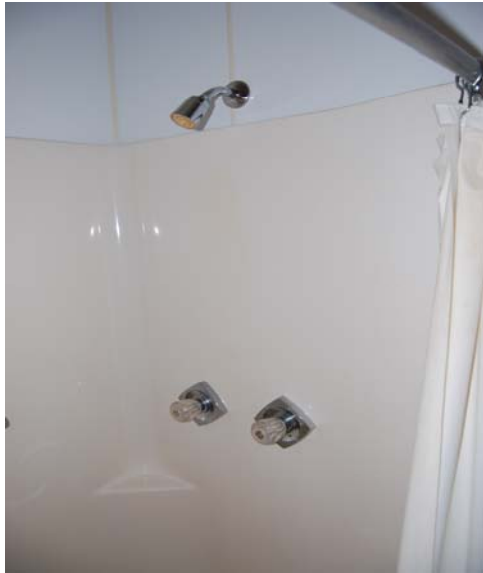
*Fiberglass shower most likely installed in 1970's*

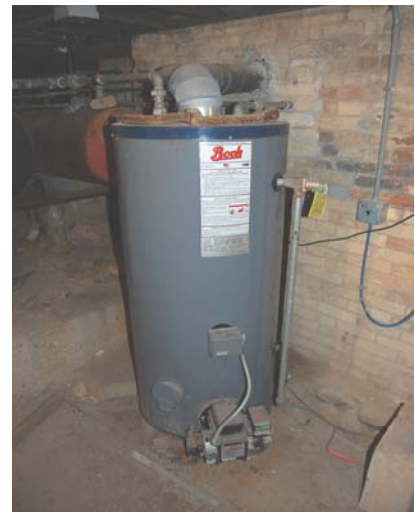
*Fuel oil fired water heater*

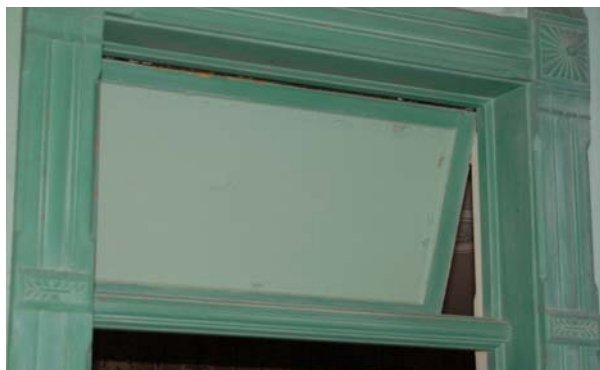
*Typical transom window above an interior door*

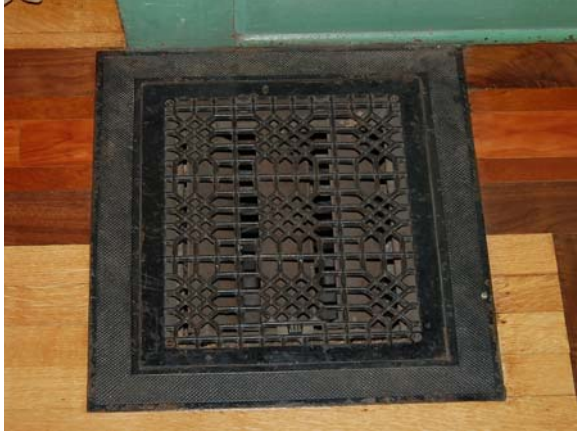
*Floor grate for central heating system*

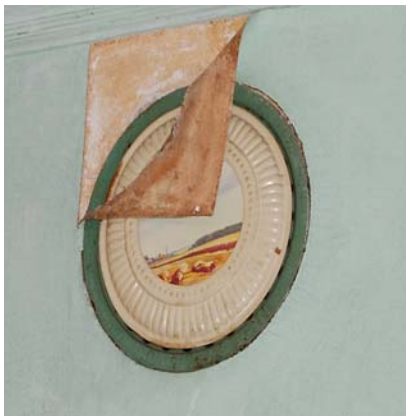
*Capped flue pipe of removed wood burning pot belly stove*

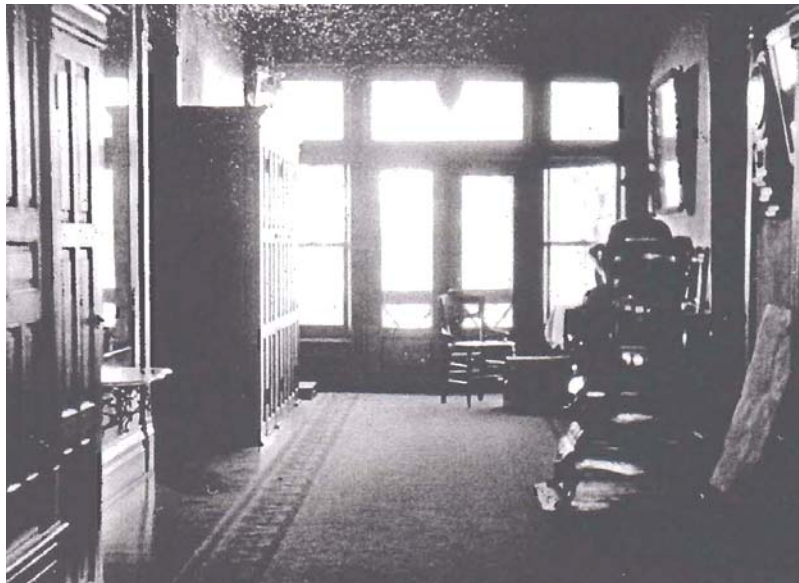
*Photo (undated) of coal or wood burning potbelly stove in second floor hallway, possibly removed at time of a furnace installation in 1940's  
Photo: Black Point Preserve archives*

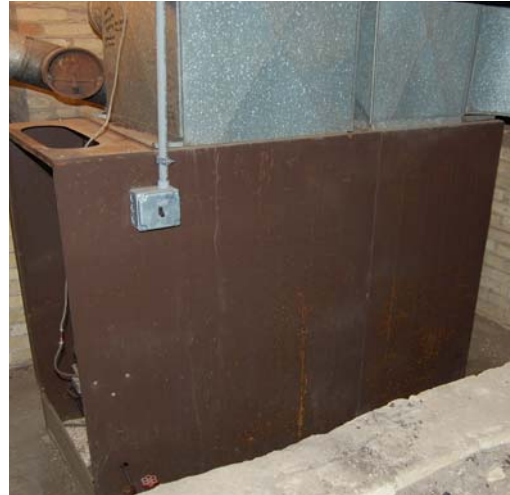
*Existing oil fired furnace installed in 1986-87*

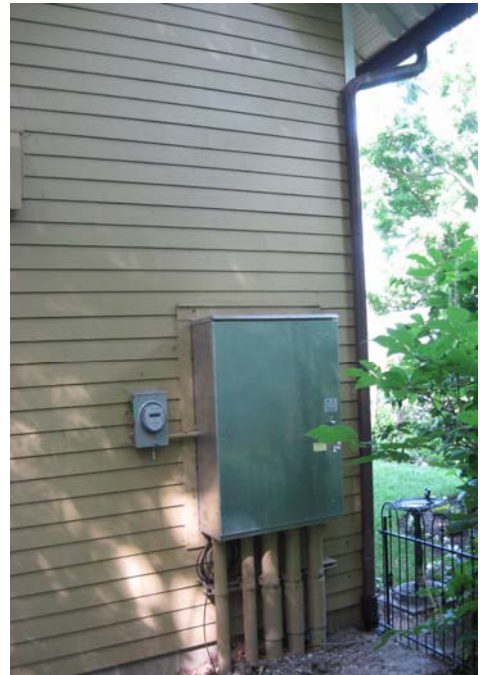
*New underground service at Visitors Center outbuilding installed in 2006*

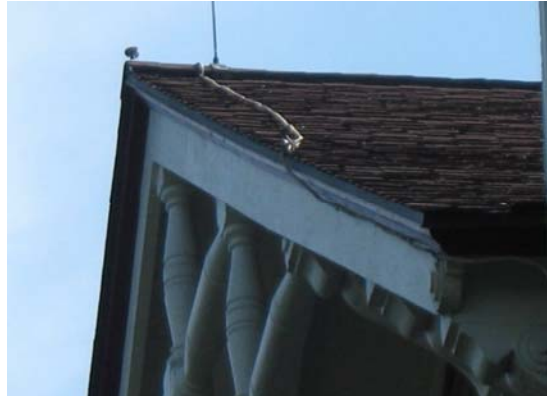
*The existing lightning protection system was inspected and repaired in 2006*

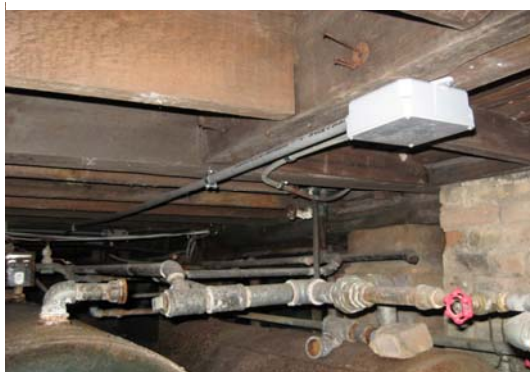
*The connection between new crawl space wiring and original wiring. All crawl space wiring was replaced in 2006.*

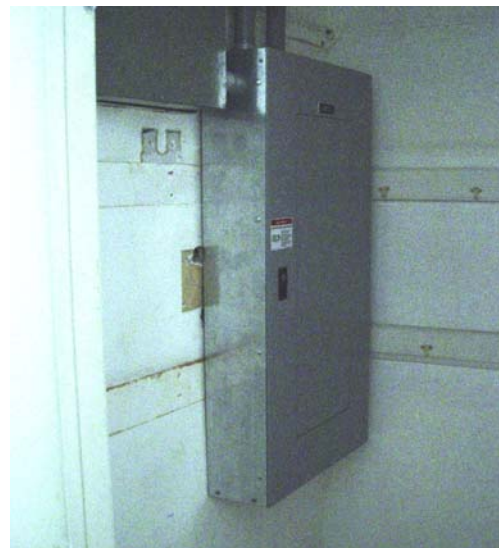
*On the second floor a new circuit panel replaced an early plug-fuse panel in 2006.*

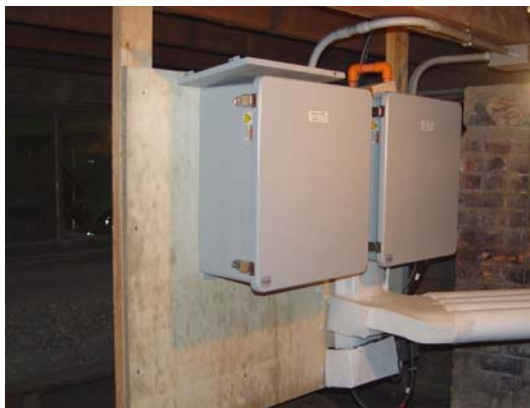
*VESDA air sampling fire detection system installed in 2006 in the crawl space.*

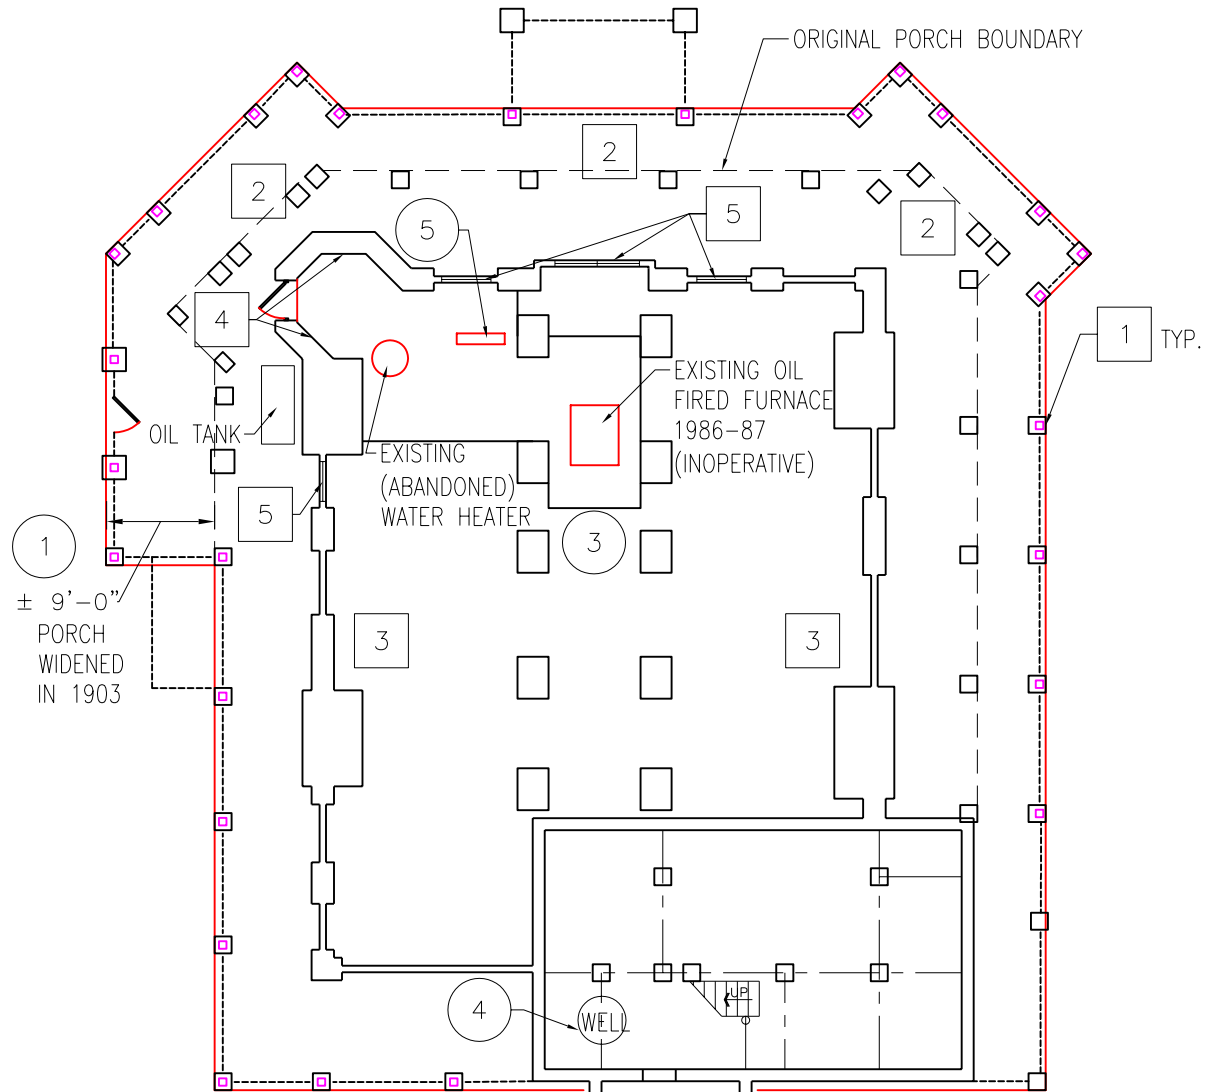
NOTES ON EXISTING CONDITIONS

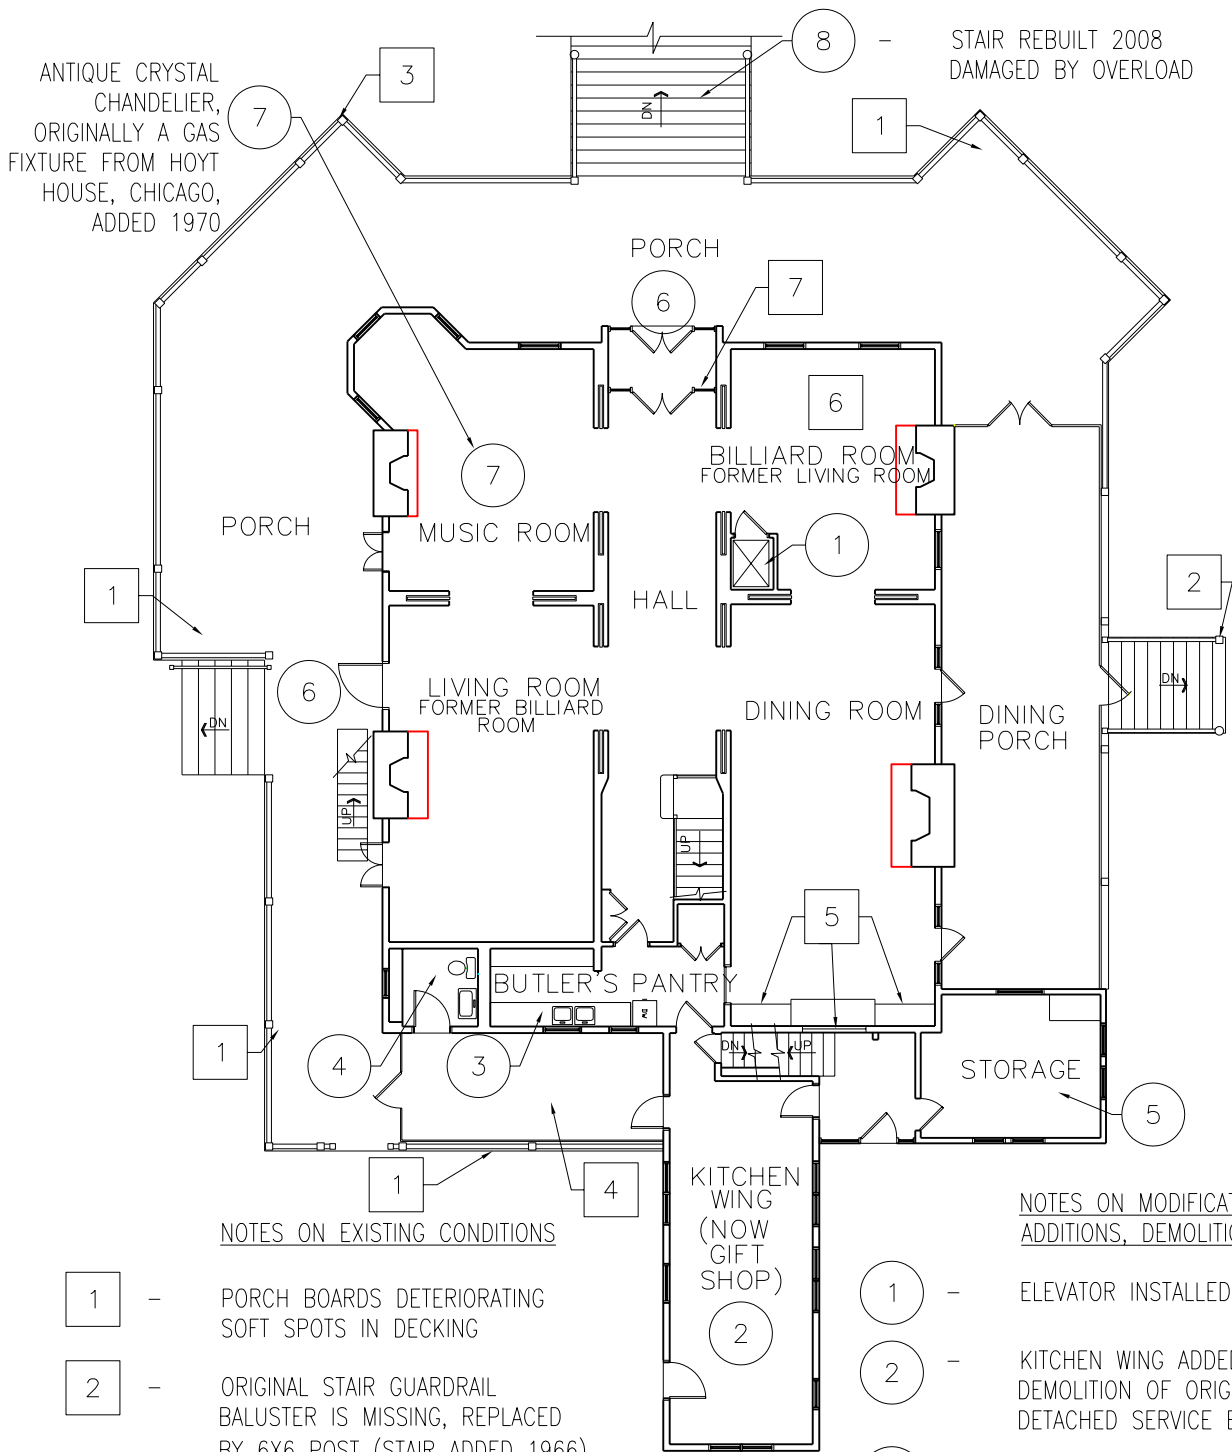
ANTIQUE CRYSTAL CHANDELIER, ORIGINALLY A GAS FIXTURE FROM HOYT HOUSE, CHICAGO, ADDED 1970

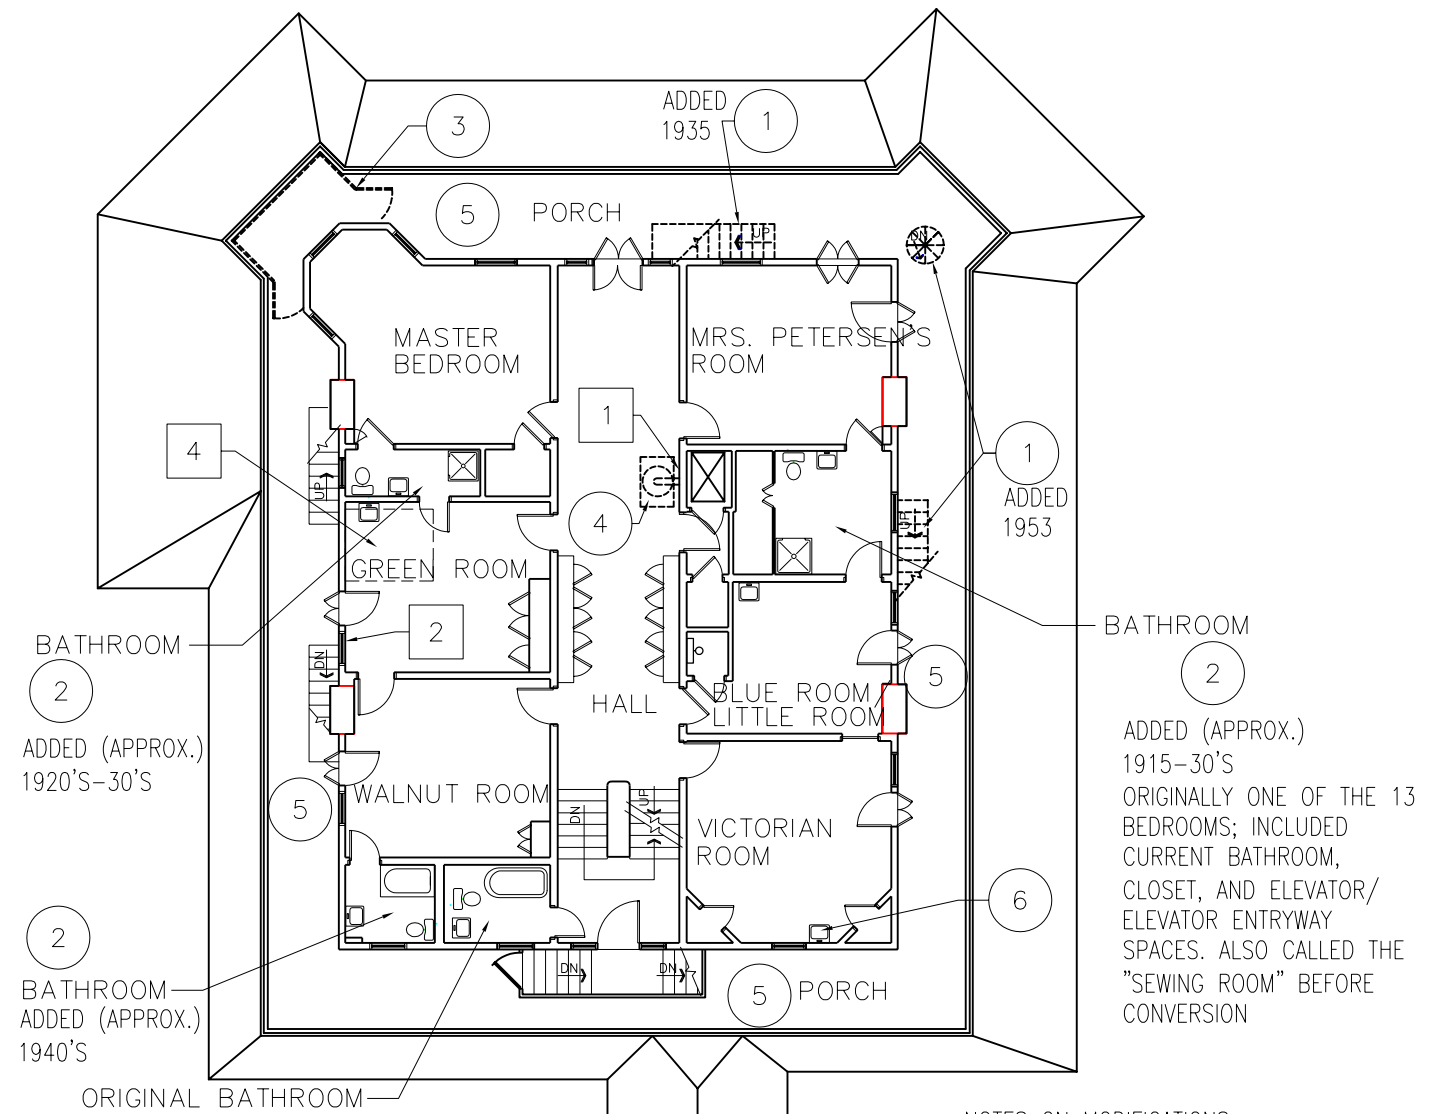
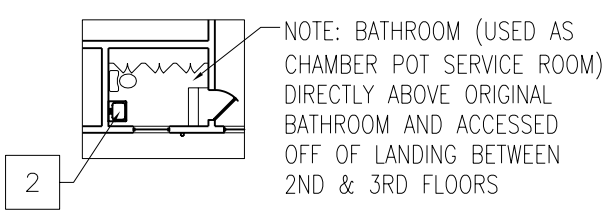
NOTES ON EXISTING CONDITIONS

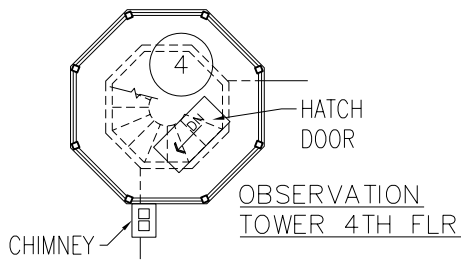
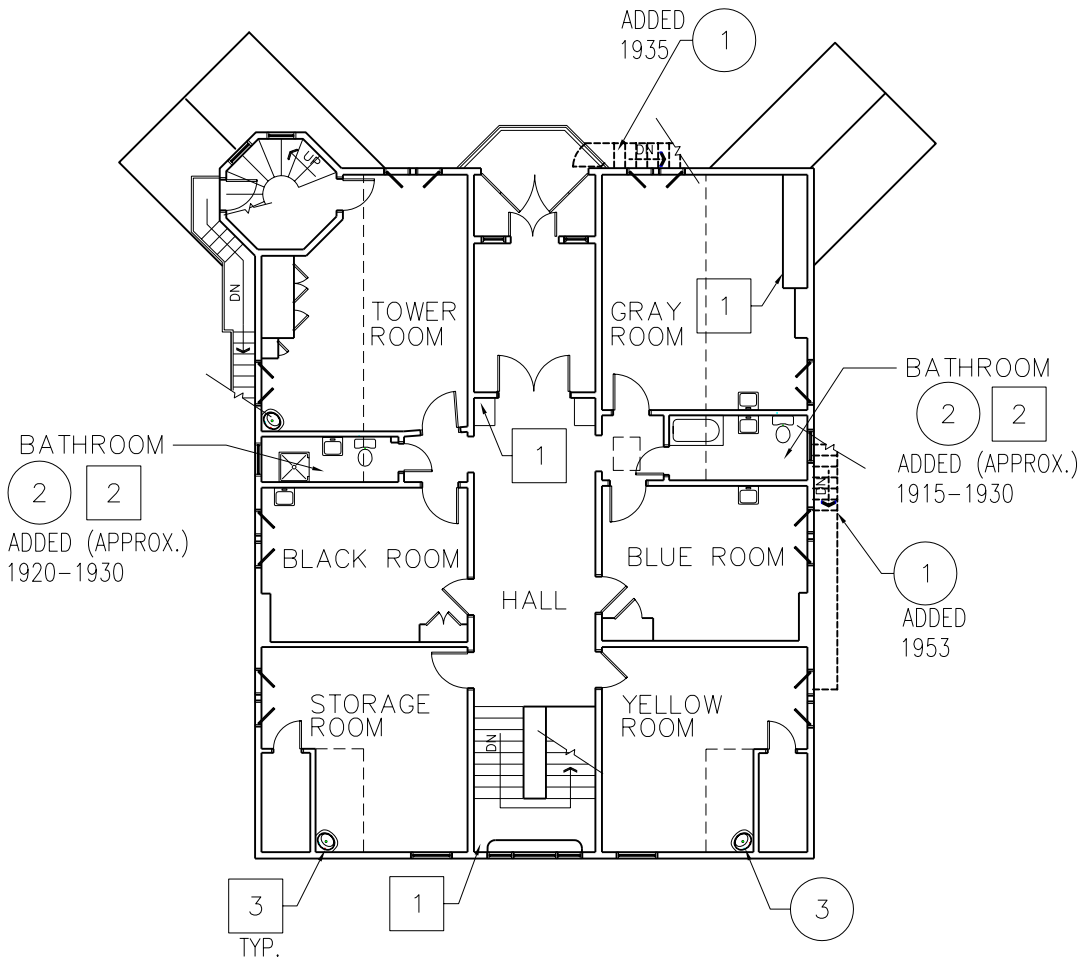
NOTES ON EXISTING CONDITIONS

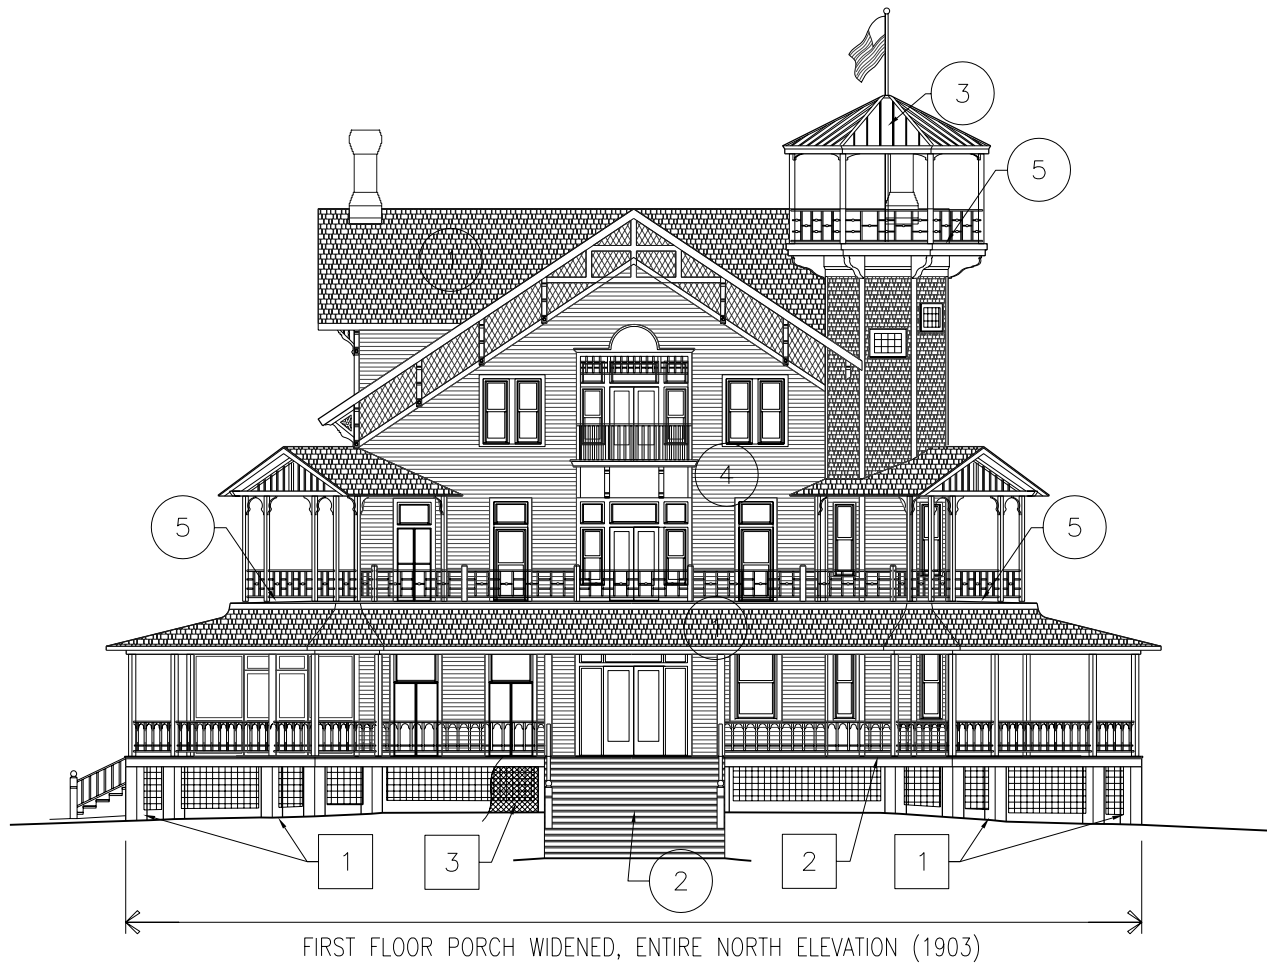
NOTES ON EXISTING CONDITIONS
