# Black Point Historic Preserve Historic Structures Report

## Table of Contents

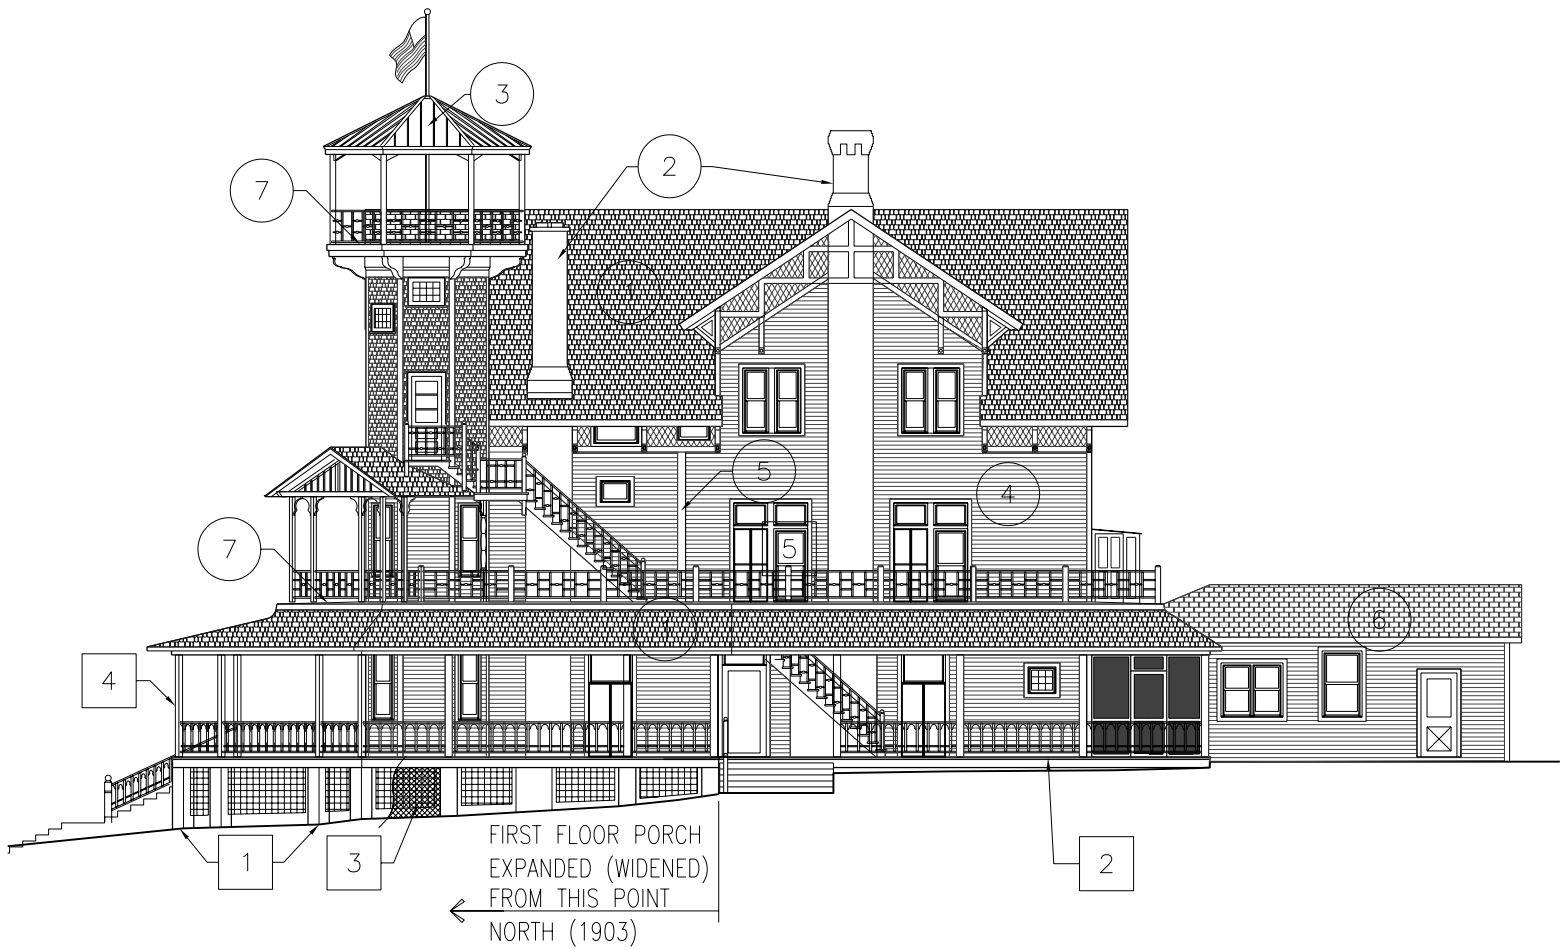
NOTES ON EXISTING CONDITIONS

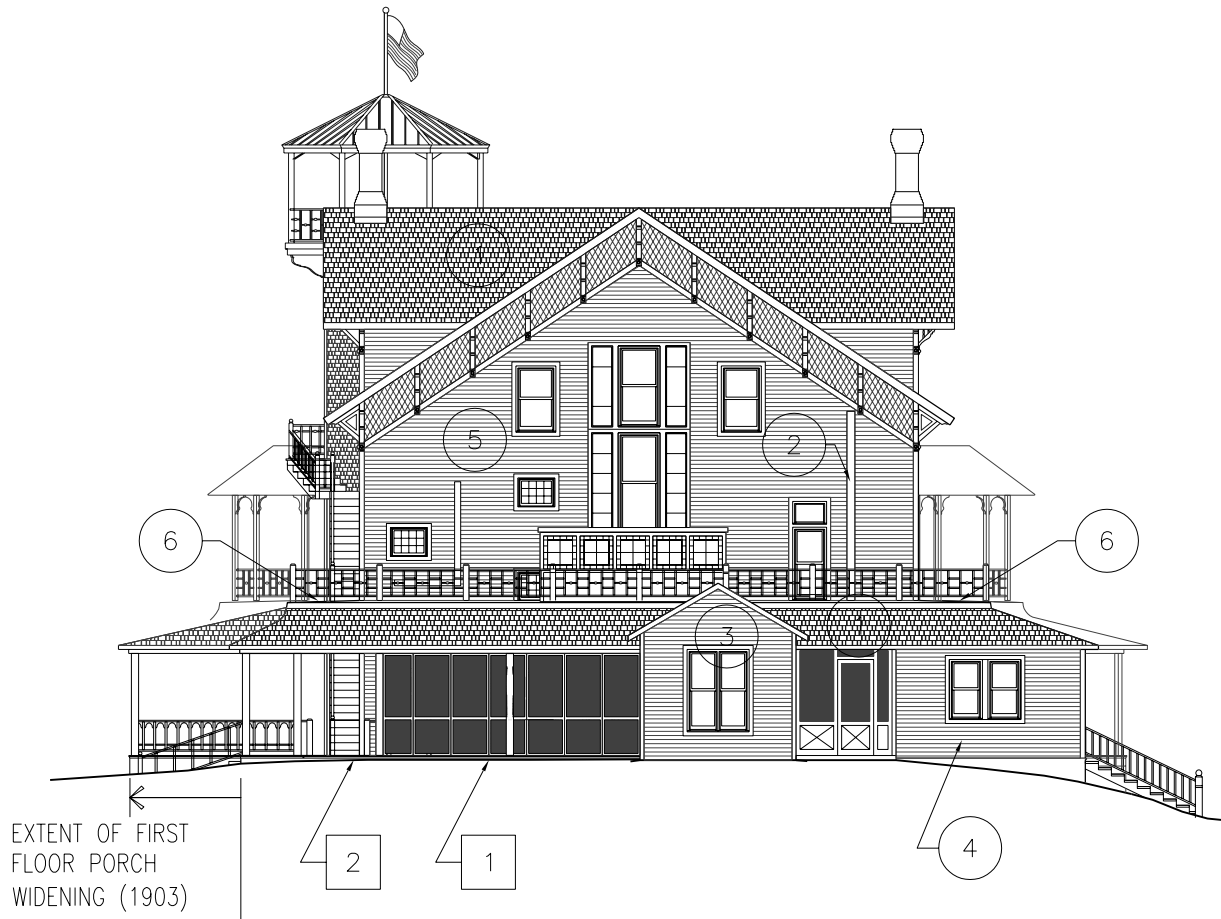
NOTES ON EXISTING CONDITIONS

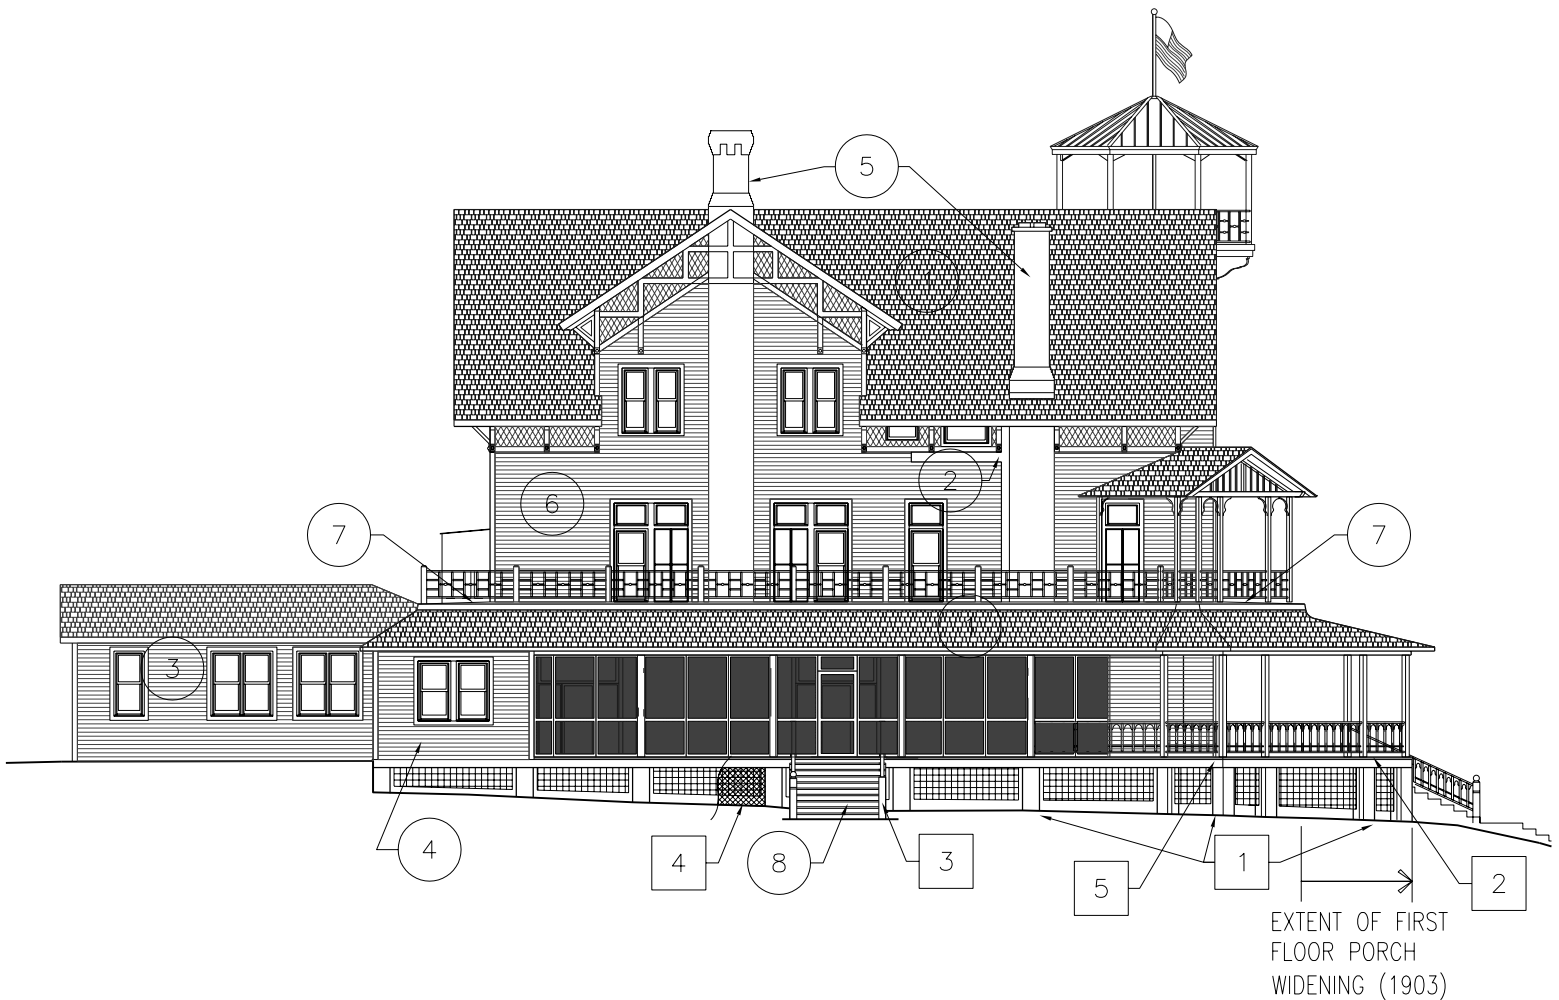
NOTES ON EXISTING CONDITIONS

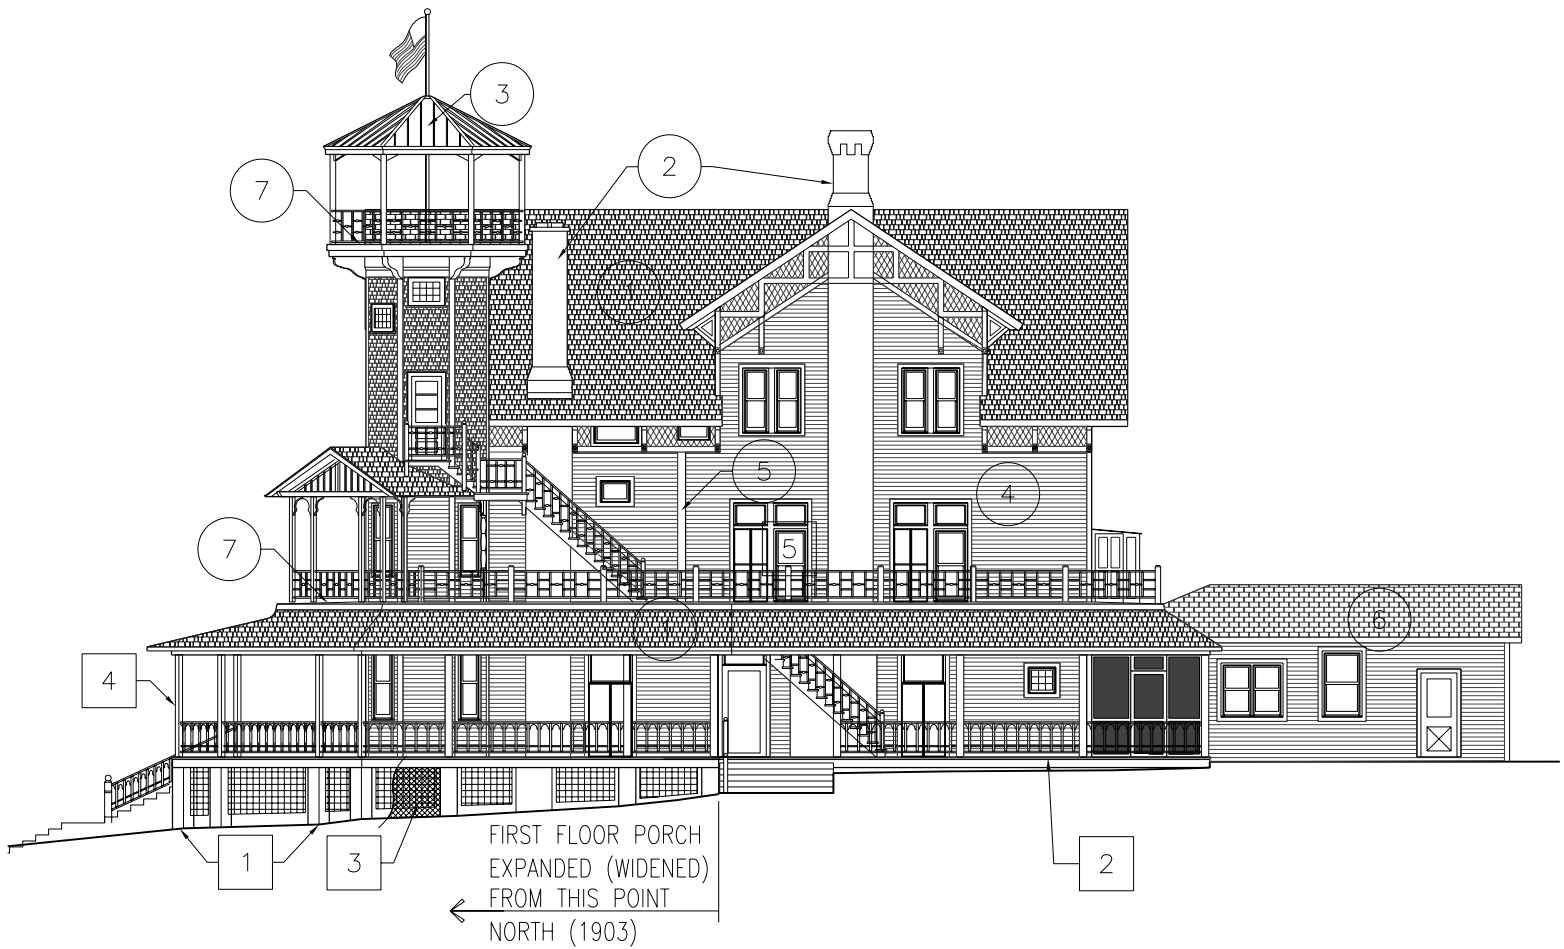
NOTES ON EXISTING CONDITIONS

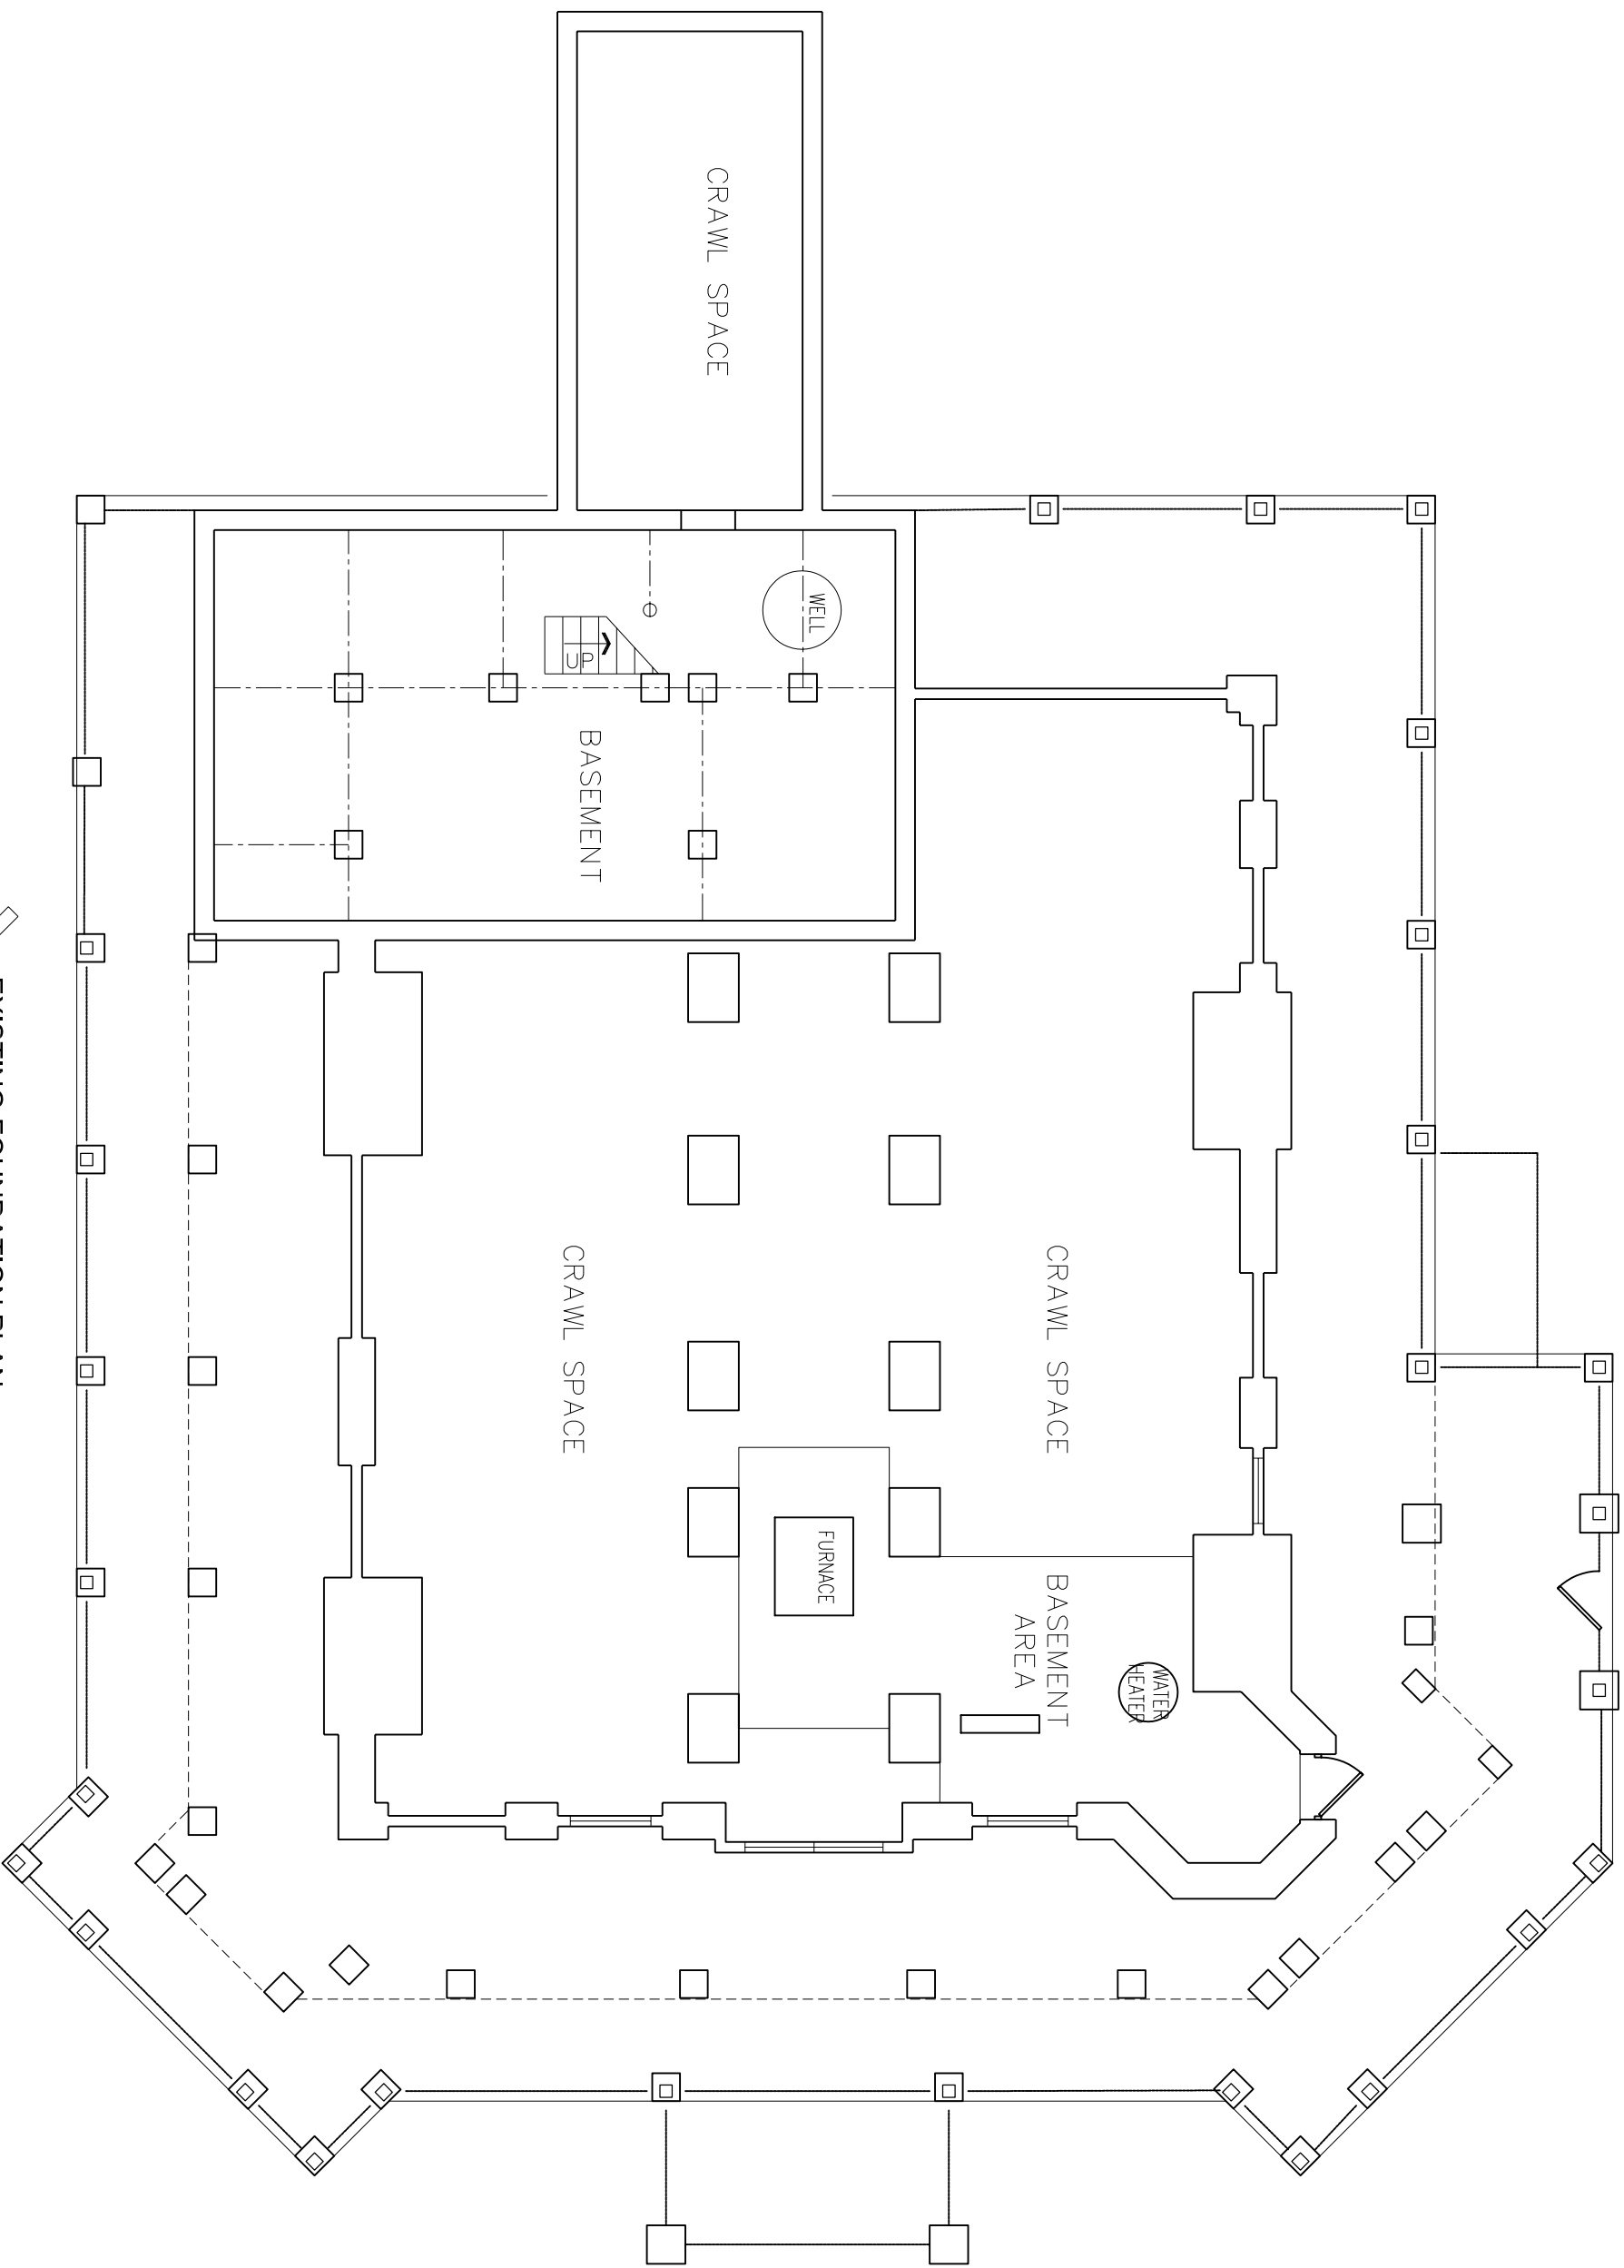
- Restoration of brick paver paths and driveway
- Reconstruction and repair of large portions of public lake path for long term stability and safety
- Historical review of existing tree and plant species
  - Compare existing trees and plantings to the historic 1901 plan
  - Outline preservation and maintenance recommendations
- Site renovations to accommodate museum guests
  - Further evaluate site for bus access and parking needs. Minimal space currently provided adjacent to garage and tool shed area
  - Evaluate employee parking area for current and future use
  - Accessible parking space
  - Review acquisition of land lost from original Black Point Estate, in particular those areas retaining 1901-1905 site planning details and without private development

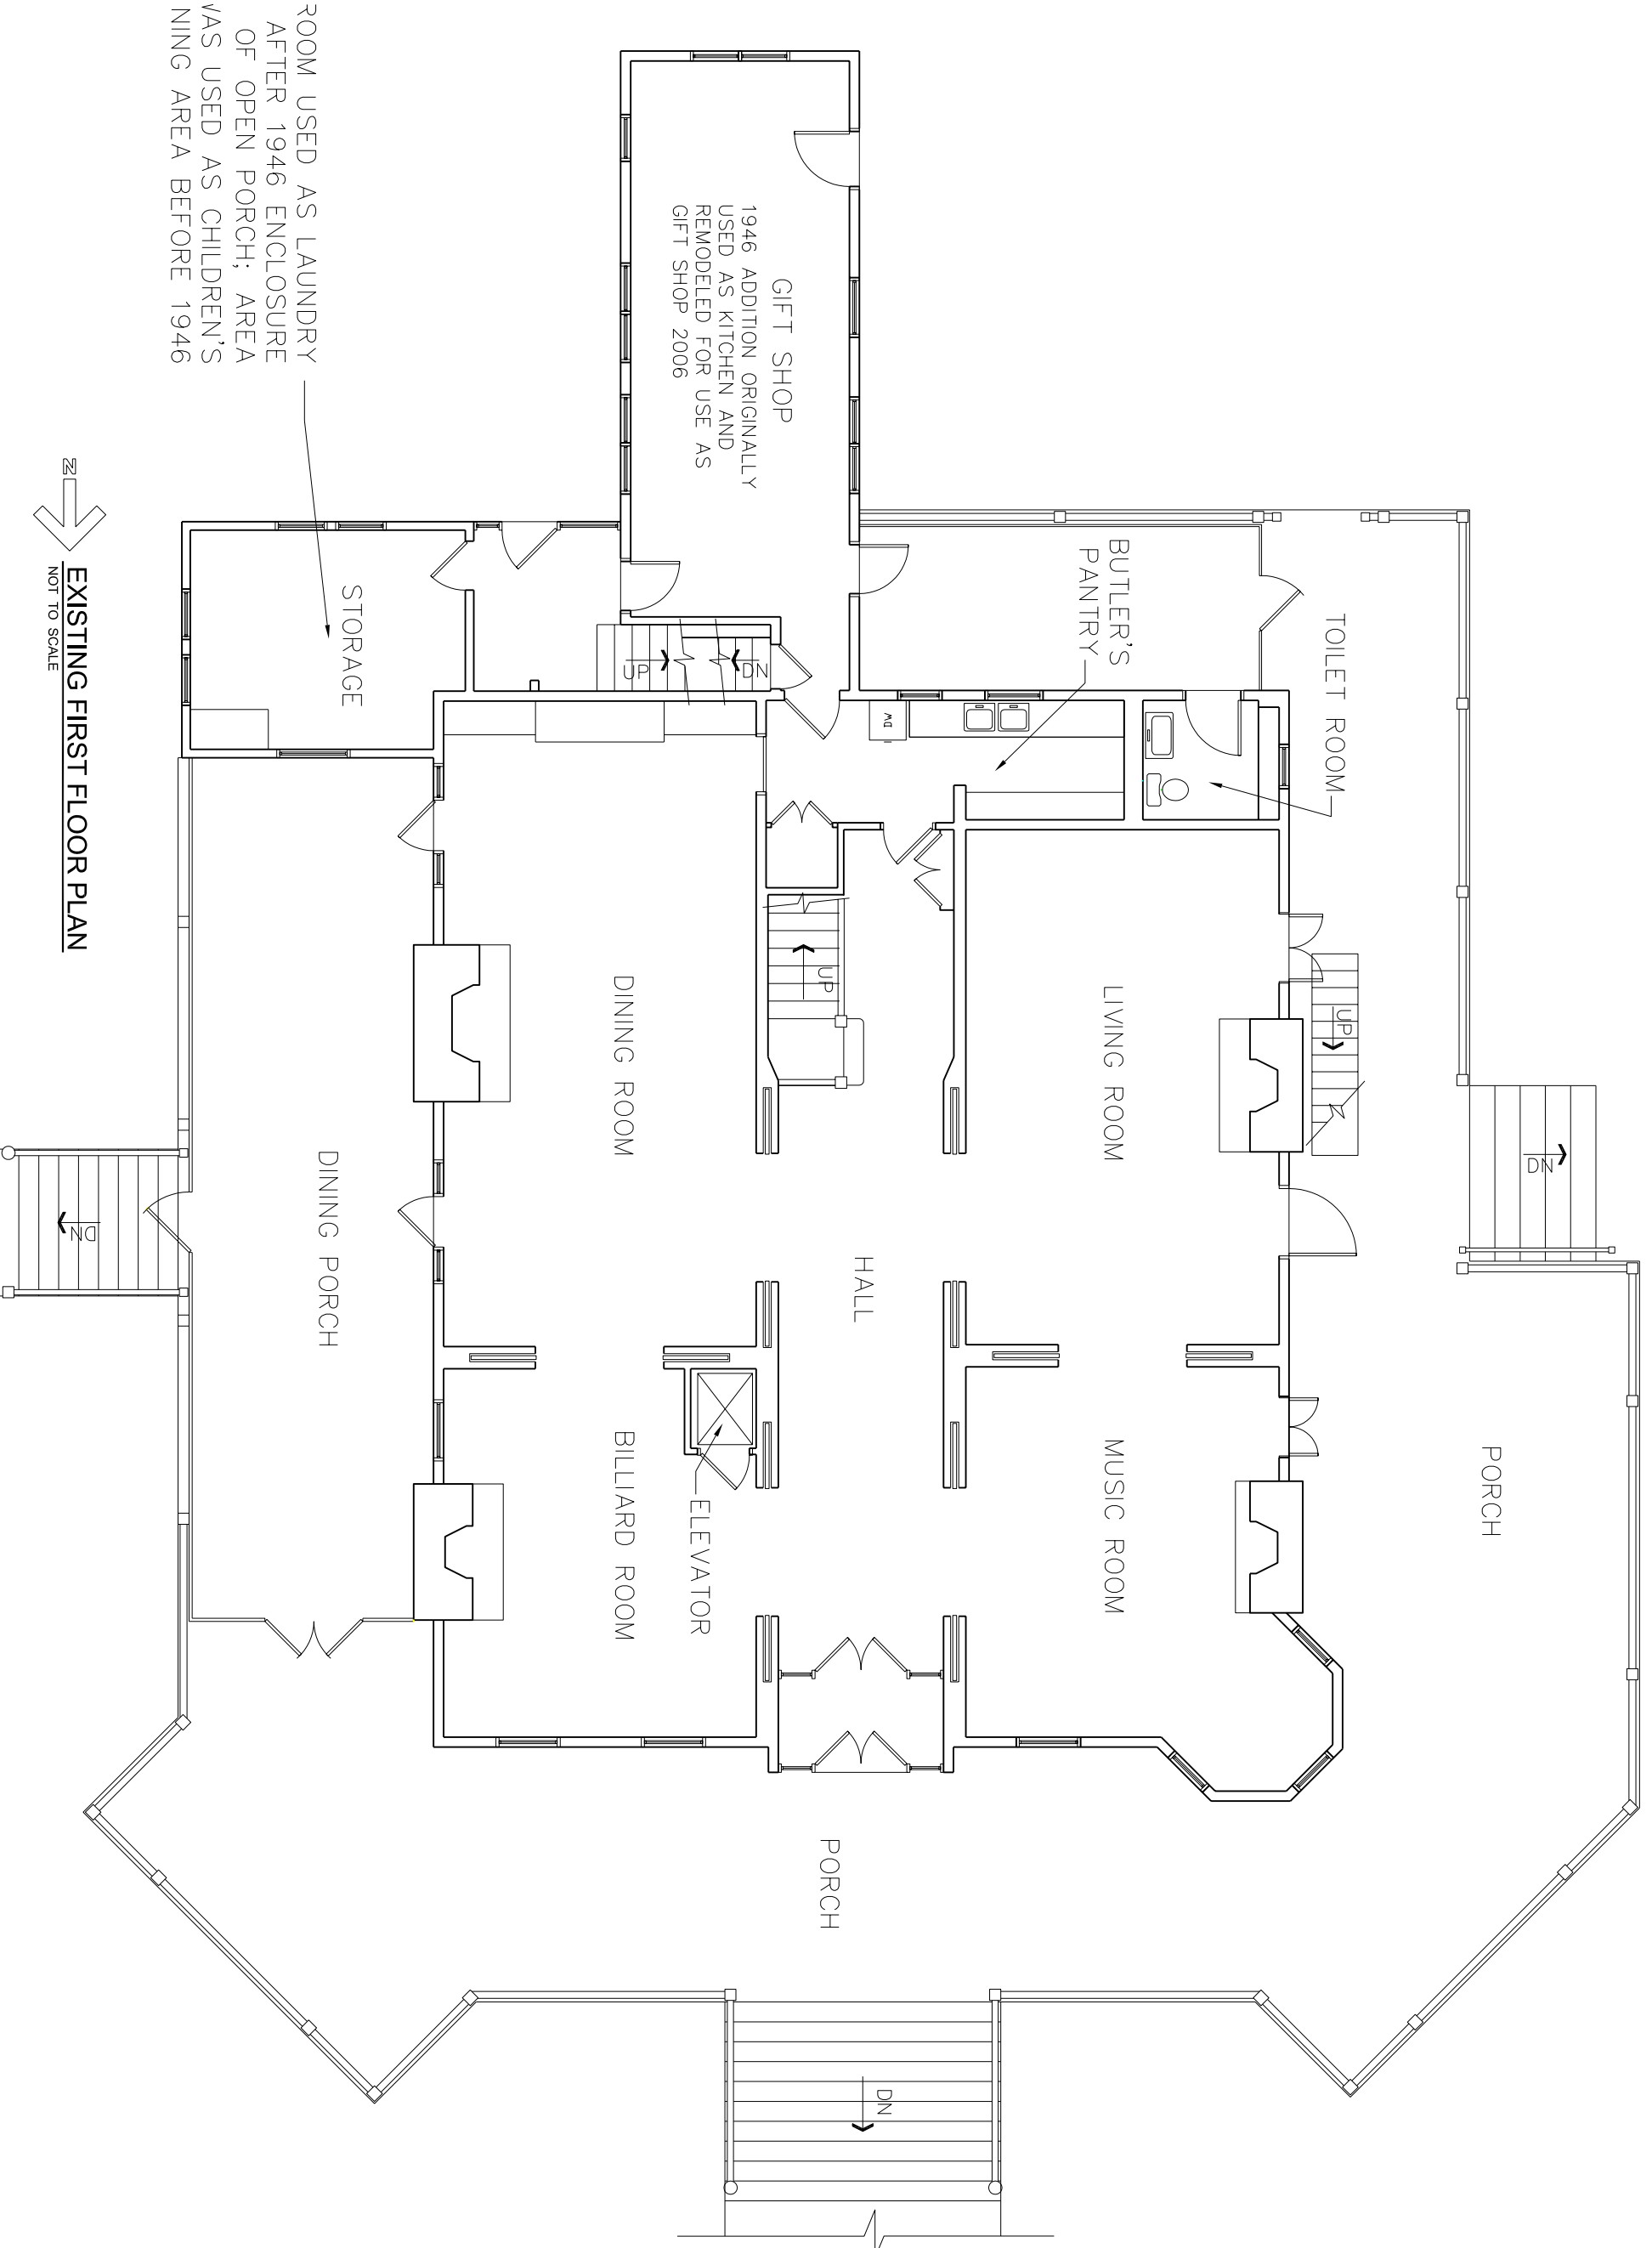
**STELLING & ASSOCIATES ARCHITECTS, LTD.**  
 181 W. CHESTNUT STREET P.O. BOX 506  
 BURLINGTON, WI 53105  
 TELEPHONE: (262) 763-6725 FAX: (262) 763-1971

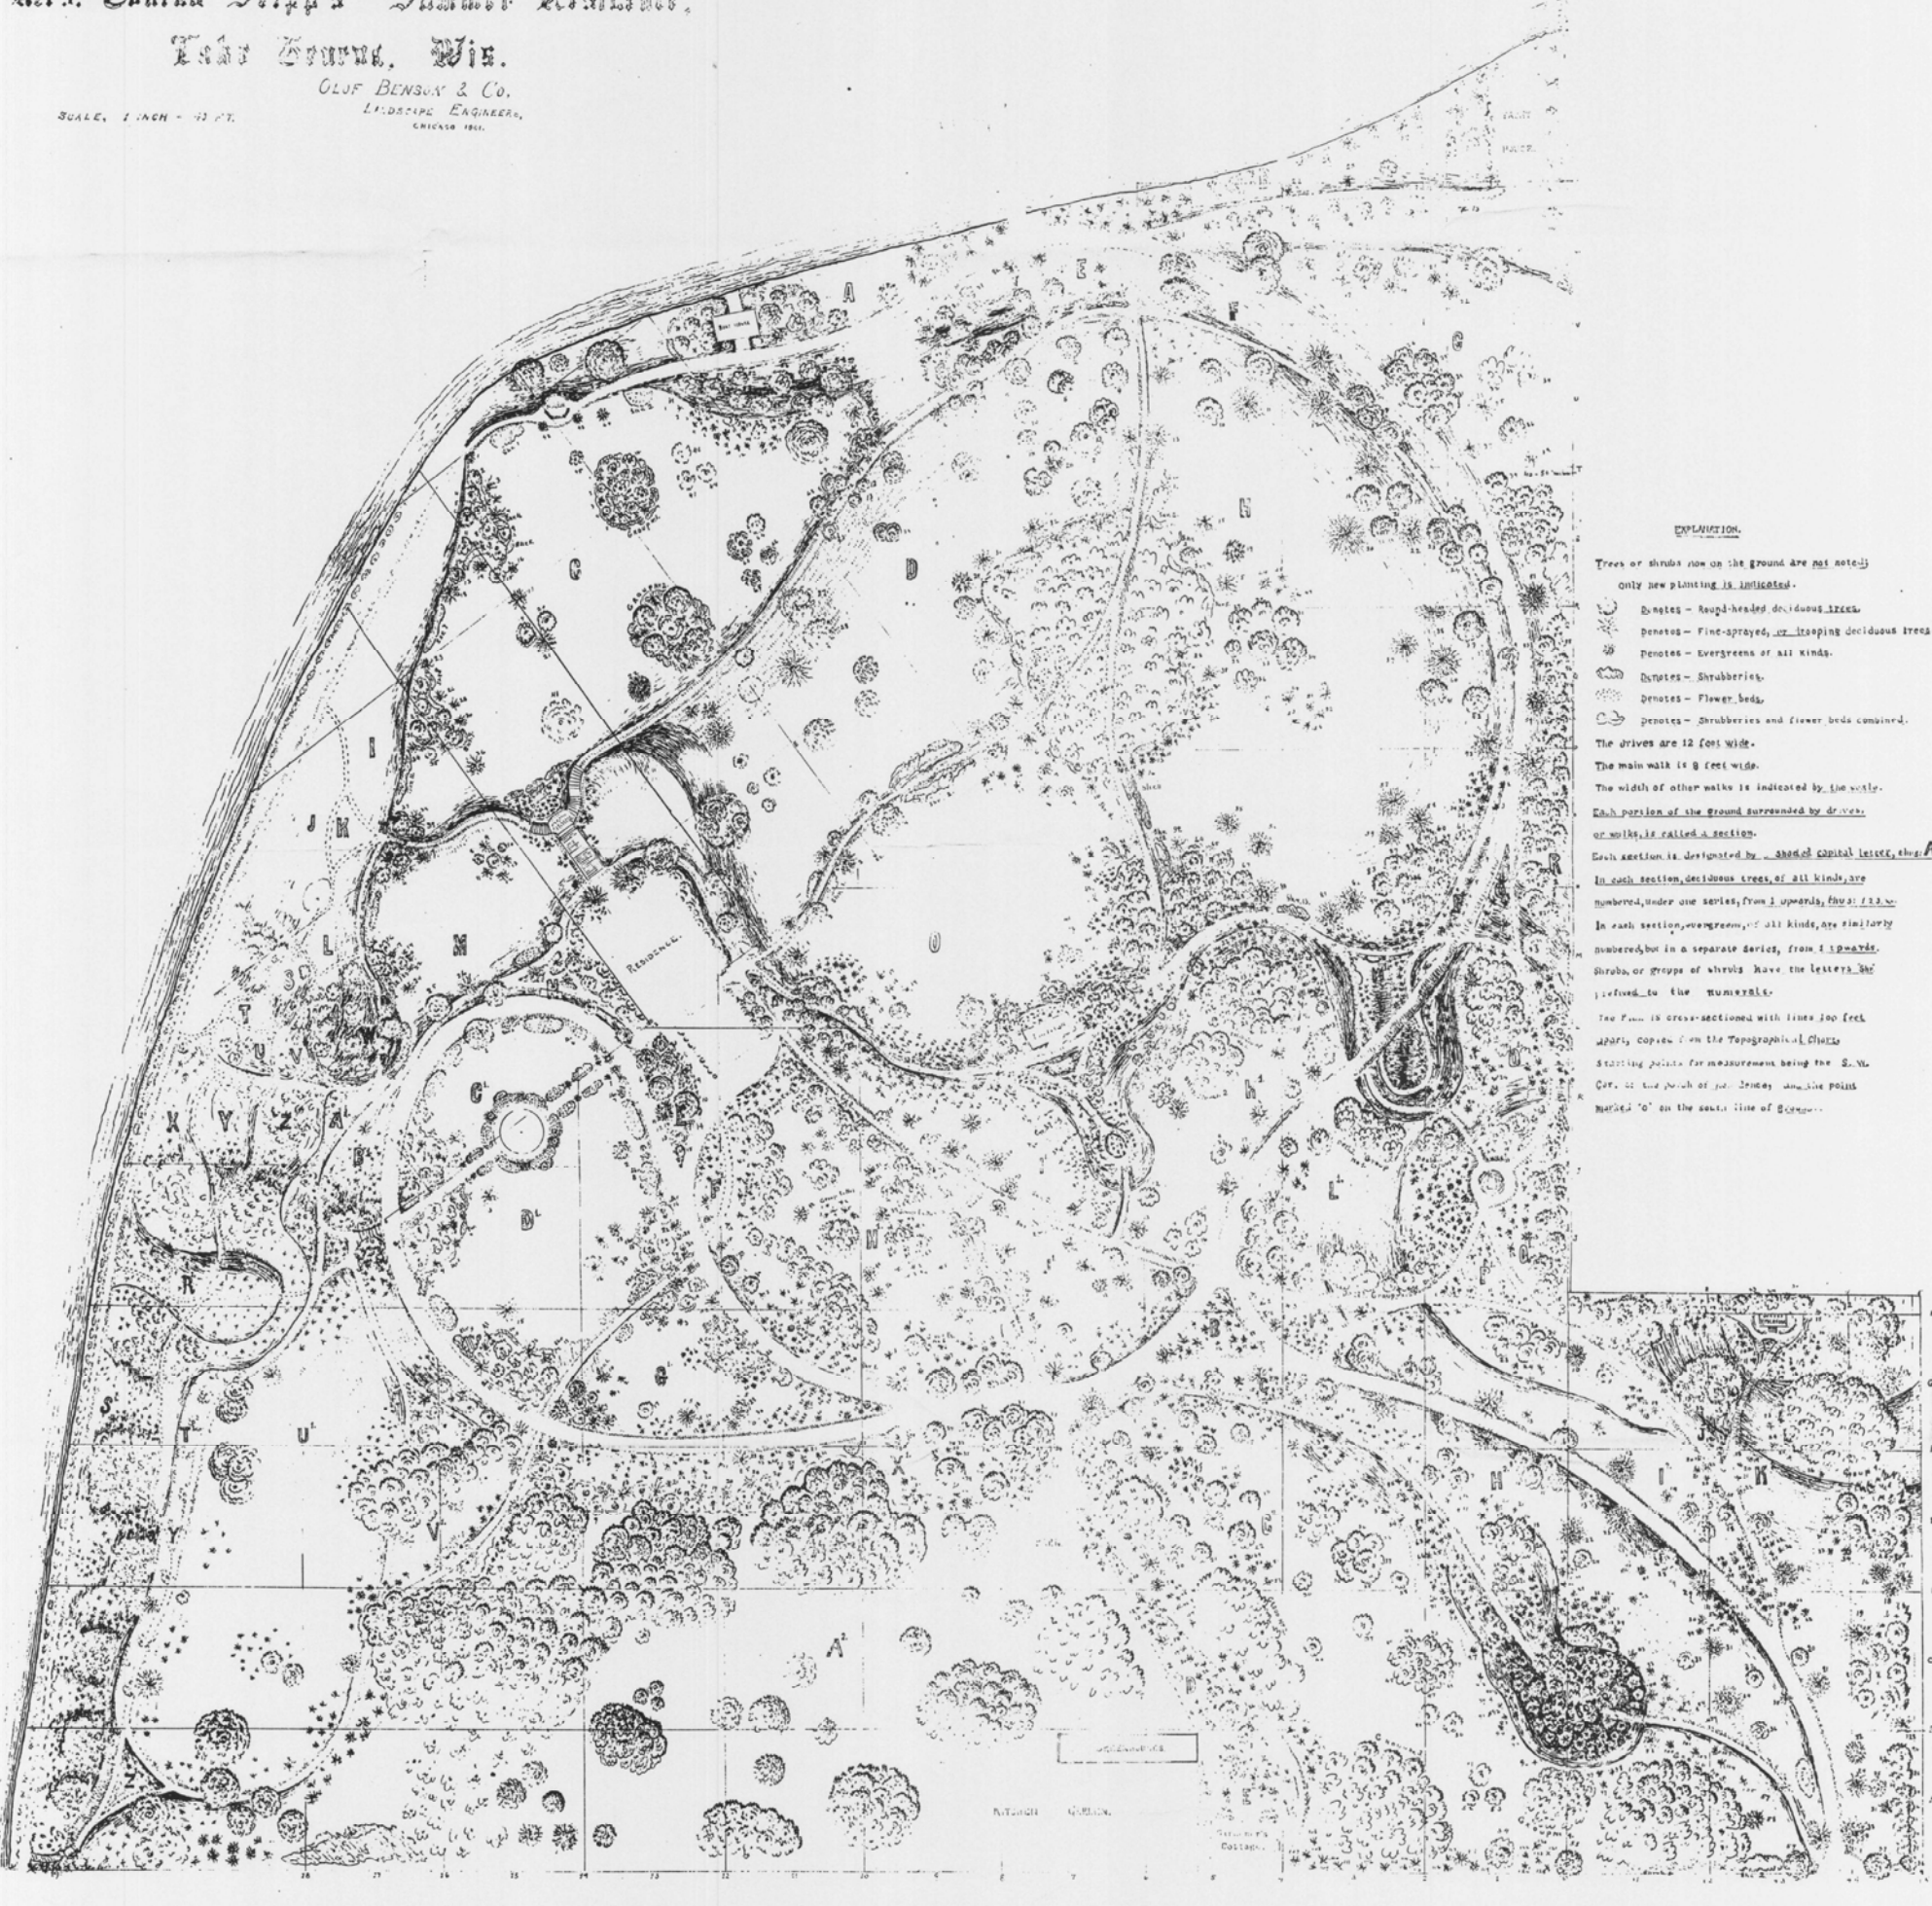
SITE PLAN BY OLOF BENSON, LANDSCAPE ARCHITECT, DATED 1901

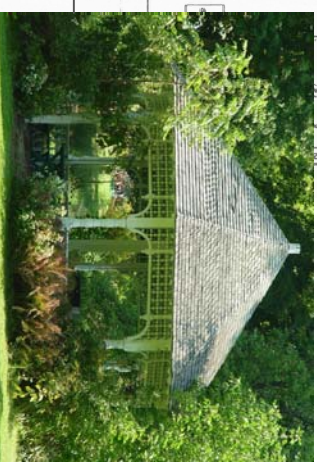
GAZEBO MOVED IN 1980 AS IT STANDS TODAY ON THE FORMER BAKER FARM PROPERTY IT IS MISSING SOME OF ITS ORIGINAL DETAILS, SUCH AS THE FINAL
