# FACILITY EVALUATION

## FOREST HEALTH PROTECTION LABORATORY 3911 Fish Hatchery Road Fitchburg, WI 53711

DSF Project # 07J2Q  
Architecture Madlson Project # 0801

May 14, 2009

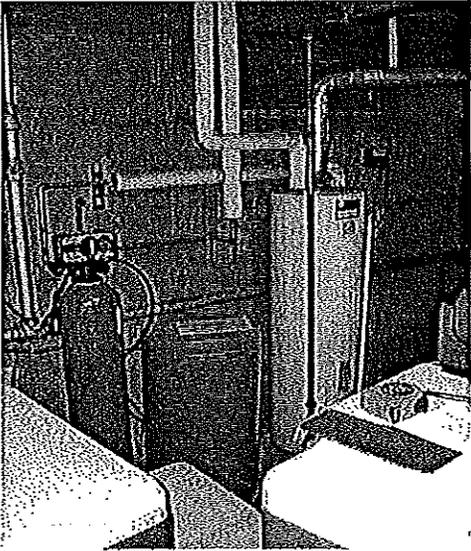
A 3/4" water softener(Hellenbrand 85) for the hot water service is located in Mech B01, along with a gas-fired 30-gallon water heater(Ruud RP 308-37). Hot and cold water are a combination of galvanized(original) and copper piping(remodeling) with insulation missing on significant lengths of the exposed piping. No hot water recirculation system is provided.

WATER SOFTENER AND HEATER

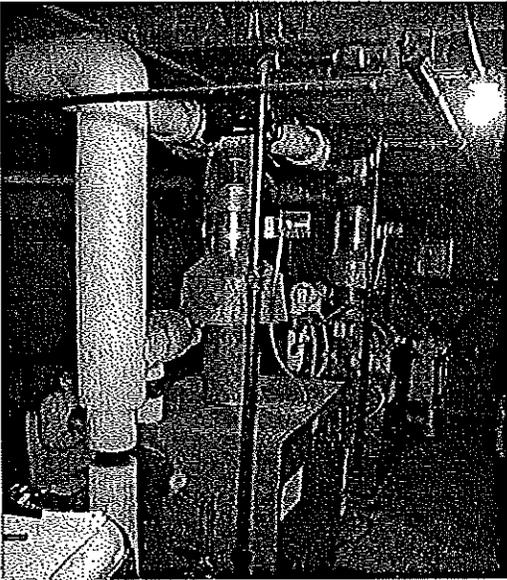
The heating system consists of a zoned low-pressure steam heat system with five zones of control: Lab 101, west offices, east office/toilet, head house and greenhouse. Two steam boilers(Burnham 409) serving the steam heating system appear to have been replaced in 1983 and are rated at 196 MBH output and 225 MBH input each with an automatic flue dampers.

STEAM BOILERS

The steam system should be replaced with either a hot water heating system or an all air system, if the envelope improvements are completed. The greenhouse addition will require radiation heating, which could be accomplished with a dedicated high-efficiency condensing boiler.

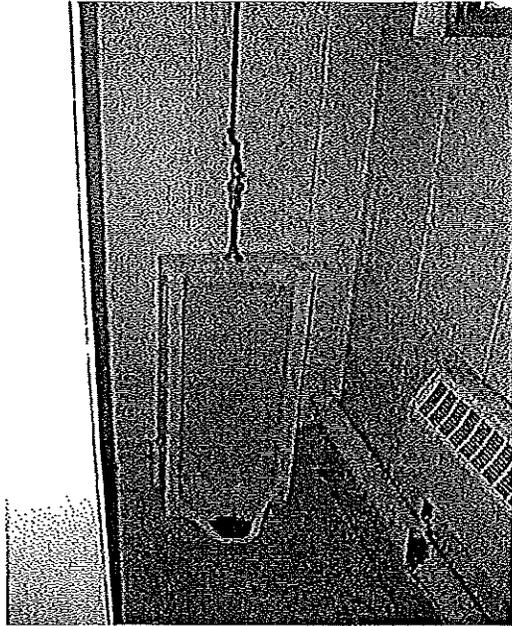
The public toilets consist of tank-type water closets, floor-mounted urinals and wall-mounted lavatories and all appear to be original and at the end of their useful life. Lab sinks, emergency shower and head house sinks all appear to be original as well.

EXISTING URINAL

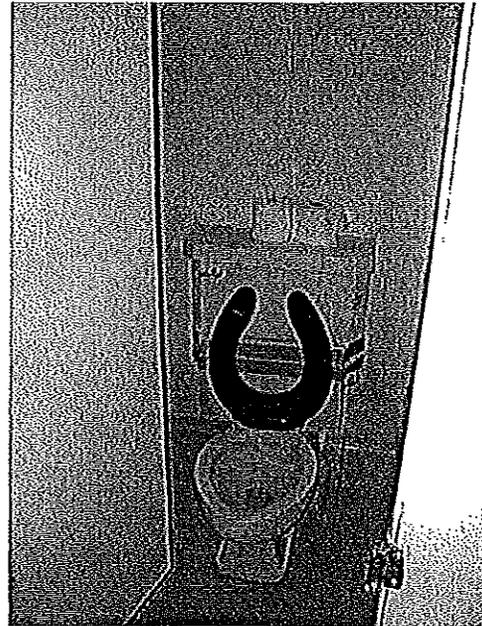
EXISTING WATER CLOSET

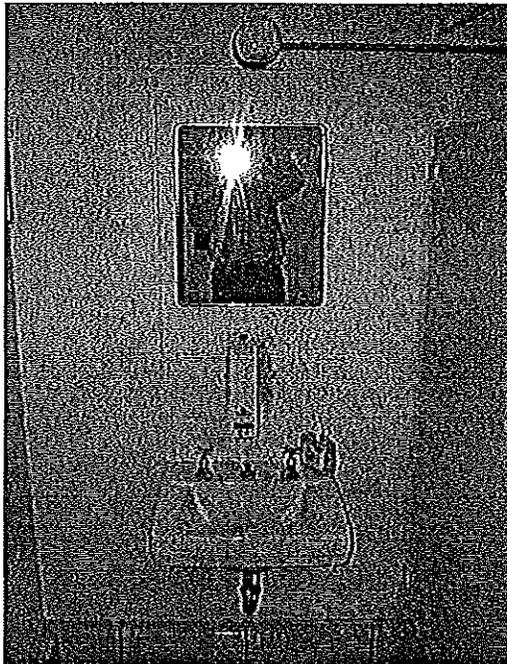
EXISTING LAVATORY

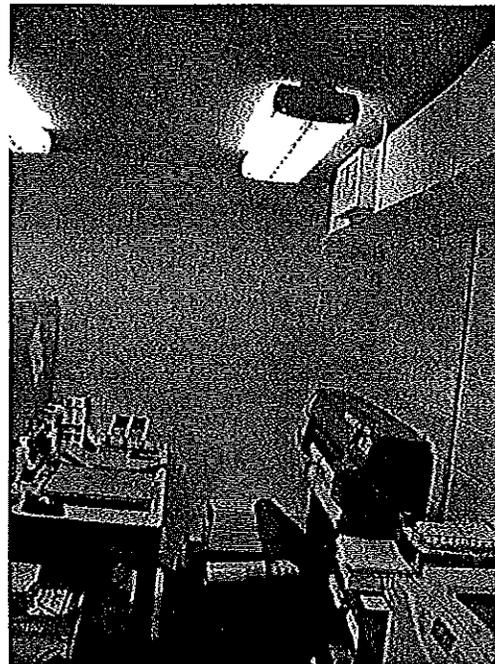
TYPICAL OFFICE LIGHTING AND DUCTWORK

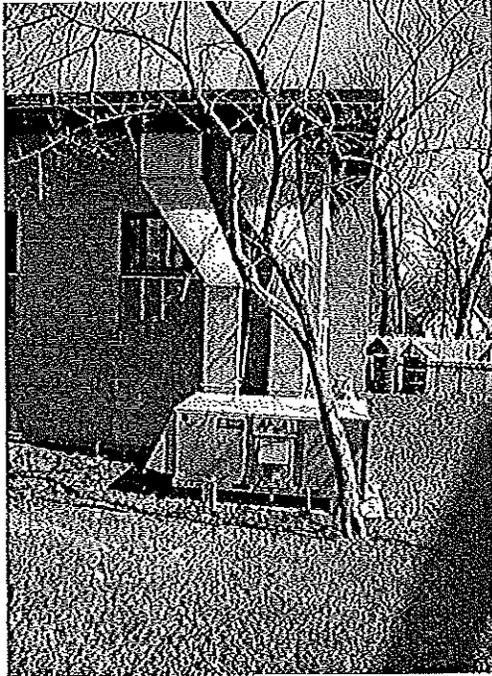
PACKAGED HEAT/COOL UNIT

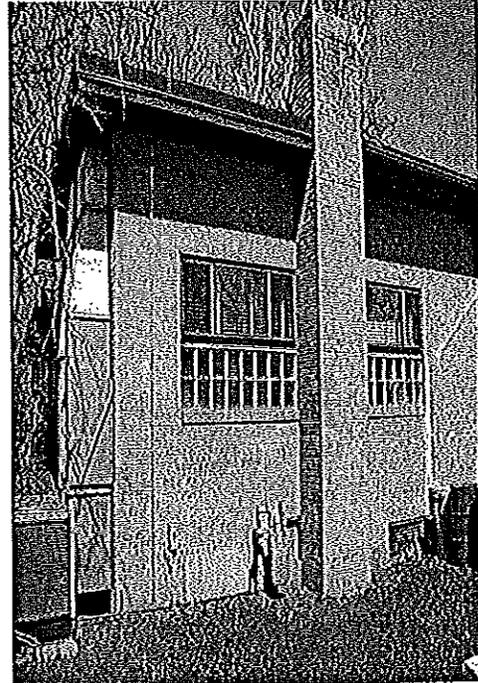
Gas service to building is provided on the south side and serves the boiler, water heater, incinerator and gas distribution for lab outlets in Lab 101.

SOUTH EXPOSURE AND GAS SERVICE

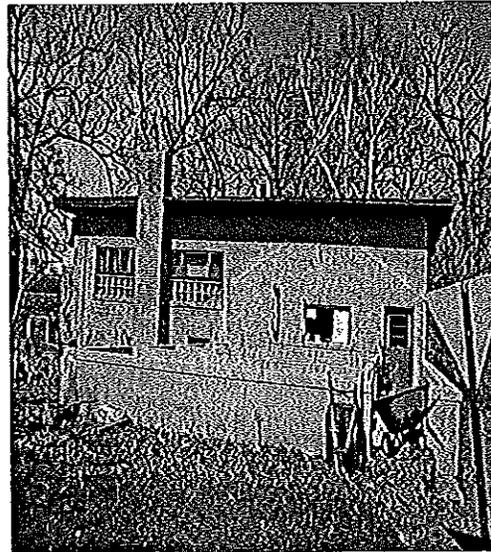
SOUTH EXPOSURE WITH GREENHOUSE ADDITION
