University of Wisconsin-Superior: Barstow Hall Exhaust Study Final Report

Project Number: 12-359

December 14, 2012

Karges-Faulconbridge, Inc.
Engineers

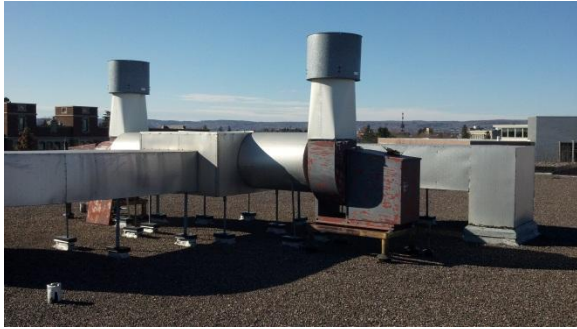
Picture 1

6. Exhaust fans are a vent-utility set type. Picture 1: EF-3 & EF-5. Picture 2: EF-4 & EF-6.
7. The handwritten tags and factory stamped tags do not match. The handwritten tags appear to match the design document fan locations, and all references to exhaust fans are based on these tags. Appendix A contains a handwritten schematic of fan locations and tags.

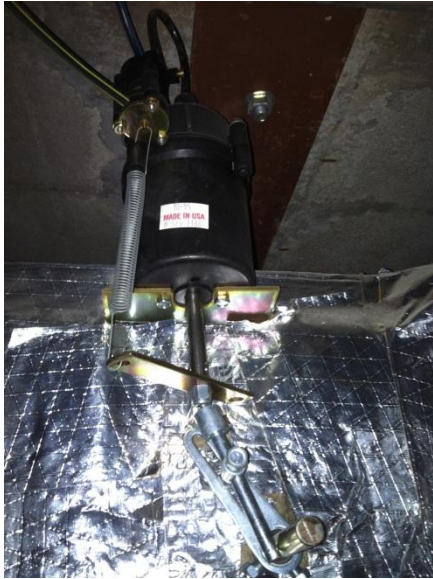
Picture 3

When the system scheduled to unoccupied mode, we observed that all four lab exhaust fans (EF-3, 4, 5, 6) all remained operational. The hood exhaust valves were observed in various stages of operation when the system was toggled to unoccupied. Some dampers were operational, some hoods had actuators that operated, but was slipping on the shaft, and some actuators failed to modulate at all. For example, **Picture 3** below shows an actuator that has been mounted in an inefficient manner. Due to the angle of installation, as we observed the actuator to stroke, part-way through the rotation the damper stopped rotating, and the actuator continued to drive until the linkage socket joint buckled and popped the actuator through the remainder of the stroke. The red arrow in **Picture 4** below shows a pneumatic line that was disconnected.

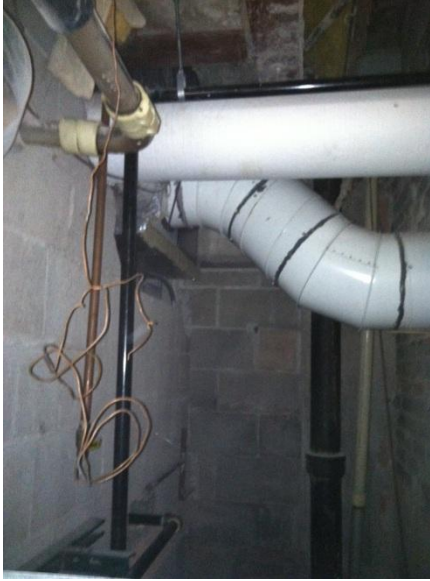
Picture 5

1. Design documents call for a 12"x12" duct run from the main to this lab. Installed duct is only a 12"ø duct, which has significantly less area (1 ft² vs 0.785 ft²).
2. Rough field estimates appear to indicate that even the original design document undersized this duct, and a 16"ø to 18"ø (or equivalent) duct may be required.
3. The installation of ductwork to this zone is not ideal:
 - i. The take-off for this duct run is installed directly on an elbow, which does not provide ideal conditions. See pictures below. **Picture 5:** Side view of duct take-off directly on elbow. Duct main continues horizontally to the left and vertically up through a chase. **Picture 6:** View of installation below the chase.

4. The filter racks should be sealed by a combination of gaskets and blank-off plates to prevent the bugs from bypassing filters.
 - a. Estimated Cost: **\$4,000 total**
5. Replace the exhaust ductwork from the main to Lab 010A with properly sized ductwork, and limited transitions. The ductwork should attach to the main in an appropriate location to allow for favorable inlet conditions.
 - a. Estimated Cost: **\$3,000**
6. The exhaust dampers controls should be altered to prevent the exhaust dampers from modulating. The pneumatic actuator should be disconnected from the damper shaft, and pneumatic lines verified to be capped. The existing damper can be used for balancing purposes by means of fastening a mechanical stopping device to the shaft to allow adjustment and fastening by the balancer.

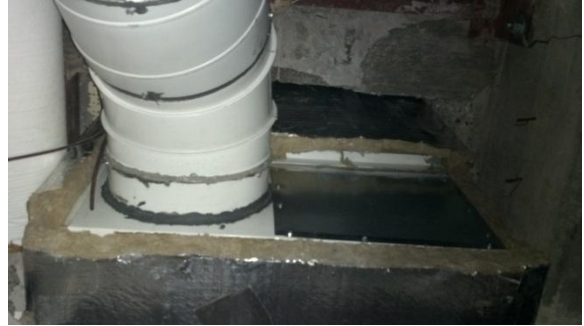
Picture 6

- ii. The exhaust duct from the main to Lab 010A has an excessive number of elbows/transitions. The actual installation has three (3) 90° elbows and four (4) 45° elbows between the duct main and Lab 010A. This also causes excessive pressure drop, and reduces flow from the space.
4. We traced this system from the lab up to the fan and did not observe any crushed or damaged ductwork.

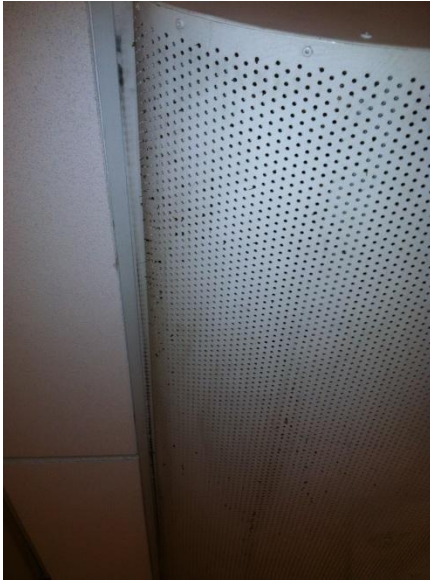
Picture 7

The displacement diffusers on the supply system are plugged with dust/debris. This restriction in supply airflow could be contributing to the negative pressure of the building which was evident on the day of testing. See pictures below. **Picture 7:** Diffuser plugged with debris. **Picture 8:** Is a close-up view of the diffuser in picture 3. **Picture 9:** A different example of plugged diffuser.

1. Disassemble and clean the displacement diffusers. This can be done by facility staff.
 - a. Estimated Time: 30 minutes per diffuser.
2. The ductwork should be cleaned or replaced.
 - a. Estimated Cost: \$1-2/ft² for cleaning. \$4-6/ft² for replacement.
3. Treat hydronic chilled water system as recommended by Closed Systems Labs. Additional information would be required to properly estimate the size of the system for estimation purposes.
 - a. Estimated Cost: Typically around \$12/gal for premix solution.

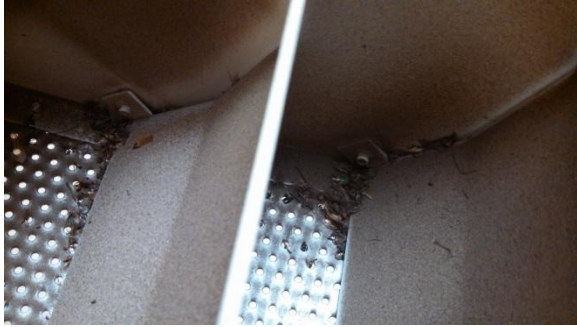
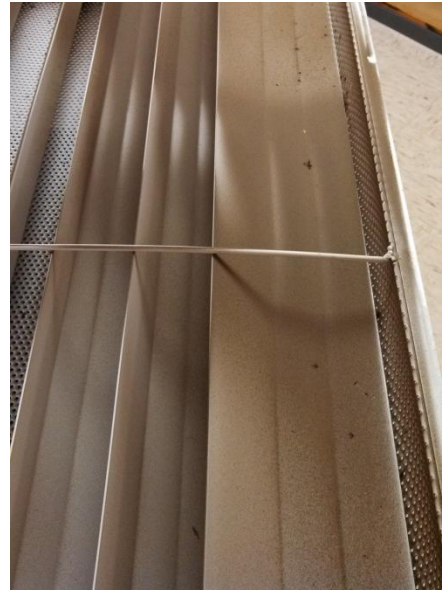
We disassembled one diffuser and attempted to clean it in Lab 9 (**Pictures 10 & 11**). We were able to shake out some of the debris, but most of the debris appeared to be stuck onto the diffuser and would require a combination of vacuuming and washing the diffuser to thoroughly clean the unit. Note that the dark areas in **Picture 11** are not shadows; that is the dust/debris stuck to diffuser. Just dumping out the loose particulate resulted in an increase in 20 cfm. We also observed sections of this this duct to be

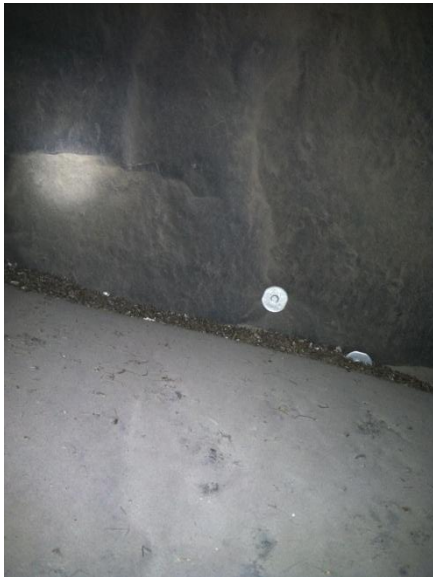
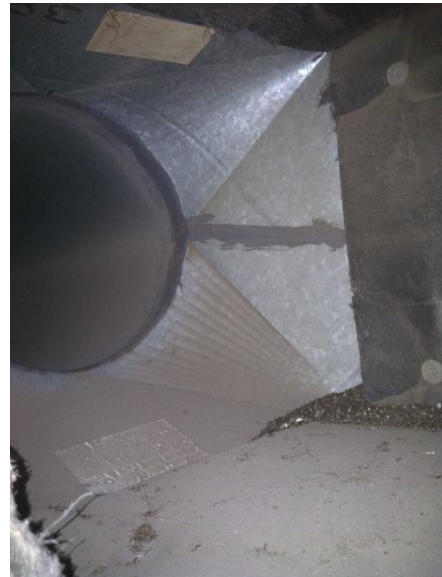
both internally lined, and insulated externally. The ductwork also contained bugs/debris. (Pictures 12 & 13)

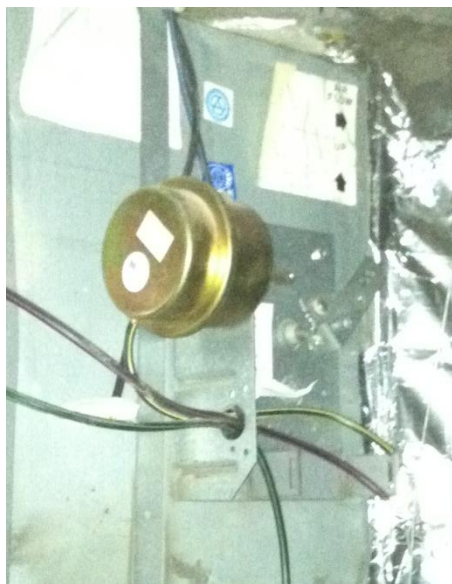
Picture 17

Supply VAV damper positions mostly observed at 100% open (not controlling). Also observed damper actuators that were missing/removed/disconnected. **Picture 17:** the damper-actuator linkage has been disconnected.

Similarly on the supply side, the remainder of the VAV dampers should be detached from the actuator, and provided with a mechanical adjustment/stop device.

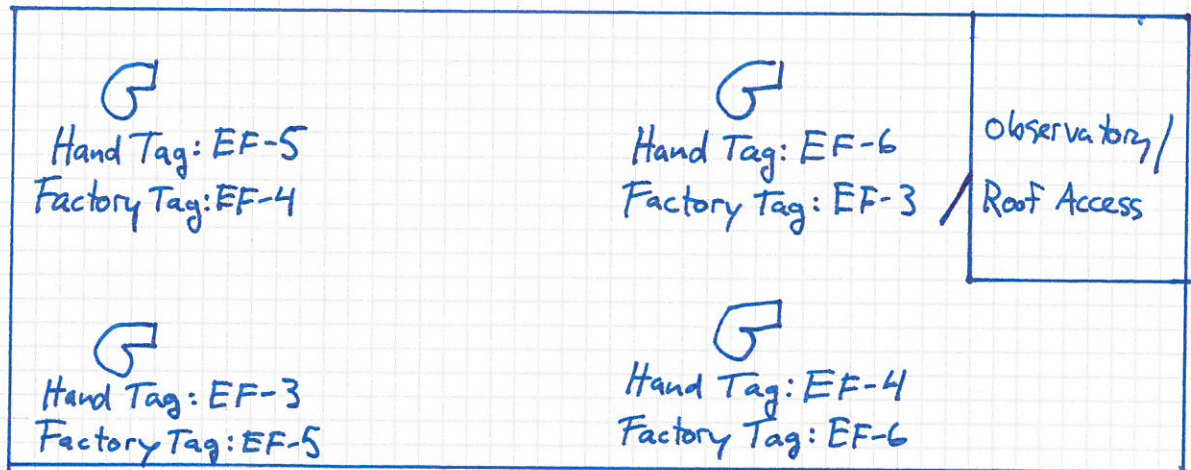
Appendix A – Rooftop Exhaust Fan Schematic

Handwritten EF Tags match 2010 EF locations (M201)
All KFI references are to handwritten tags.
