Wisconsin's Capitol Park

A REHABILITATION MASTER PLAN

- Approved by the State Capitol and Executive Residence Board (SCERB) on October 31, 2000.
- Printed in October 2004.

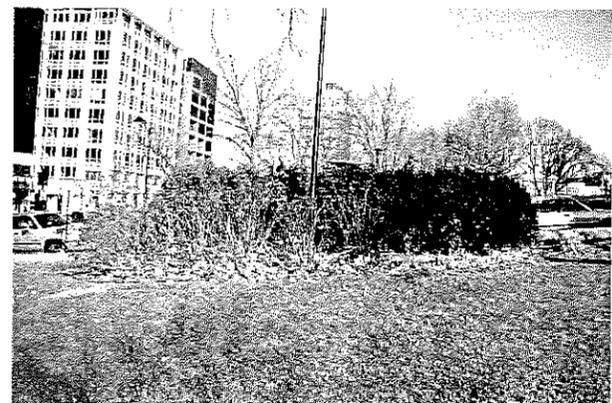
The existing plantings along the axial approaches are inconsistent, and comprised of a combination of herbaceous plants and evergreen and deciduous shrubs (figure 2.13). In some cases (*e.g.*, West Washington Avenue), the overall design lacks symmetry. The basic structure and sense of order embodied in John Nolen's design for the axial approaches has been lost.

FIGURE 2.13 Large evergreen and deciduous shrubs surrounding one of the semi-circular seats, 1999.

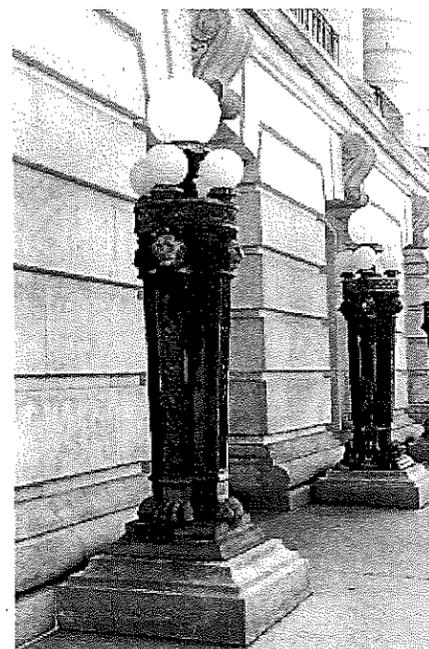
Lights All of the original bronze light fixtures remain in place and in operable condition (figures 3.7-3.9). The fixtures produce a warm, soft light, although illumination levels are less than in other areas of the park. A 1987 inventory determined that all of the park's the bronze fixtures and artwork suffer from varying levels of corrosion caused by pollution.⁵⁹

FIGURE 3.7 Ornamental bronze light fixtures located at one of the Capitol porticos.

Lights The condition of the bronze light fixtures should be assessed on a regular basis. The historic lights should be maintained, and conserved as necessary. The green patina, which naturally has accrued to the bronze surfaces, should be preserved, unless its removal is deemed necessary to preserve the integrity of the light standards. No new light fixtures should be added to the terrace.

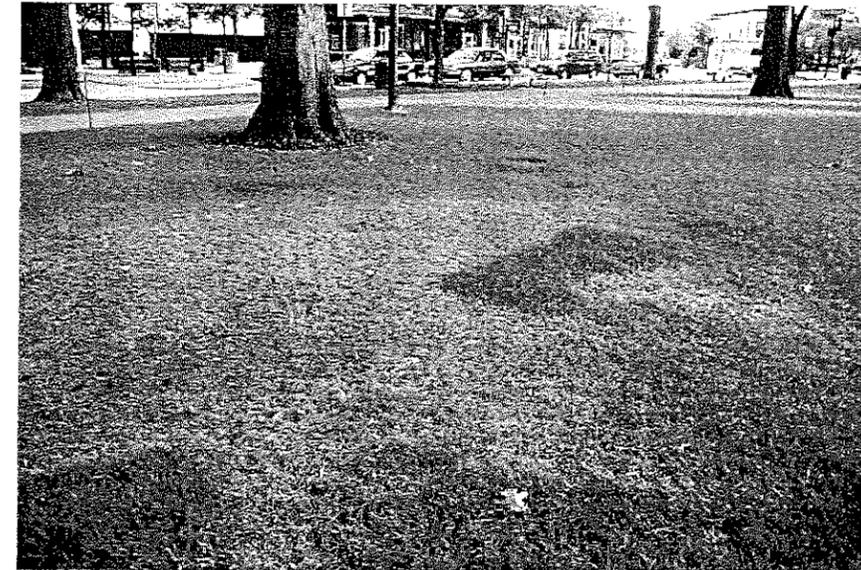
FIGURE 4.7 Special events may seriously damage the health of the turf. The 1998 Wisconsin Sesquicentennial Celebration left behind the large patches of dead turf pictured here.

The current health of the turf is variable. In many areas the turf is in poor condition, due to insufficient light and soil compaction caused by heavy human use (figures 4.7 and 4.8). In 1989 landscape managers began utilizing temporary fencing to minimize human impacts during heavily attended events such as Saturday farmers' markets. Nonetheless, patches of sparse turf occur over extensive areas, especially beneath shade trees where the grass may be slower to recover (figure 4.9). Events such as Concerts on the Square and the 1998 statehood sesquicentennial celebration have the capacity to inflict severe damage.

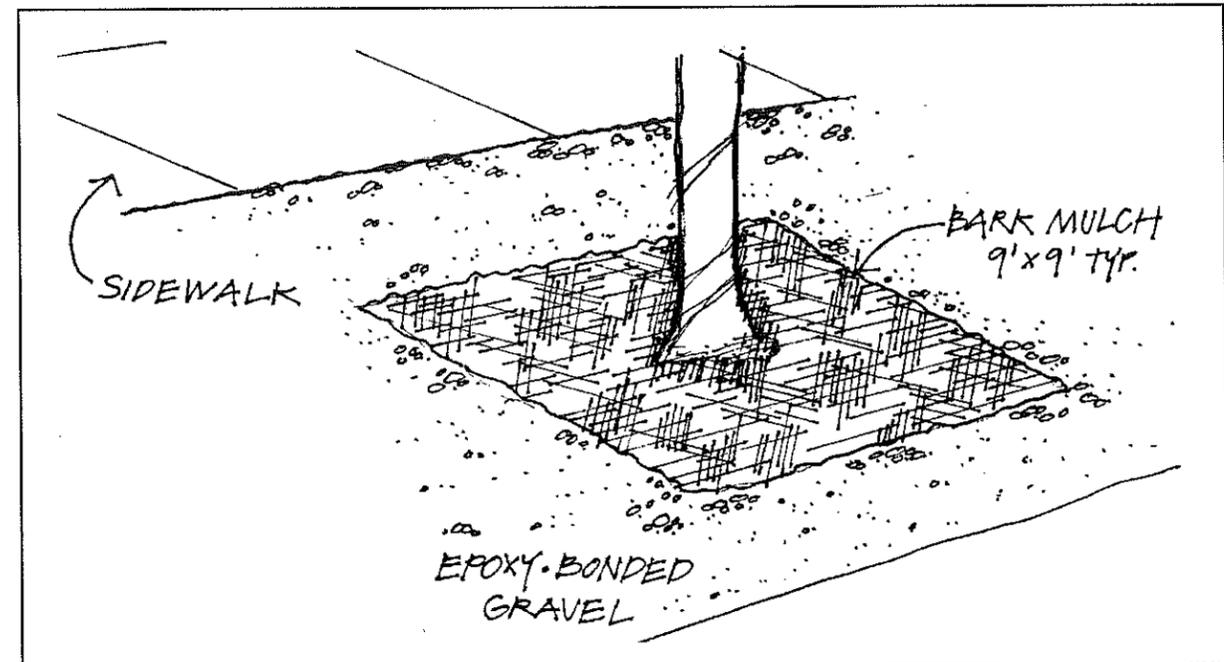
FIGURE 5.12 Typical bark mulch detail found at 16 of the 44 Norway maple trees within the epoxy-bonded gravel median.
