2009 Condition Report for Northeast Plaza and Northwest Plaza and Barrier Wall Repair Options

**Milwaukee State Office Building
819 North 6th Street
Milwaukee, Wisconsin**

DSF Project No. 08C1A

November 2, 2009

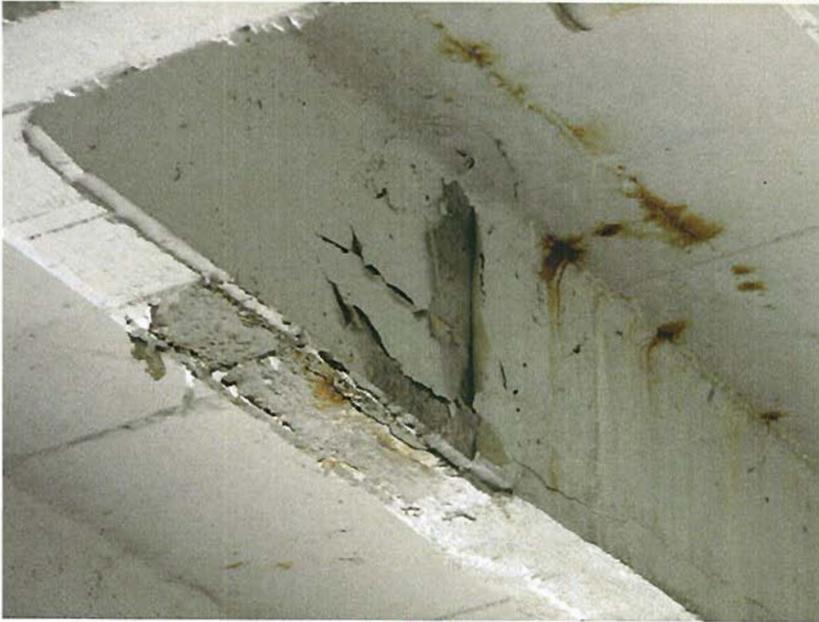
Photo #33

Presently, water is infiltrating the occupied space below the northeast plaza and the northwest plaza. Extensive active leakage is present in the northeast plaza and active leakage in the northwest plaza occurs only during heavy rainfalls. Evidence of past leakage is present below the northeast and northwest plazas as well. Active leakage was not reported under the east and west plazas. However, evidence of past leakage was observed under the west plaza. See Sketch 2 – Leak Location Sketch and photos 33 through 52.
