UNIVERSITY OF WISCONSIN – LA CROSSE RESIDENCE LIFE FACILITY ASSESSMENT

DFD Project No. 15A1H

Date: April 25, 2016

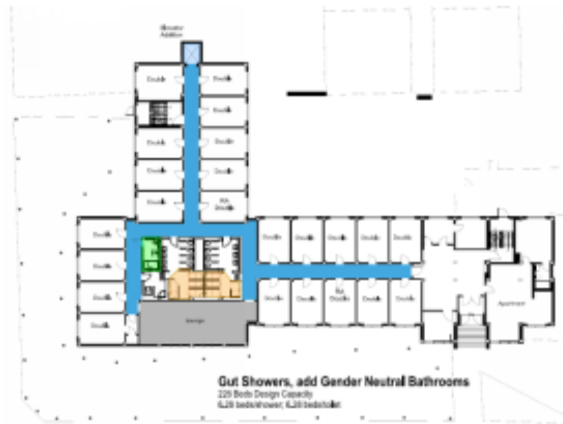
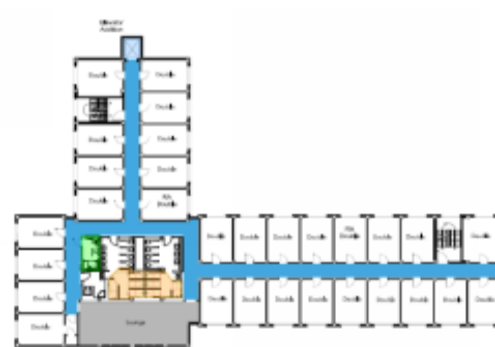
No fire suppression system
 Inadequate ventilation

Provide fire sprinklers; replace electrical power systems; refurbish bathroom exhaust systems; gut remodel showers, add ADA/Gender Neutral bathrooms, add elevator.

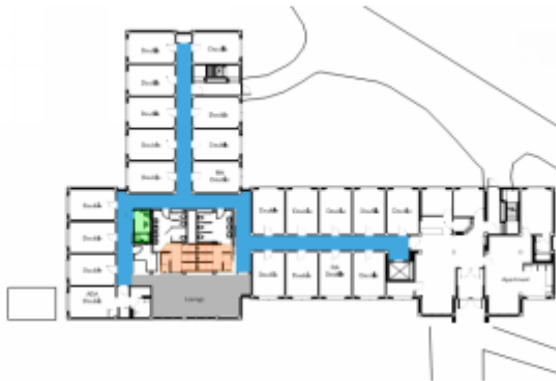
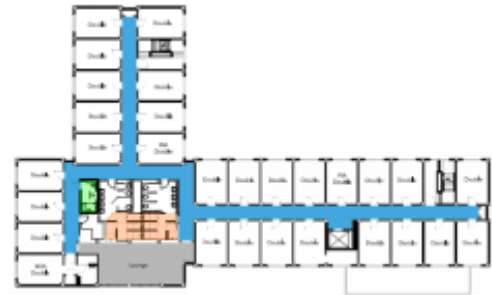
No fire suppression system
 Inadequate ventilation
 28 year old elevator

Provide fire sprinklers;
 refurbish elevator; replace
 electrical power systems;
 refurbish bathroom exhaust
 systems; gut remodel showers,
 add ADA/Gender Neutral
 bathrooms, add elevator.

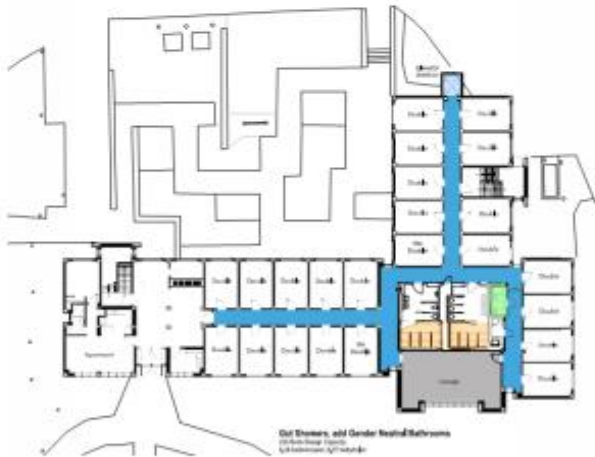
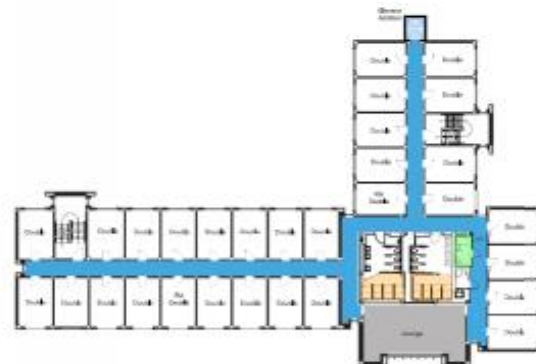
No fire suppression system
 Inadequate ventilation

Provide fire sprinklers; replace electrical power systems; refurbish bathroom exhaust systems; gut remodel showers, add ADA/Gender Neutral bathrooms, add elevator.

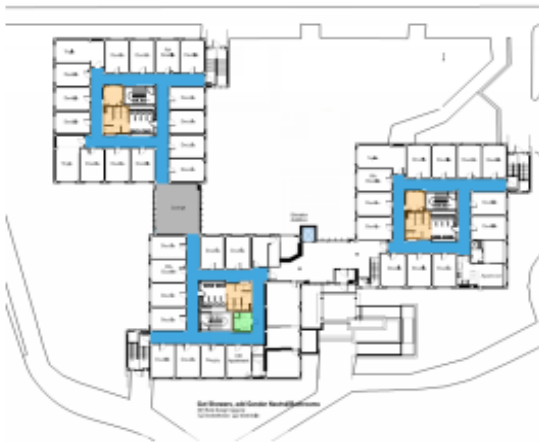
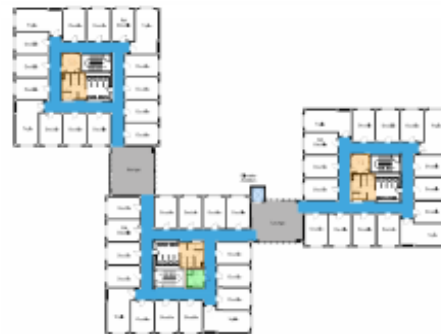
No fire suppression system
 No code compliant fire alarm system
 Inadequate ventilation

Provide fire sprinklers; provide compliant fire alarm system; replace electrical power systems; refurbish bathroom exhaust systems; gut remodel showers, add ADA/Gender ADA/Gender Neutral bathrooms, add elevator.

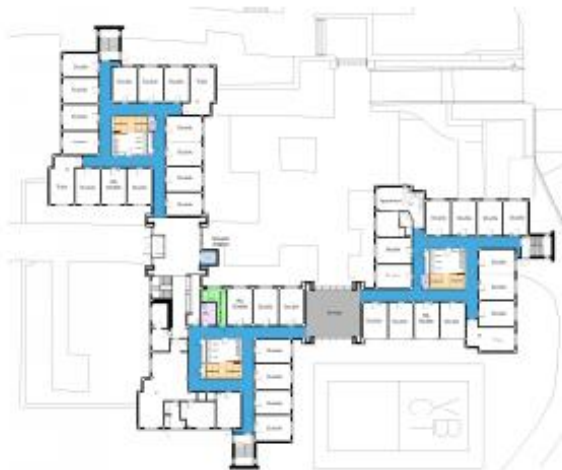
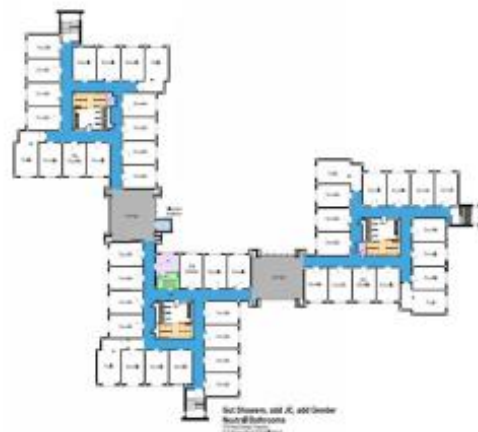
No fire suppression system
 Inadequate ventilation

Provide fire sprinklers; provide compliant fire alarm system; replace electrical power systems; refurbish bathroom exhaust systems; gut remodel showers, add ADA/Gender Neutral bathrooms, add elevator.

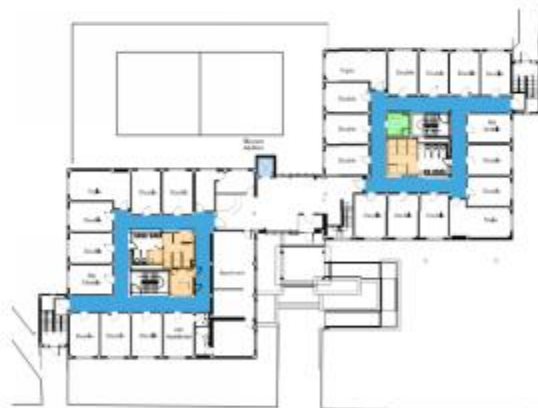
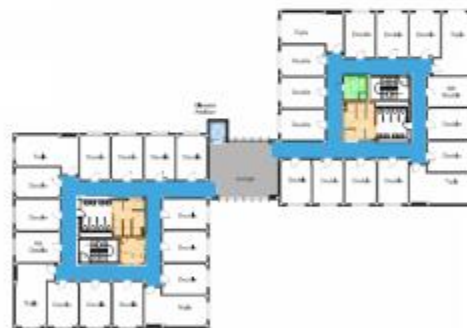
No fire suppression system
 Inadequate ventilation

Provide fire sprinklers; replace electrical power systems; refurbish bathroom exhaust systems; gut remodel showers, add ADA/Gender Neutral bathrooms, add elevator.

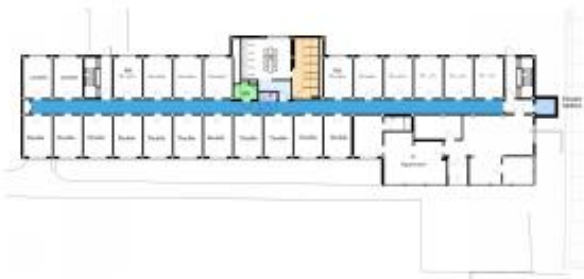
No fire suppression system
 Inadequate ventilation

Provide fire sprinklers;
 refurbish elevator; replace electrical power systems;
 refurbish bathroom exhaust systems; gut remodel showers, add ADA/Gender Neutral bathrooms, add

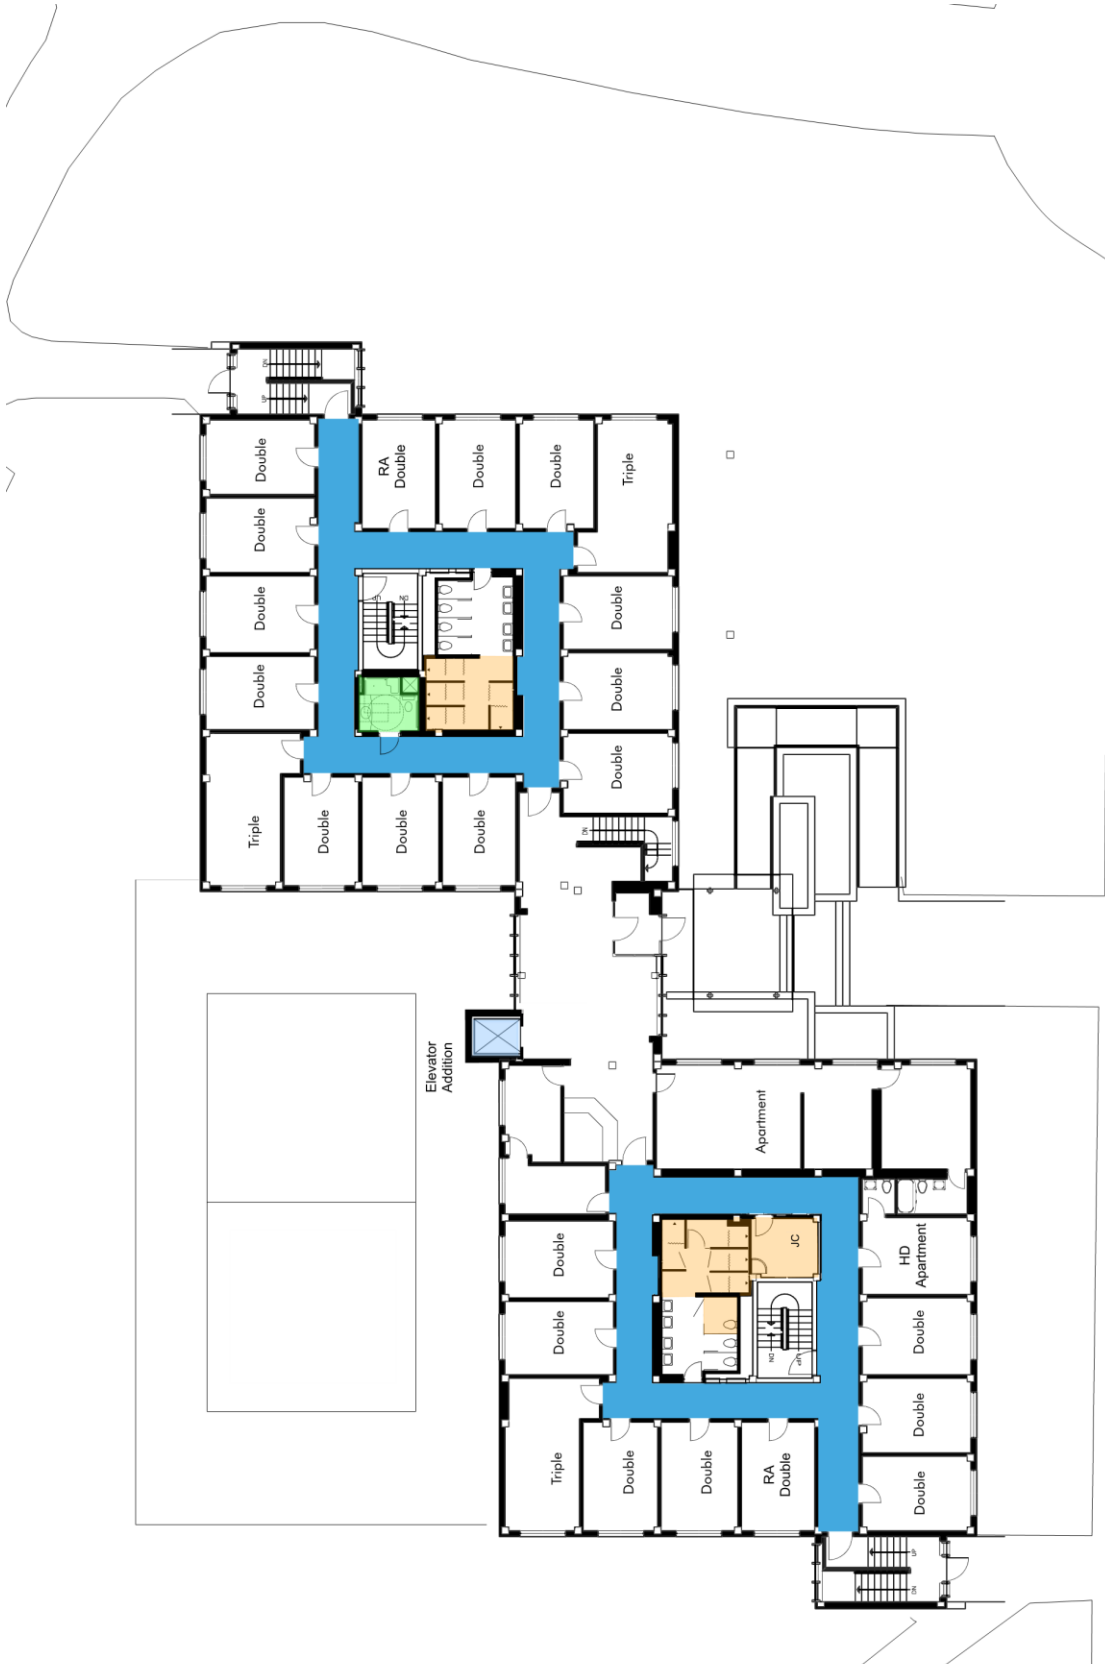
Gut Showers, add Gender Neutral Bathrooms
 261 Beds Design Capacity
 7,25 beds/shower, 8,16 beds/toilet

- Provide fire sprinklers
- Replace electrical power systems
- Refurbish bathroom exhaust systems
- Gut remodel showers
- Add ADA/Gender Neutral bathrooms
- Add elevator

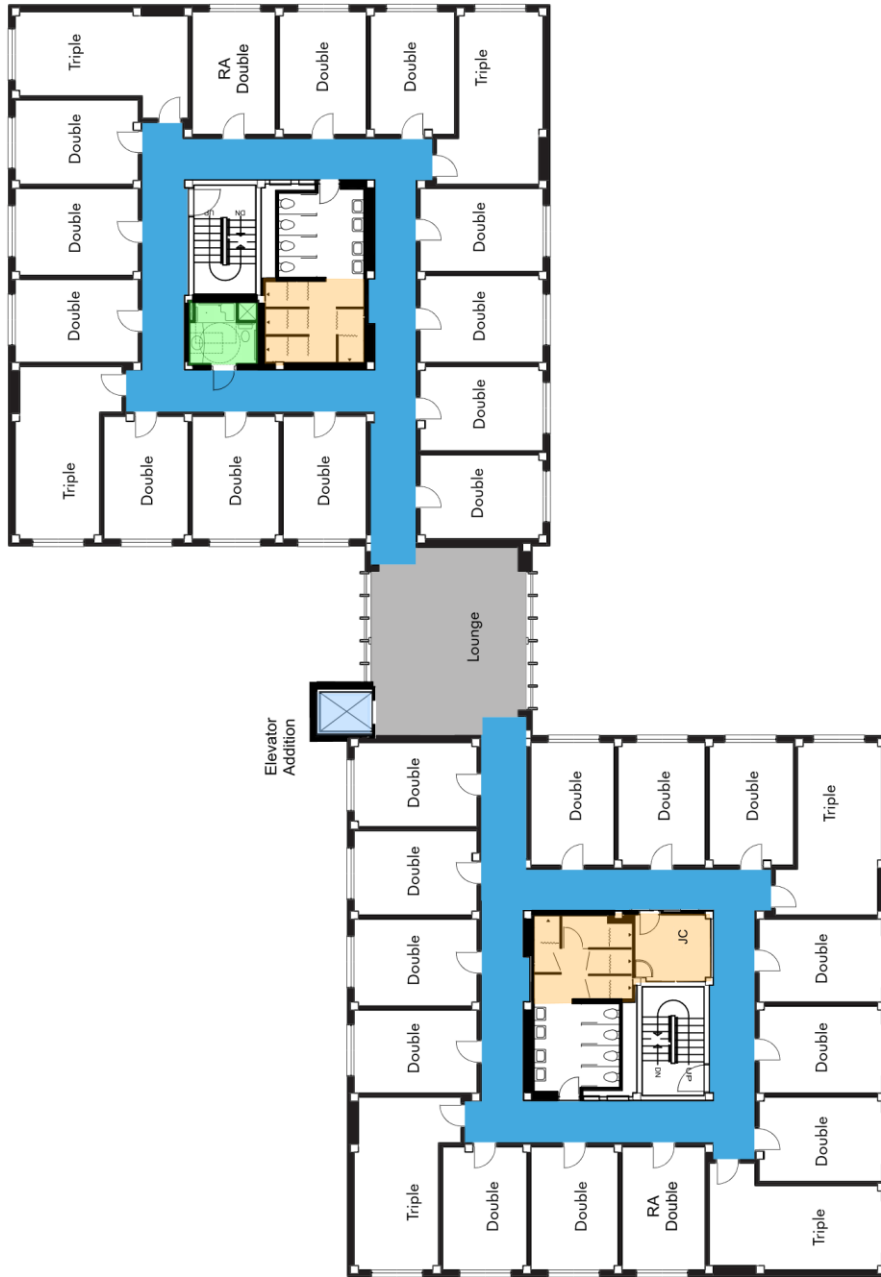
First Floor Plan

Gut Showers, add Gender Neutral Bathrooms
261 Beds Design Capacity
7.25 beds/shower, 8.16 beds/toilet

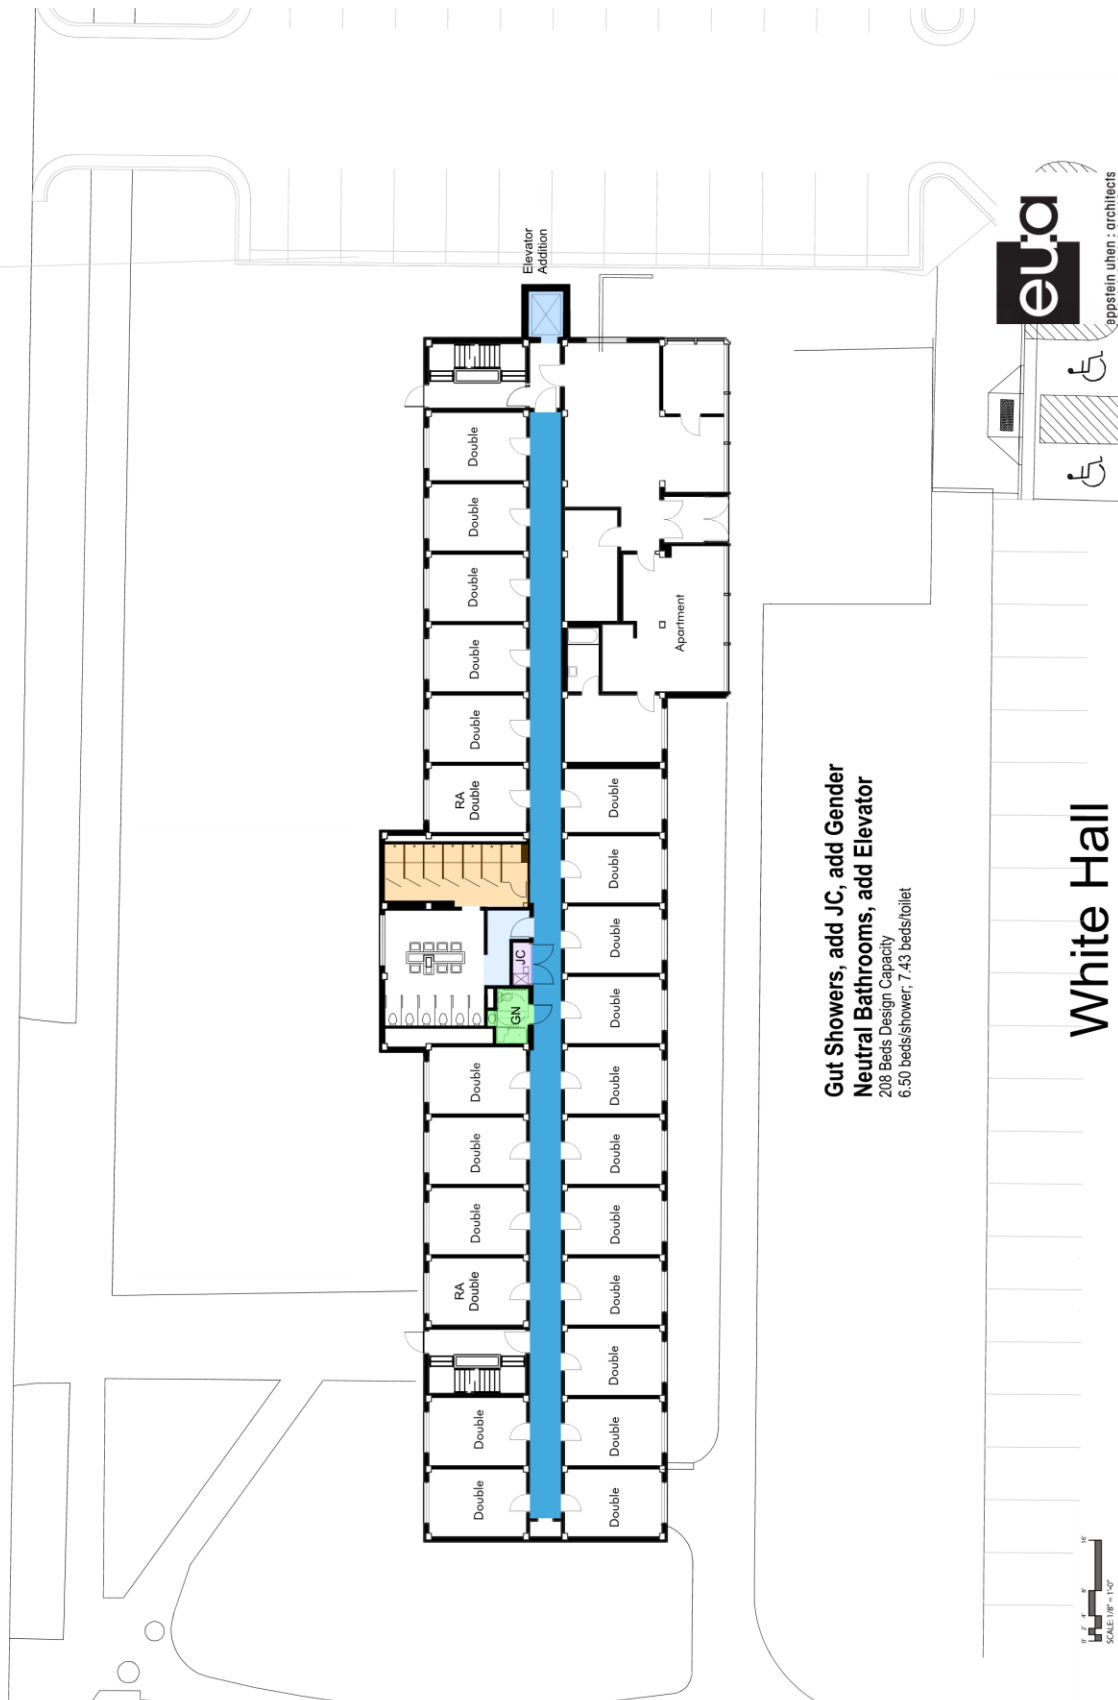
**Gut Showers, add JC, add Gender
Neutral Bathrooms, add Elevator**
208 Beds Design Capacity
6.50 beds/shower, 7.43 beds/toilet

- Provide fire sprinklers
- Replace electrical power systems
- Refurbish bathroom exhaust systems
- Gut remodel showers
- Add ADA/Gender Neutral bathrooms
- Add elevator.
