University of Wisconsin-Superior: Barstow Hall Exhaust Study Final Report

Project Number: 12-359

December 14, 2012

Karges-Faulconbridge, Inc.
Engineers

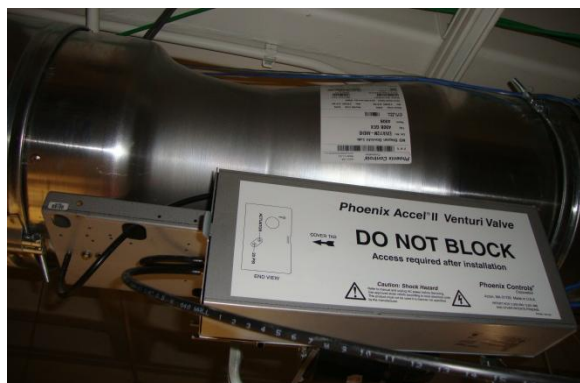
Picture 18

The base recommendation is to convert the Constant Volume (CV) air system to a Variable Air Volume (VAV) system. From previous experience, this can result in an approximate 20% airflow reduction. Airflow control valves are added to the supply air, fume hood exhaust, and constant volume exhaust systems (combined flammable storage cabinets and snorkels). Sash controls, zone presence sensors, and room controls are installed to provide room control. **Picture 18** below is an example of a new control valve.

The existing supply and exhaust air systems serving lab spaces and fume hoods are constant volume. Significant energy savings can be realized when converting to variable air volume (VAV) systems, without sacrificing lab safety.
