Wisconsin's Capitol Park

A REHABILITATION MASTER PLAN

- Approved by the State Capitol and Executive Residence Board (SCERB) on October 31, 2000.
- Printed in October 2004.

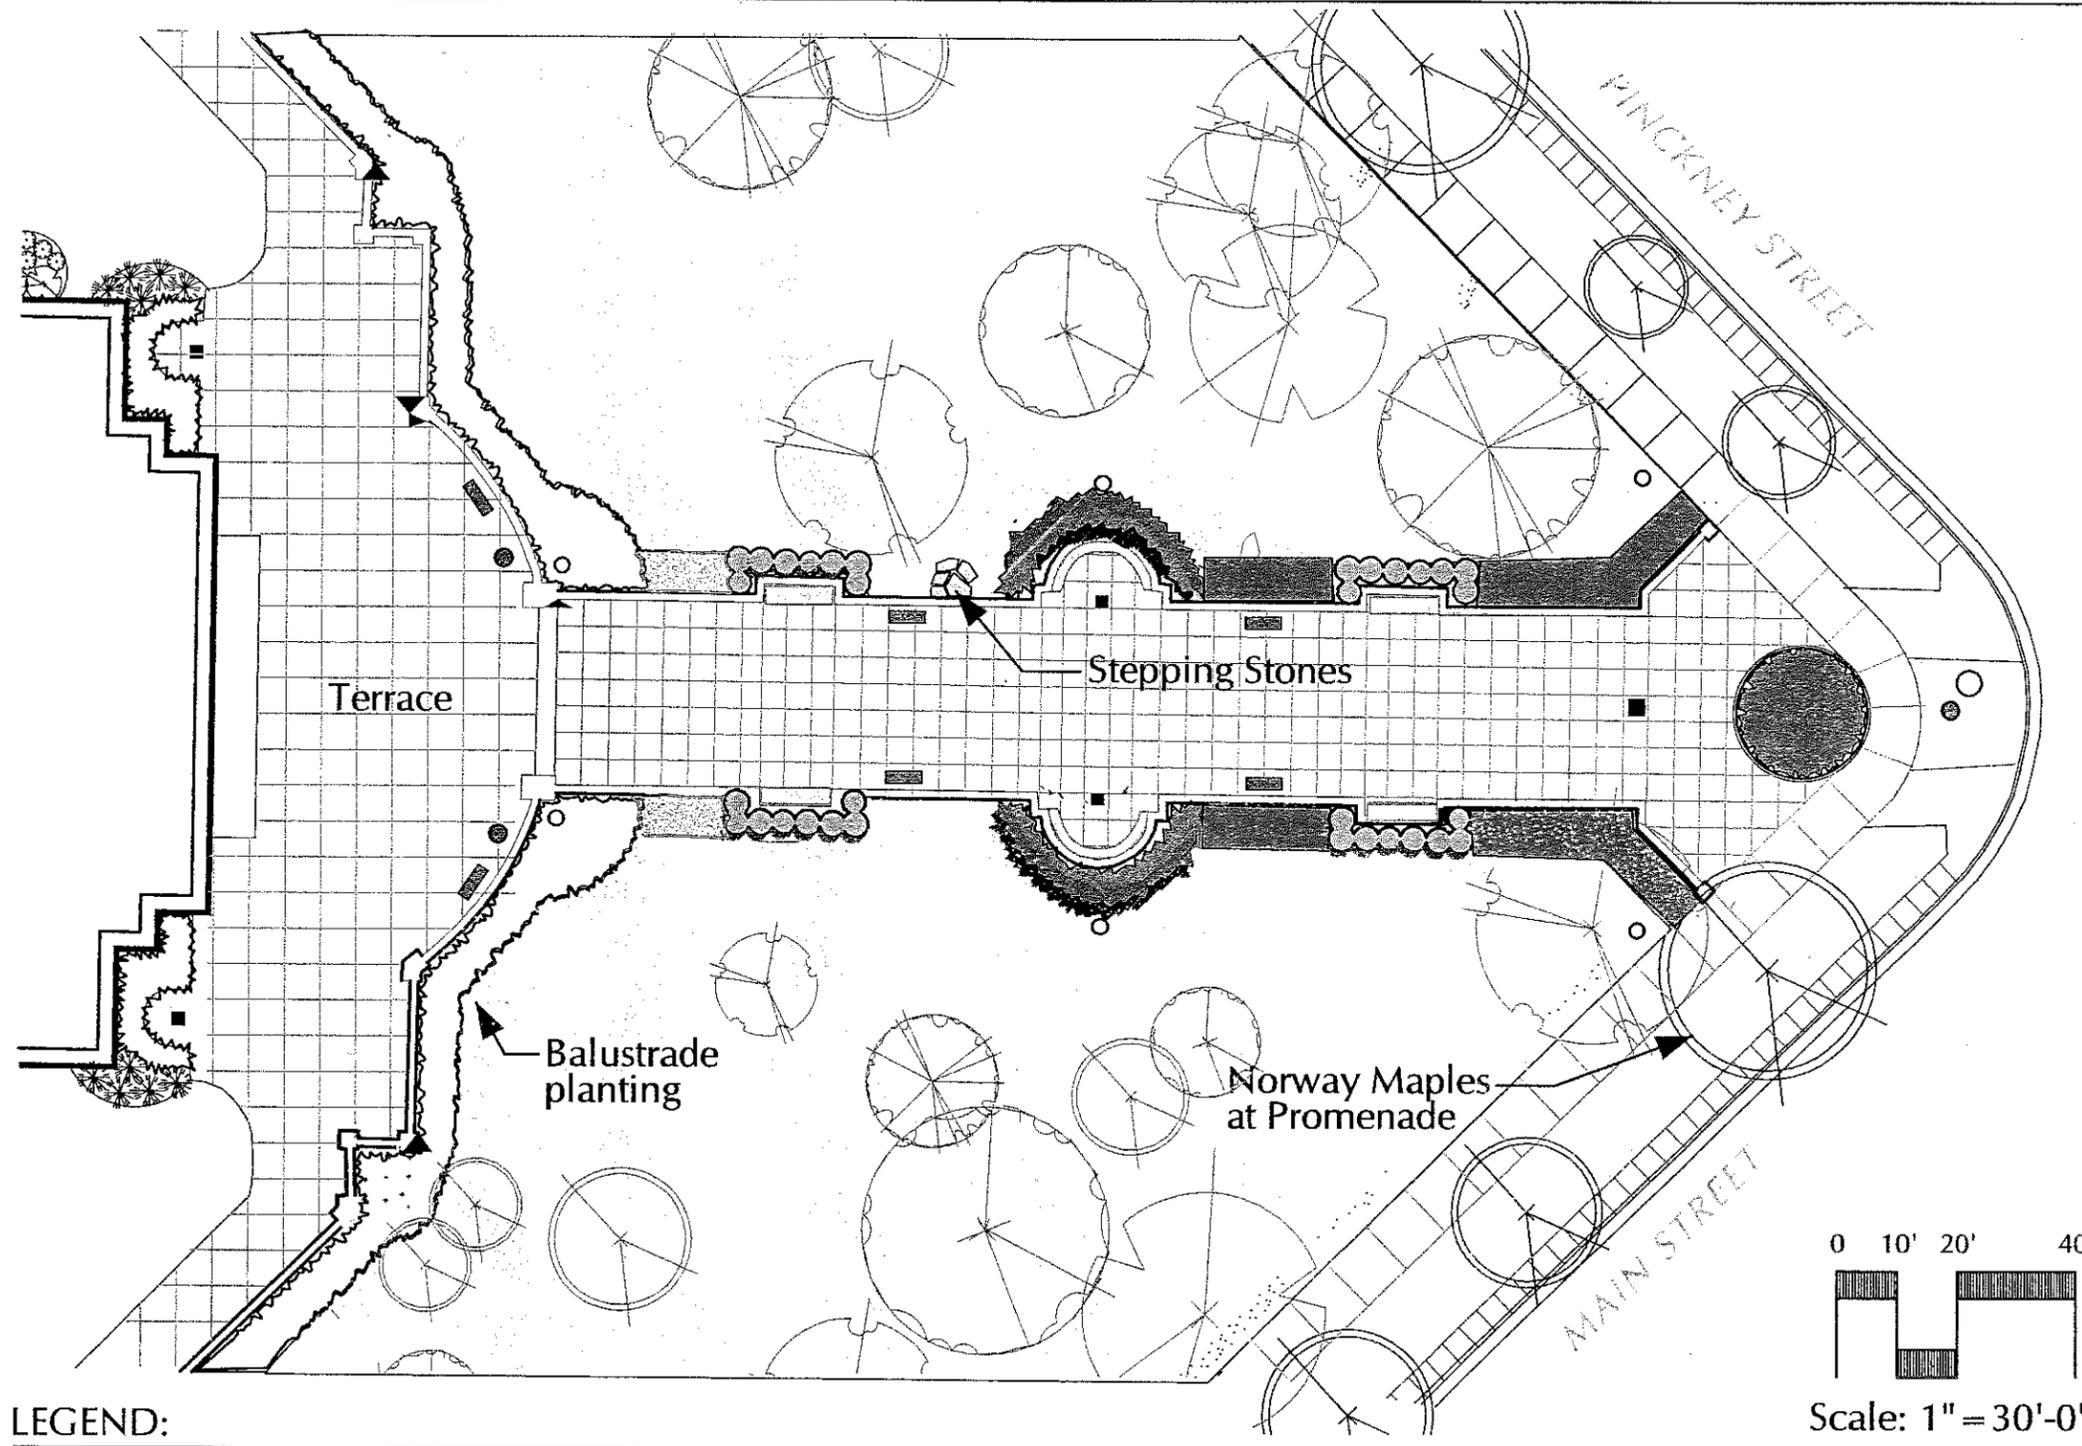
AXIAL APPROACH: TYPICAL WALKWAY (2000)

DIAGRAM 2.2 A typical axial approach to the Capitol, as inventoried in 2000, depicts the drastic deviation from the 1912 plan.

Trees The basic structure and sense of order embodied in John Nolen's design for the axial approaches has been lost (diagram 2.2). Although some of the new trees died during the construction period, all of the axial *allées* eventually were established as specified in Nolen's landscape plan (figure 2.9). Most of the trees matured, and by the 1950s created the dramatic spatial effect intended by Nolen (figure 2.10). Since the mid-twentieth century, however, attrition has gradually taken a toll on the integrity of the axial *allées*.

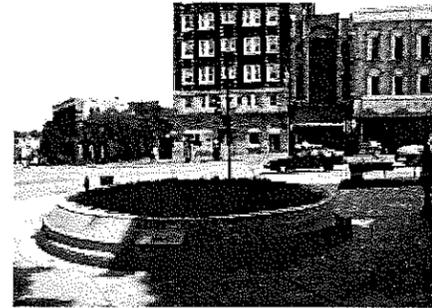
FIGURE 2.14 In 1998 the Wisconsin Law Enforcement Memorial replaced the circular flower bed located at the North Hamilton Street entrance to Capitol Park.

Annual Flower Beds Flower beds for annuals remain at two of the three corners where they historically were located: King, and South Hamilton (the space at State Street was occupied by the weather kiosk). In 1998 the bed at the end of the North Hamilton Street approach was replaced by the Wisconsin Law Enforcement Memorial (figure 2.14). Additional flower beds have been installed along the granite coping flanking some of the walkways (figure 2.15). These linear beds were planted first along the King Street walkway in 1982 because "grass was hard to grow because people kept cutting across [the lawn]."²⁹ The elaborate annual flower displays, which are relatively recent elements of the Capitol Park landscape, have become popular features with the public (figure 2.16).

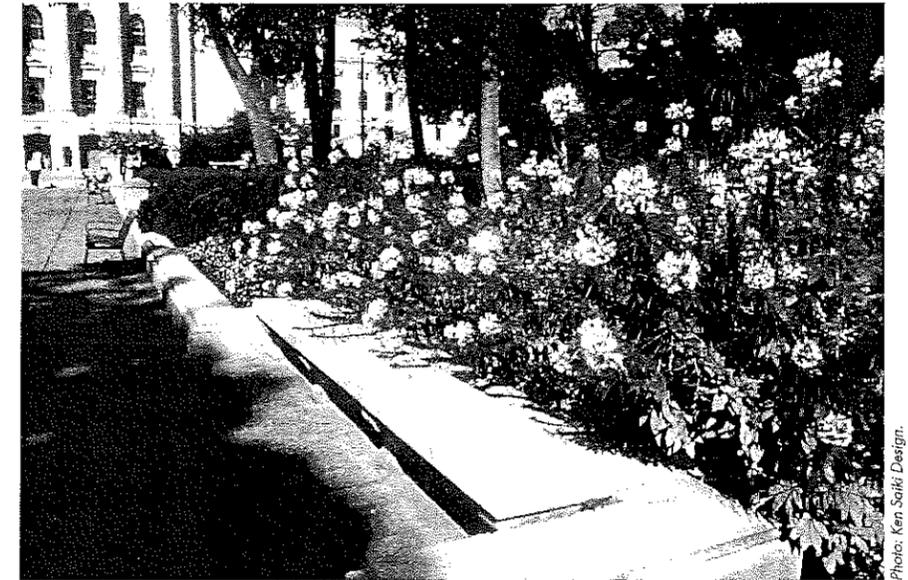
FIGURE 2.15 Large flowering annuals tower over one of the granite benches, 1998. In contrast, Nolen's planting plan called for low, neatly-clipped evergreen hedges.

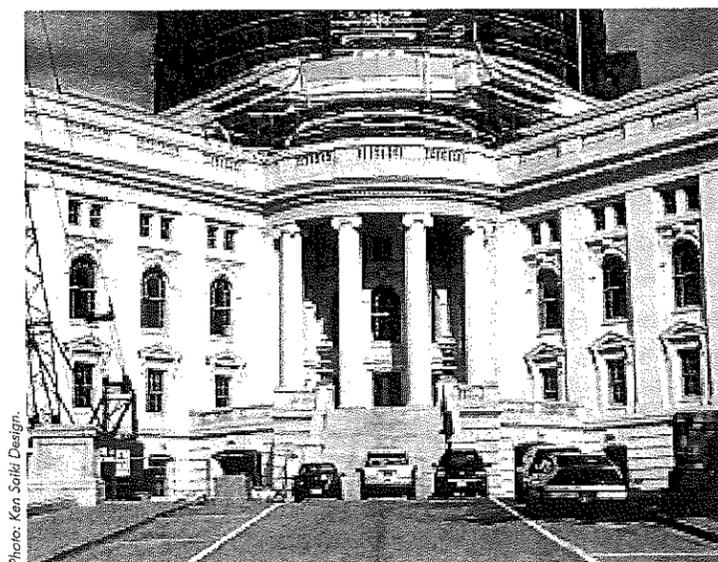
Parking The original angled parking spaces within the park’s driveways have been replaced by parallel spaces. Perhaps to compensate for the loss of total parking spaces that this change produced, three additional spaces were added at the foot of each of the grand stairs. These parking spaces compromise both the functionality and the aesthetic quality of the stairs (figure 2.17).

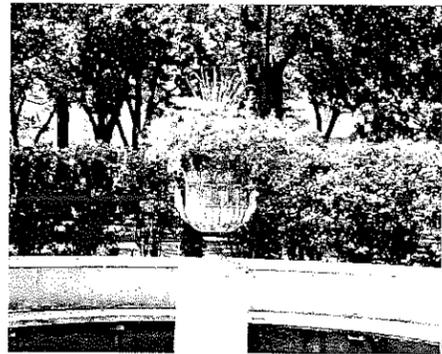
FIGURE 2.18 One of sixteen bronze vases that serve as focal points for the semi-circular seating niches along the axial approaches.

Vases All of the vases remain in good physical condition in their original locations (figure 2.18). A 1987 inventory, however, determined that all of park's bronze fixtures and artwork exhibited varying levels of corrosion caused by pollution.³¹ The character of the current vase plantings, consisting of annual flowers and tender foliage plants and vines, is congruent with the historic planting scheme for these features.

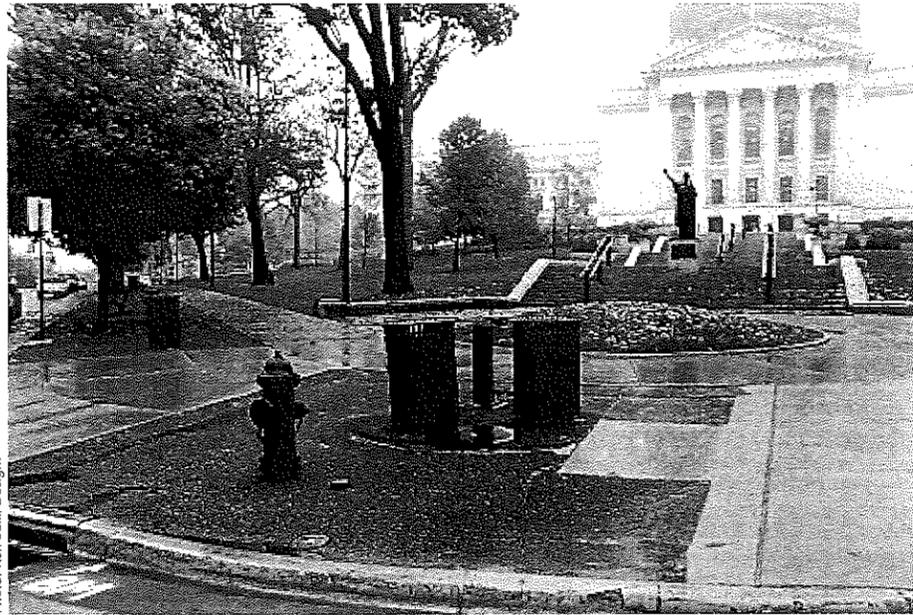
FIGURE 2.23 A drinking fountain, fire hydrant, and two trash receptacles terminate the State Street vista.

Drinking Fountains Modern drinking fountains were installed at the four corners of the park during the early 1980s when the promenade area was reconstructed. These fixtures occupy positions almost directly on the site's principal axes. Diminutive in size and utilitarian in design, they are inappropriate features for such important locations (figure 2.23).

Fire Hydrants Fire hydrants should be moved to new positions that are near, but not directly upon, the site's primary axes.

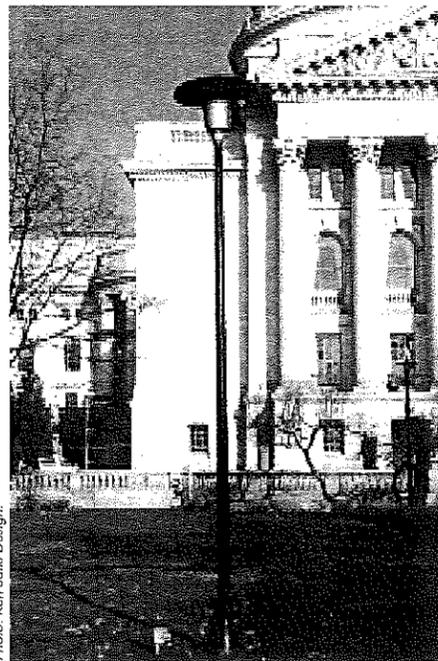
Lights All of the cast iron standards that originally lined the walkways of the park were replaced with Modern, aluminum fixtures in 1964 as part of an effort to upgrade the Capitol's electrical system (diagram 2.4). Matching fixtures were installed in additional locations, including the circle seats flanking the driveways and the base of the terrace balustrade. The provision of light in these areas may have been intended to increase overall illumination in the park; a 1964 newspaper article noted that lighting in the park had "been a source of disturbance to both Madison and Capitol Police for some years."³⁹ The public vigorously protested the loss of the historic light fixtures, however. Some citizens demanded, in vain, that the original fixtures be returned to the park. Fourteen years later, a team of planning and design professionals criticized the Modern light fixtures as "out of character" with the Neoclassical Capitol building and park.⁴⁰ Nonetheless, all of these aesthetically incongruent fixtures currently remain in place along the park's eight formal approaches (figure 2.24). The current lighting levels at the axial walkways and driveways are acceptable.

FIGURE 2.24 One of the space-age light fixtures that replaced the historic cast-iron lights in 1964.

Lights The historic cast iron light fixtures should be recreated according to Geo. B. Post & Sons' original design (figure 2.26), and installed in their historic locations. The replicas may contain lighting elements that conform to contemporary illumination standards. Special light distribution hardware may be necessary.

In locations where light fixtures historically were not present, the existing Modern lights should be replaced by new units that have an unobtrusive, contemporary design that is compatible with the Neoclassical architecture of the Capitol and the park (diagram 2.6). The more recent "additions" thus should be distinguishable from the historic features of the landscape design. In both fixtures, the light source should harmonize with the warm, soft light produced by the incandescent fixtures of the terrace. The cool, harsh light produced by typical HID light sources is undesirable. A warmer HID source would be preferable.

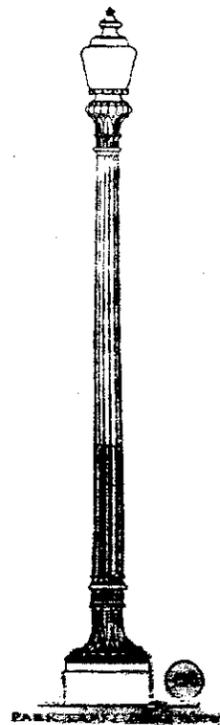
FIGURE 2.26 Detail of the park light designed by Geo. B. Post & Sons. The lights should be replicated and installed in their historic locations.

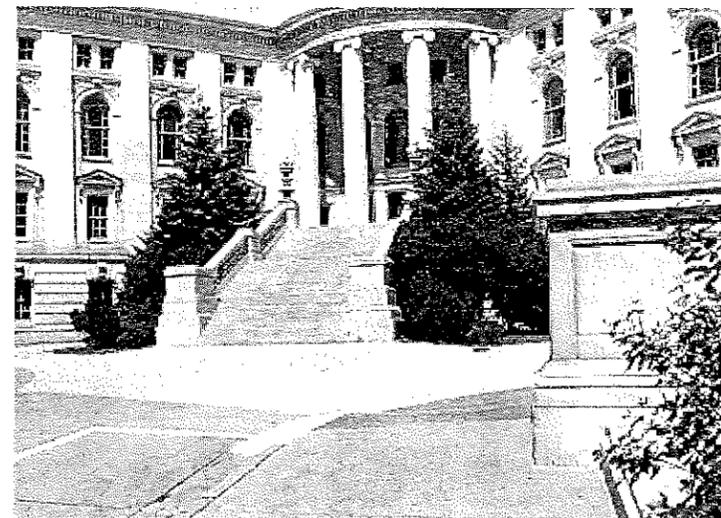
As of 1998, plantings at the four wing ends were inconsistent—entirely absent at the State Street entrance, and comprised of large deciduous shrubs and small trees at the other entrances. The grand stairways were flanked by large masses of deciduous trees and shrubs, and towering evergreen trees (figure 3.5). Some of these plantings were removed to accommodate construction activities during 1998-2000.

FIGURE 3.5 Overgrown vegetation and asymmetrical planting design at one of the grand staircases, 1998.

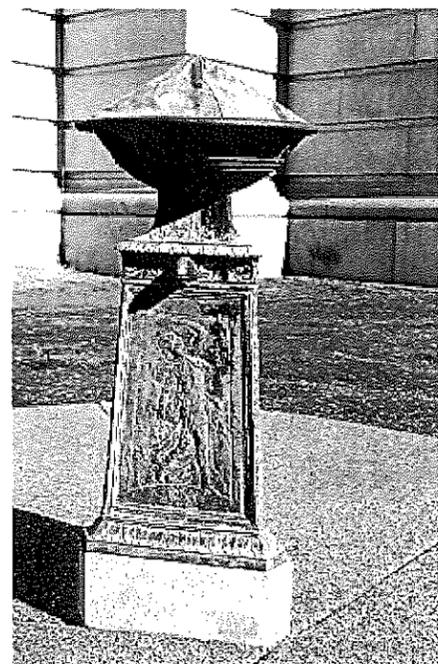
Some of the bronze drinking fountains are missing from their original locations; others are non-functional and need repair and conservation.

Drinking Fountains Most of these features remain intact, in varying physical condition (figure 3.6). Some of the bronze drinking fountains are missing from their original locations; other fountains are non-functional and in need of repair and conservation. A 1987 inventory determined that all of the park's the bronze fixtures and artwork suffer from varying levels of corrosion caused by pollution.⁵⁸

FIGURE 3.6 One of the historic bronze drinking fountains remaining in place on the terrace.

Drinking Fountains The historic bronze drinking fountains should be repaired and returned to their original locations. A professional conservator should regularly assess the condition of the bronze. The green patina, which has accrued naturally to the metal, should be preserved, unless its removal is deemed necessary to preserve the integrity of the fountains. No new drinking fountains should be added to the terrace.

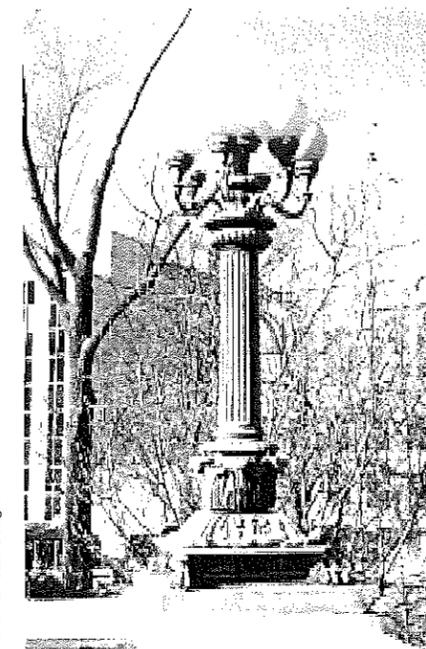
Lights All of the original bronze light fixtures remain in place and in operable condition (figures 3.7-3.9). The fixtures produce a warm, soft light, although illumination levels are less than in other areas of the park. A 1987 inventory determined that all of the park's the bronze fixtures and artwork suffer from varying levels of corrosion caused by pollution.⁵⁹

FIGURE 3.8 One of the historic bronze light fixture located at the terrace balustrade.

Lights The condition of the bronze light fixtures should be assessed on a regular basis. The historic lights should be maintained, and conserved as necessary. The green patina, which naturally has accrued to the bronze surfaces, should be preserved, unless its removal is deemed necessary to preserve the integrity of the light standards. No new light fixtures should be added to the terrace.

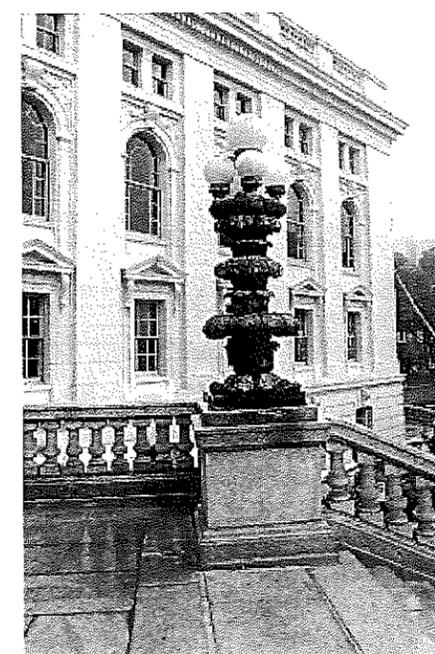
FIGURE 3.9 Historic bronze light fixture located at one of the Capitol's grand stairways.

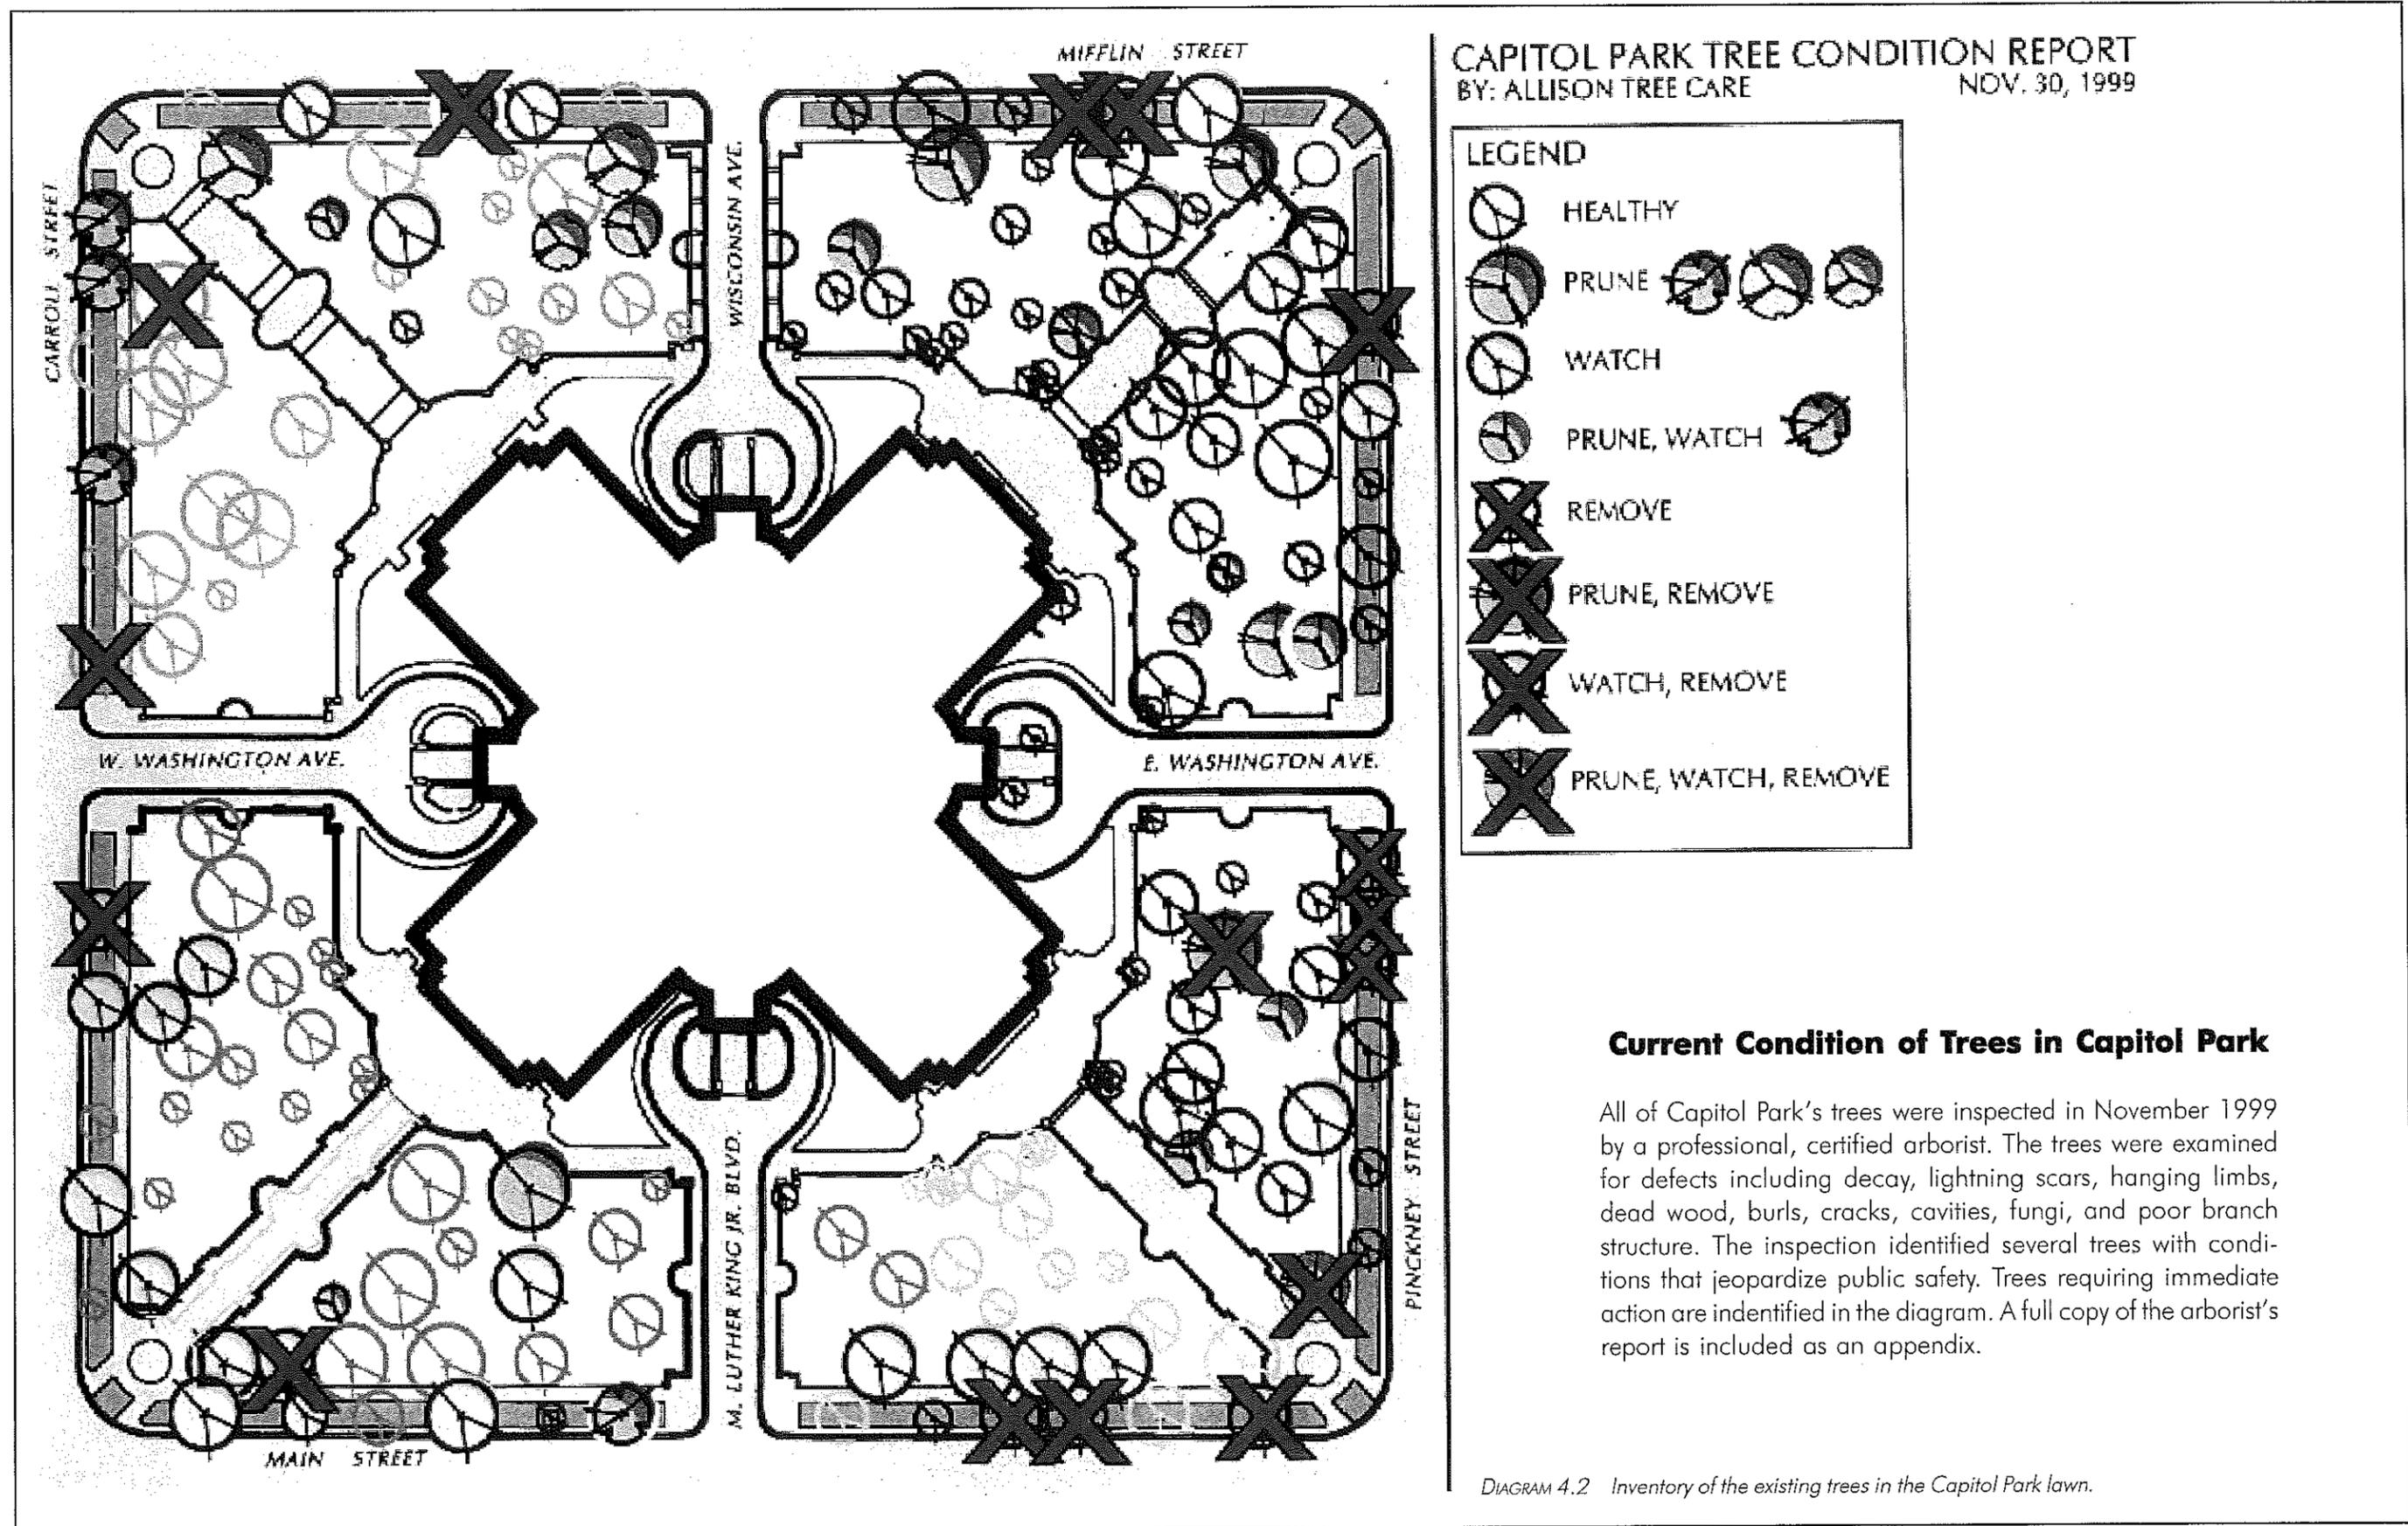
CAPITOL PARK TREE CONDITION REPORT
 BY: ALLISON TREE CARE
 NOV. 30, 1999

All of Capitol Park's trees were inspected in November 1999 by a professional, certified arborist. The trees were examined for defects including decay, lightning scars, hanging limbs, dead wood, burls, cracks, cavities, fungi, and poor branch structure. The inspection identified several trees with conditions that jeopardize public safety. Trees requiring immediate action are identified in the diagram. A full copy of the arborist's report is included as an appendix.

DIAGRAM 4.2 Inventory of the existing trees in the Capitol Park lawn.

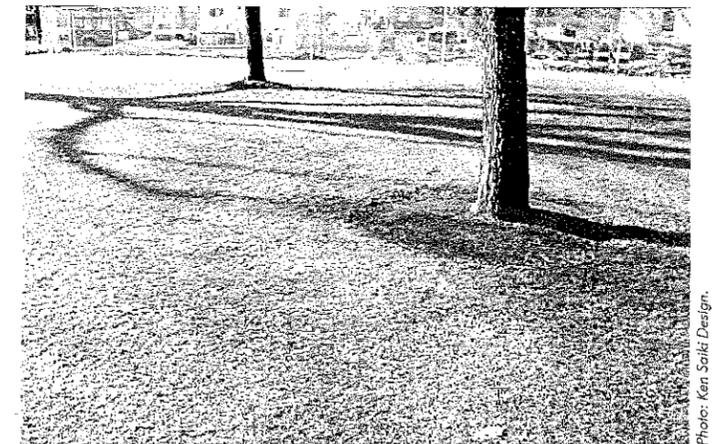
FIGURE 4.9 The cumulative, long-term effect of heavy social use may be large areas of compacted soil, capable of supporting only a sparse turf.

In many areas the turf is in poor condition, due to insufficient light, and soil compaction caused by heavy human use.

The current health of the turf is variable. In many areas the turf is in poor condition, due to insufficient light and soil compaction caused by heavy human use (figures 4.7 and 4.8). In 1989 landscape managers began utilizing temporary fencing to minimize human impacts during heavily attended events such as Saturday farmers' markets. Nonetheless, patches of sparse turf occur over extensive areas, especially beneath shade trees where the grass may be slower to recover (figure 4.9). Events such as Concerts on the Square and the 1998 statehood sesquicentennial celebration have the capacity to inflict severe damage.

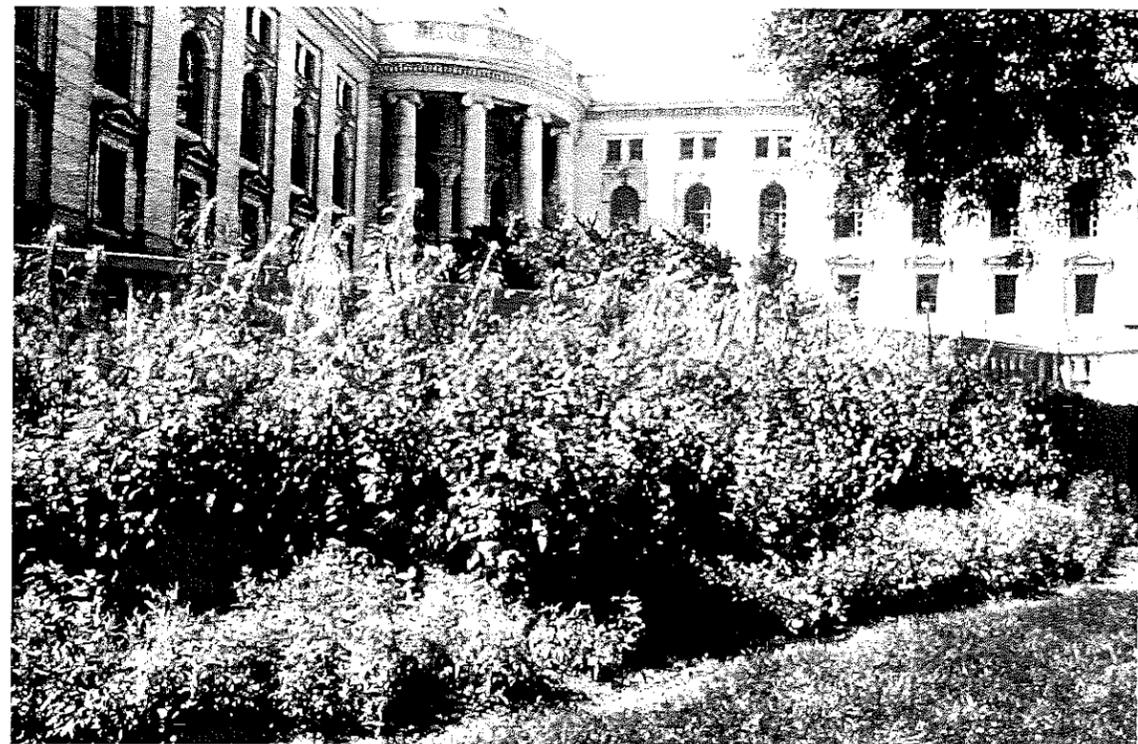
FIGURE 4.15 In many areas, the current balustrade plantings completely obscure the granite balustrade.

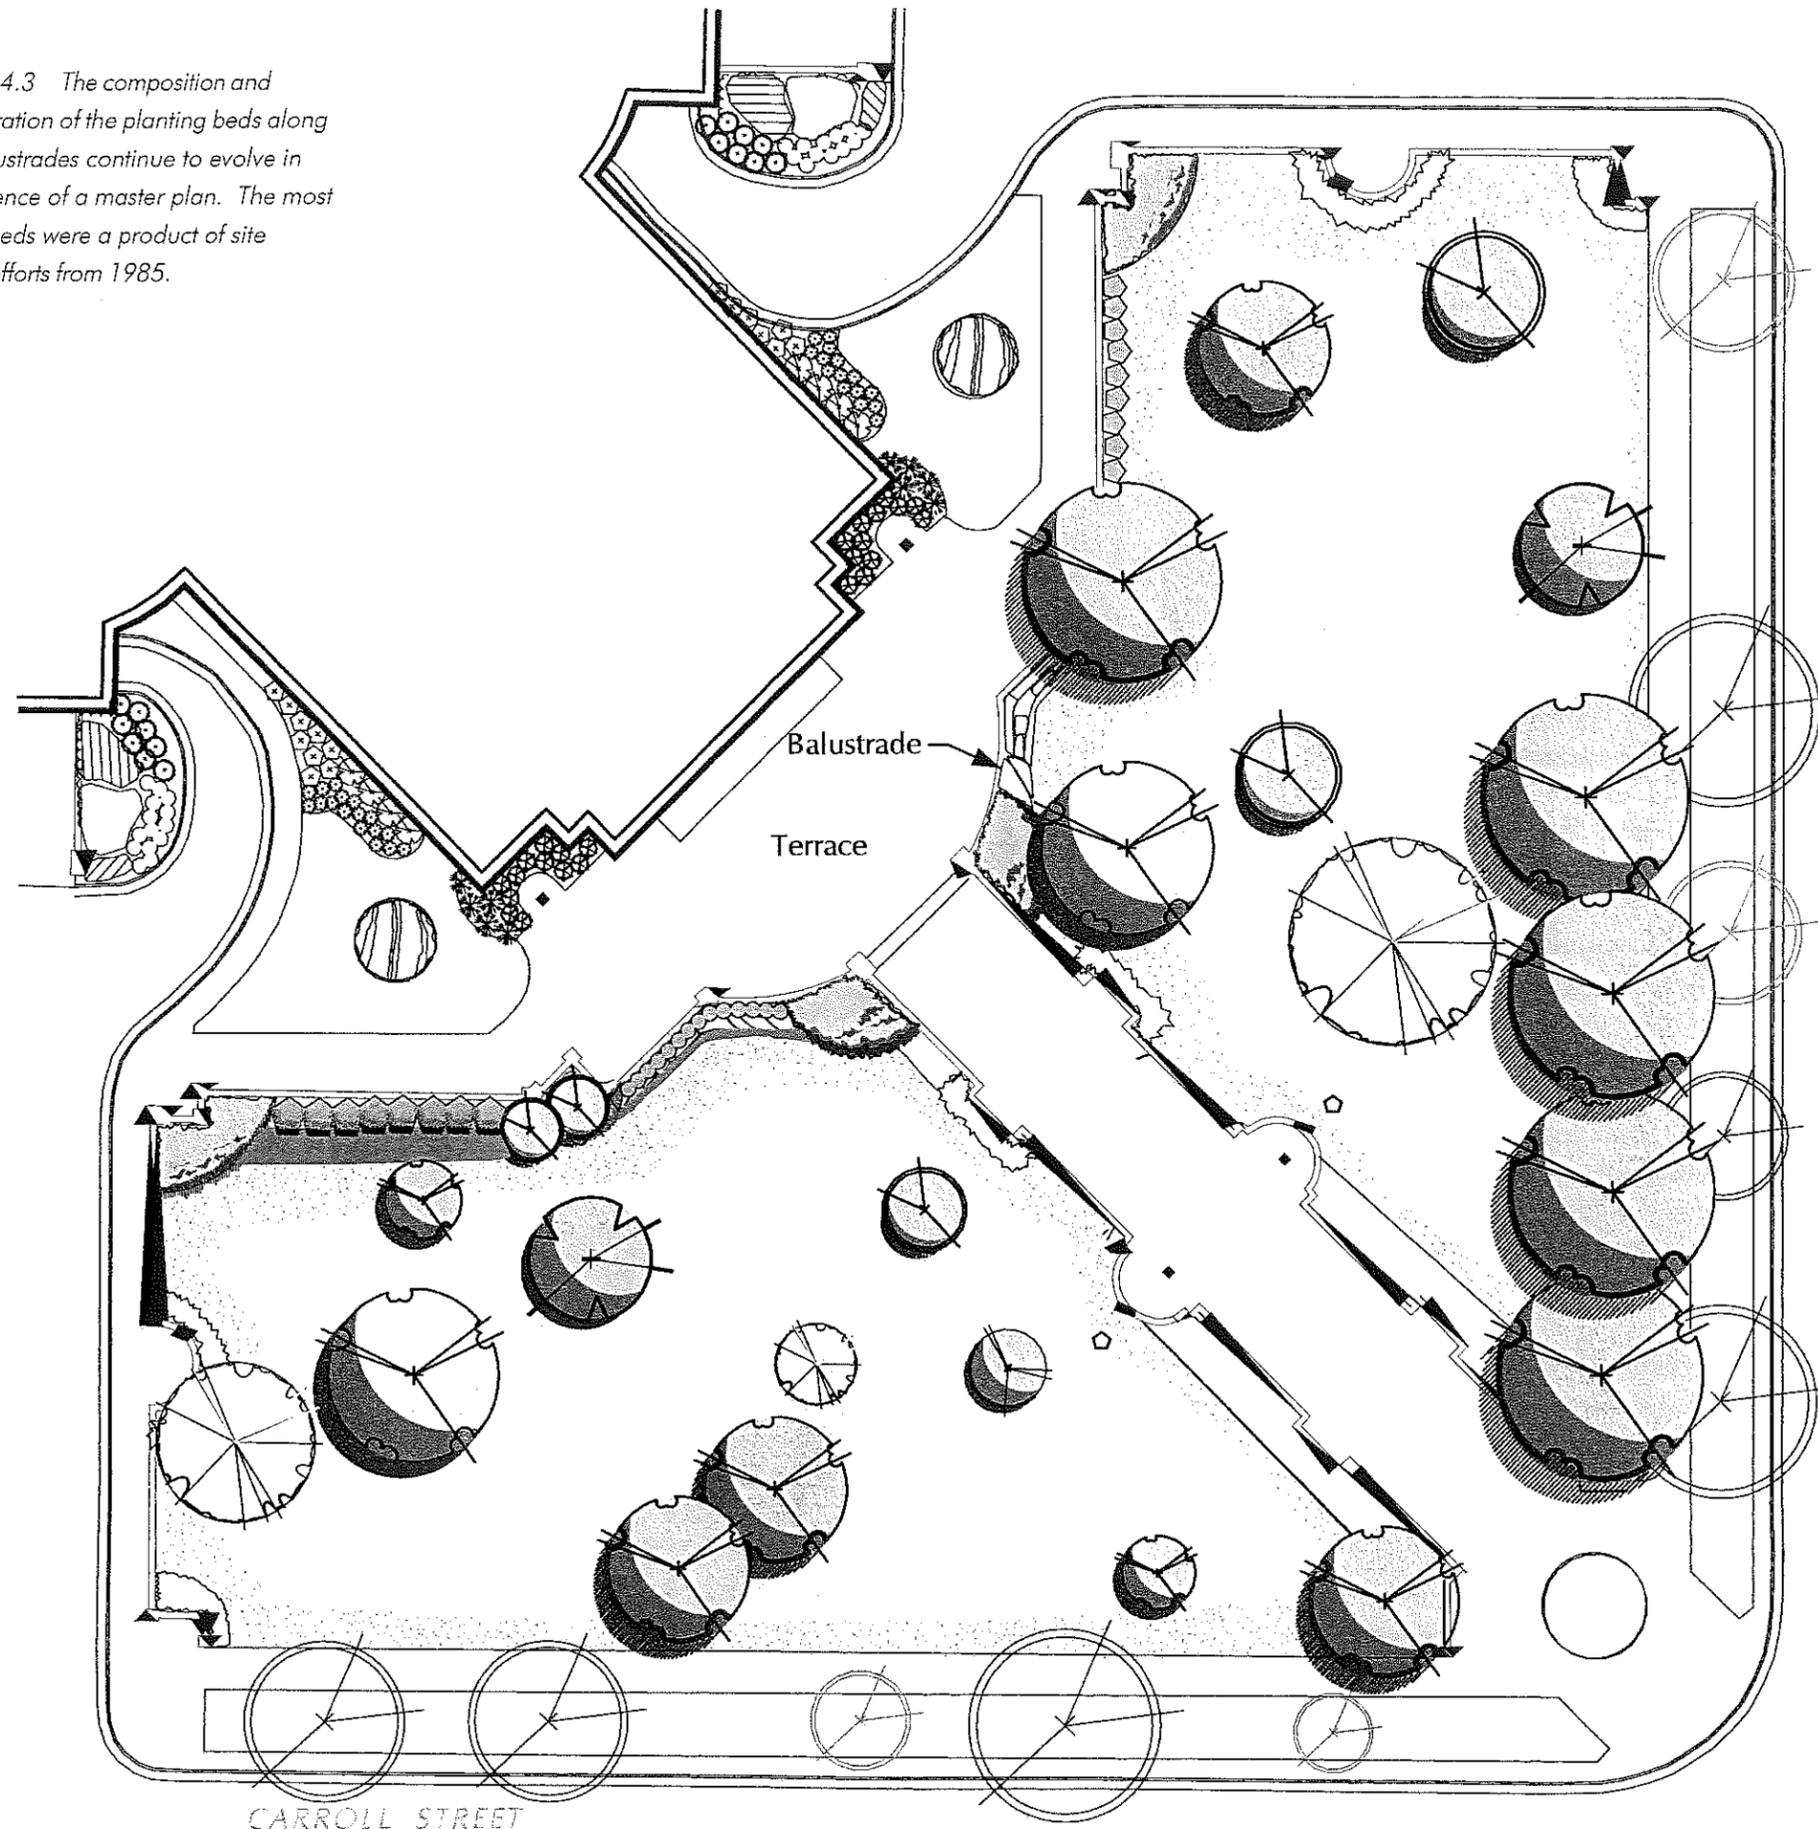
STATE CAPITOL LAWN
TYPICAL SECTION (2000)

The most recent articulation of design concepts for the shrub and perennial planting beds was developed in 1995, and derived from the redesign effort that began in 1985. Most of the plants from the mid-1980s installations now are gone.⁸⁰ The composition of the beds has continued to evolve apart from a comprehensive planting plan. The size, configuration, and planting design for the balustrade beds differ significantly from the John Nolen plan of 1912 (figure 4.12). In many places the deep beds, and the large masses of plants that they contain, completely obscure views of the balustrade (figures 4.13-4.15). Nolen's use of scale, form, and habit to achieve a sense of balance, unity, and hierarchy is lost in the current planting scheme (diagram 4.3).

DIAGRAM 4.3 The composition and configuration of the planting beds along the balustrades continue to evolve in the absence of a master plan. The most recent beds were a product of site design efforts from 1985.

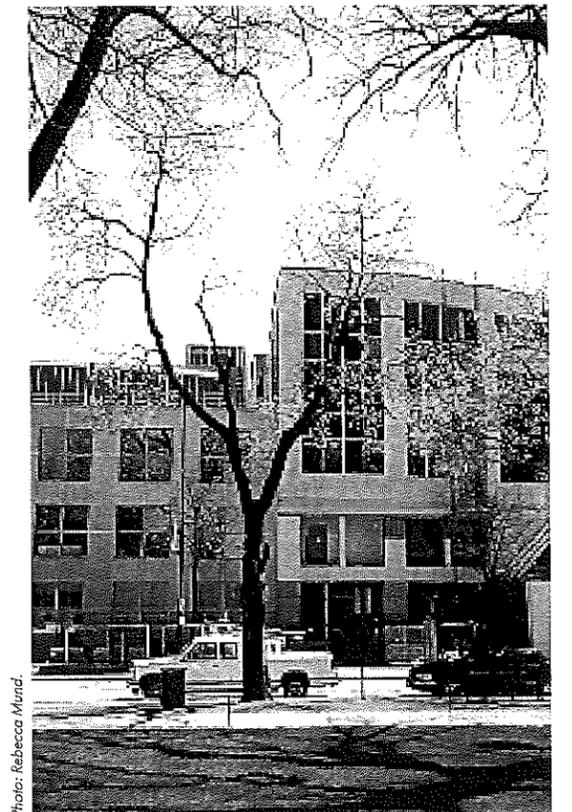
The successive attrition of many of the original trees also has diminished the effectiveness of the outer row of Norway maple trees as an architectural element. Until the mid-1980s, lost trees were rarely replaced. Of the 80 trees planted in 1916, an estimated 31 individuals remain extant. Thirteen new trees replace some of the 34 trees that have been lost. Consequently, the perimeter of the square now is defined by a single row of Norway maples of variable spacing and size. Many of the trees are malformed and/or in poor condition (figure 5.6).

FIGURE 5.6 Many of the perimeter Norway maples exhibit visible defects including decay, lightning scars, hanging limbs, dead wood, burls, cracks, cavities, and poor branch structure. Several trees are public safety hazards.

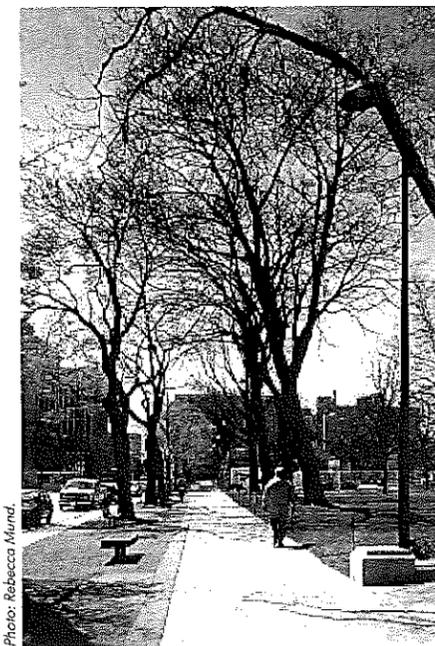
Trees The character of the promenade, or perimeter area, has changed more drastically than that of the lawns (figure 5.2). The allee effect that Nolen intended is generally absent, except for some sections where a few of the stately red oaks planted during 1912-1915 remain. Even in such areas the tall, dignified red oaks contrast sharply with the shorter, often malformed Norway maples, and thus fail to produce the aesthetic effect that Nolen and the Capitol Commission desired (figure 5.5).

FIGURE 5.5 Red oak trees planted in the lawn during the mid-1910s now tower over the perimeter Norway maples.

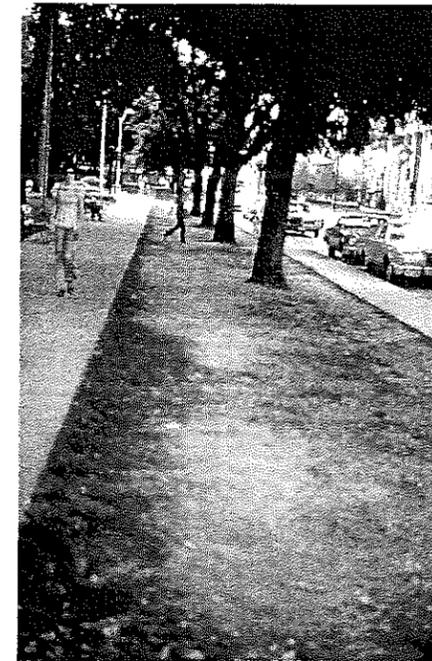
FIGURE 5.8 Heavy pedestrian traffic ruined the grass medians that lined the outer perimeter of the park. By the mid-1970s, the medians consisted primarily of compacted earth.

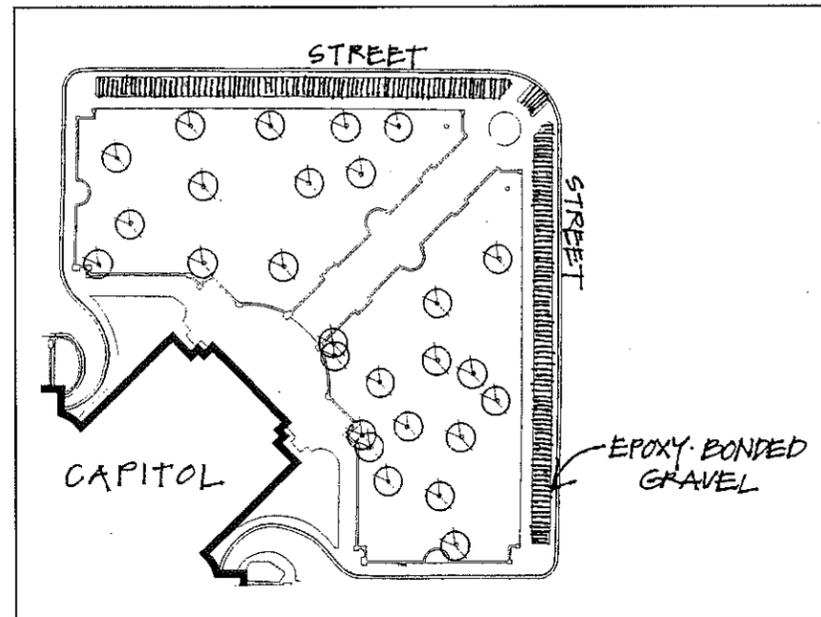
FIGURE 5.10 Location of epoxy-bonded gravel medians within a typical quadrant of Capitol Park

The Capitol Park promenade zone includes 30,850 square feet of epoxy-bonded gravel surface located between the perimeter sidewalk and the street curb (figure 5.10). The epoxy-bonded-gravel medians currently contain numerous benches, signs, trash containers, and 44 Norway maple trees. The semi-porous pavement was installed in 1980 to allow air and water to reach tree roots and accommodate

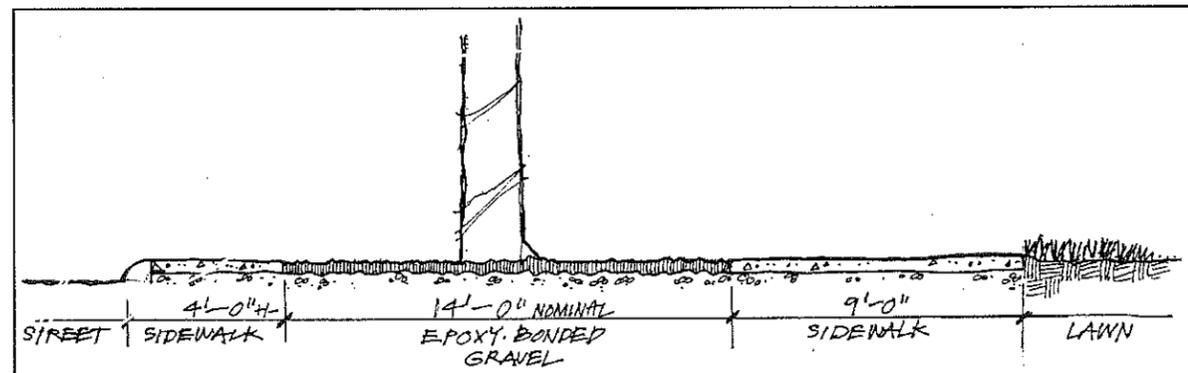
heavy pedestrian impacts and occasional vehicular traffic (figure 5.11). The interface between the trees and the surface material is not uniform throughout the promenade. The epoxy-bonded gravel surface extends to the trunks of 28 trees; the remaining 16 trees are located in 9' x 9' sections of bark mulch (figure 5.12).

FIGURE 5.11 Typical cross-section of the promenade surface.

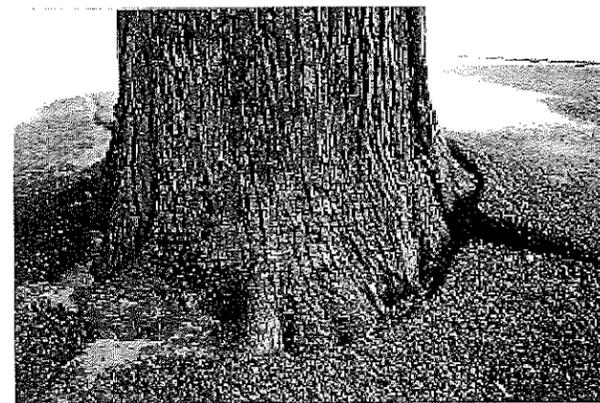
Stage 1 Upheaving

Tree roots and frost raise panels or small sections of the epoxy-bonded gravel as much as 3-1/2." The raised sections may pose a significant trip hazard. This condition is especially severe where the epoxy-bonded gravel is in direct contact with the tree trunks.

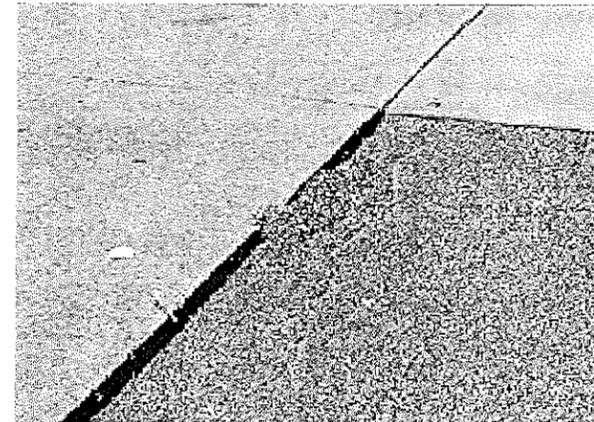
**Stage 4
Crevasse or Cavity**

The upheaving and settling of the epoxy-bonded gravel can create cavities where small animals may hide, and crevasses where feet get caught. Significant cavities exist at nearly two-thirds of the tree trunks that are in direct contact with the epoxy-bonded gravel.

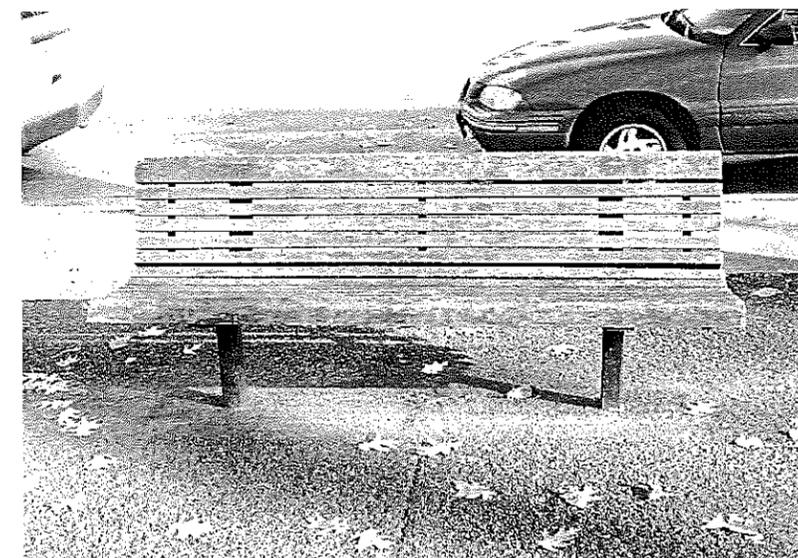
The modern wooden benches remain in place within the epoxy-bonded gravel medians (figure 5.13). Their design contrasts with the Neoclassical architecture of the Capitol building, but they are otherwise unobtrusive.

The modern wooden benches contrast with Neoclassical architecture of the Capitol building.

FIGURE 5.13 One of the wooden benches installed within the promenade during 1980.

Benches The existing modern wooden benches should be replaced with new benches that have an unobtrusive, contemporary design that is compatible with the Neoclassical architecture of the Capitol and the park, OR replaced with new benches that replicate the design of the historic wood and metal benches. The new benches may be fabricated from heavier materials to deter theft and vandalism.

The existing wooden benches should be replaced with new benches that are compatible with the Neoclassical architecture of the Capitol and the park, OR replaced with new benches that replicate the design of the historic benches.

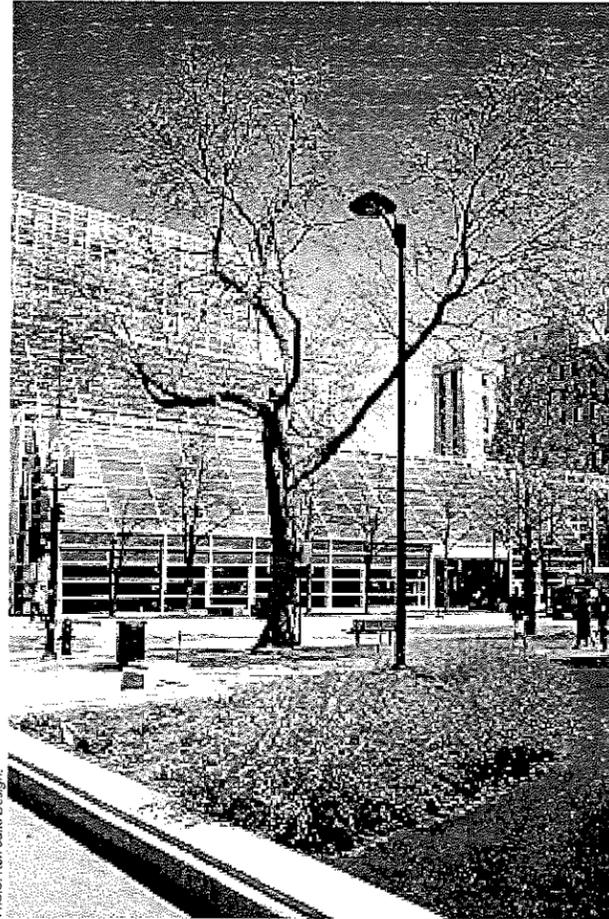
FIGURE 5.14 One of two styles of tall, modern lights along the Capitol Park promenade.

The Promenade lights are aesthetically incongruous with the Neoclassical park setting.

Lights Along with the cast-iron lights flanking the four pedestrian approaches, the original lights of the park perimeter were removed in 1964. In their place, tall, modern lights were installed on the lawn side of the perimeter walkway. Additional lights of a different style were installed in 1980 as part of the Capitol Park Terrace Project. Both lights are aesthetically incongruous with the Neoclassical park setting (figure 5.14). However, the current lighting scheme does provide adequate illumination of both the promenade and adjacent areas of the lawns.

In locations where light fixtures historically were not present, the existing Modern lights should be replaced by new units that have an unobtrusive, contemporary design that is compatible with the Neoclassical architecture of the Capitol and the park. The more recent "additions" should thus be distinguishable from the historic features of the landscape design. Special hardware may be necessary to ensure adequate light levels and distribution.
