Wisconsin's Capitol Park

A REHABILITATION MASTER PLAN

- Approved by the State Capitol and Executive Residence Board (SCERB) on October 31, 2000.
- Printed in October 2004.

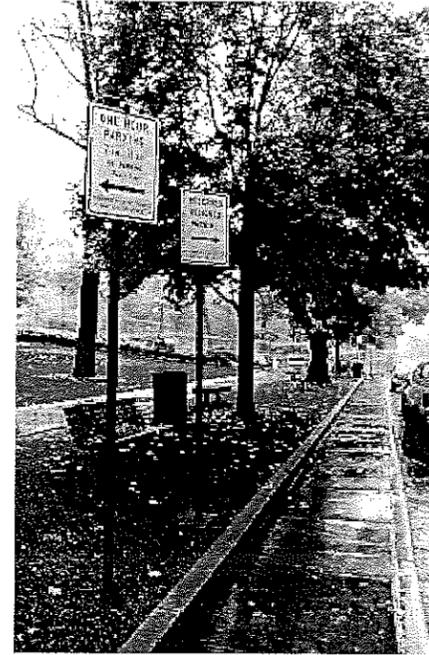
FIGURE 5.15 Numerous parking signs such as these line the curb of the promenade.

Parking Signs Numerous parking signs currently clutter the perimeter of Capitol Park (figure 5.15). The utilitarian signs perform a necessary function, but they are visually unappealing and detract from the overall aesthetic quality of the promenade.

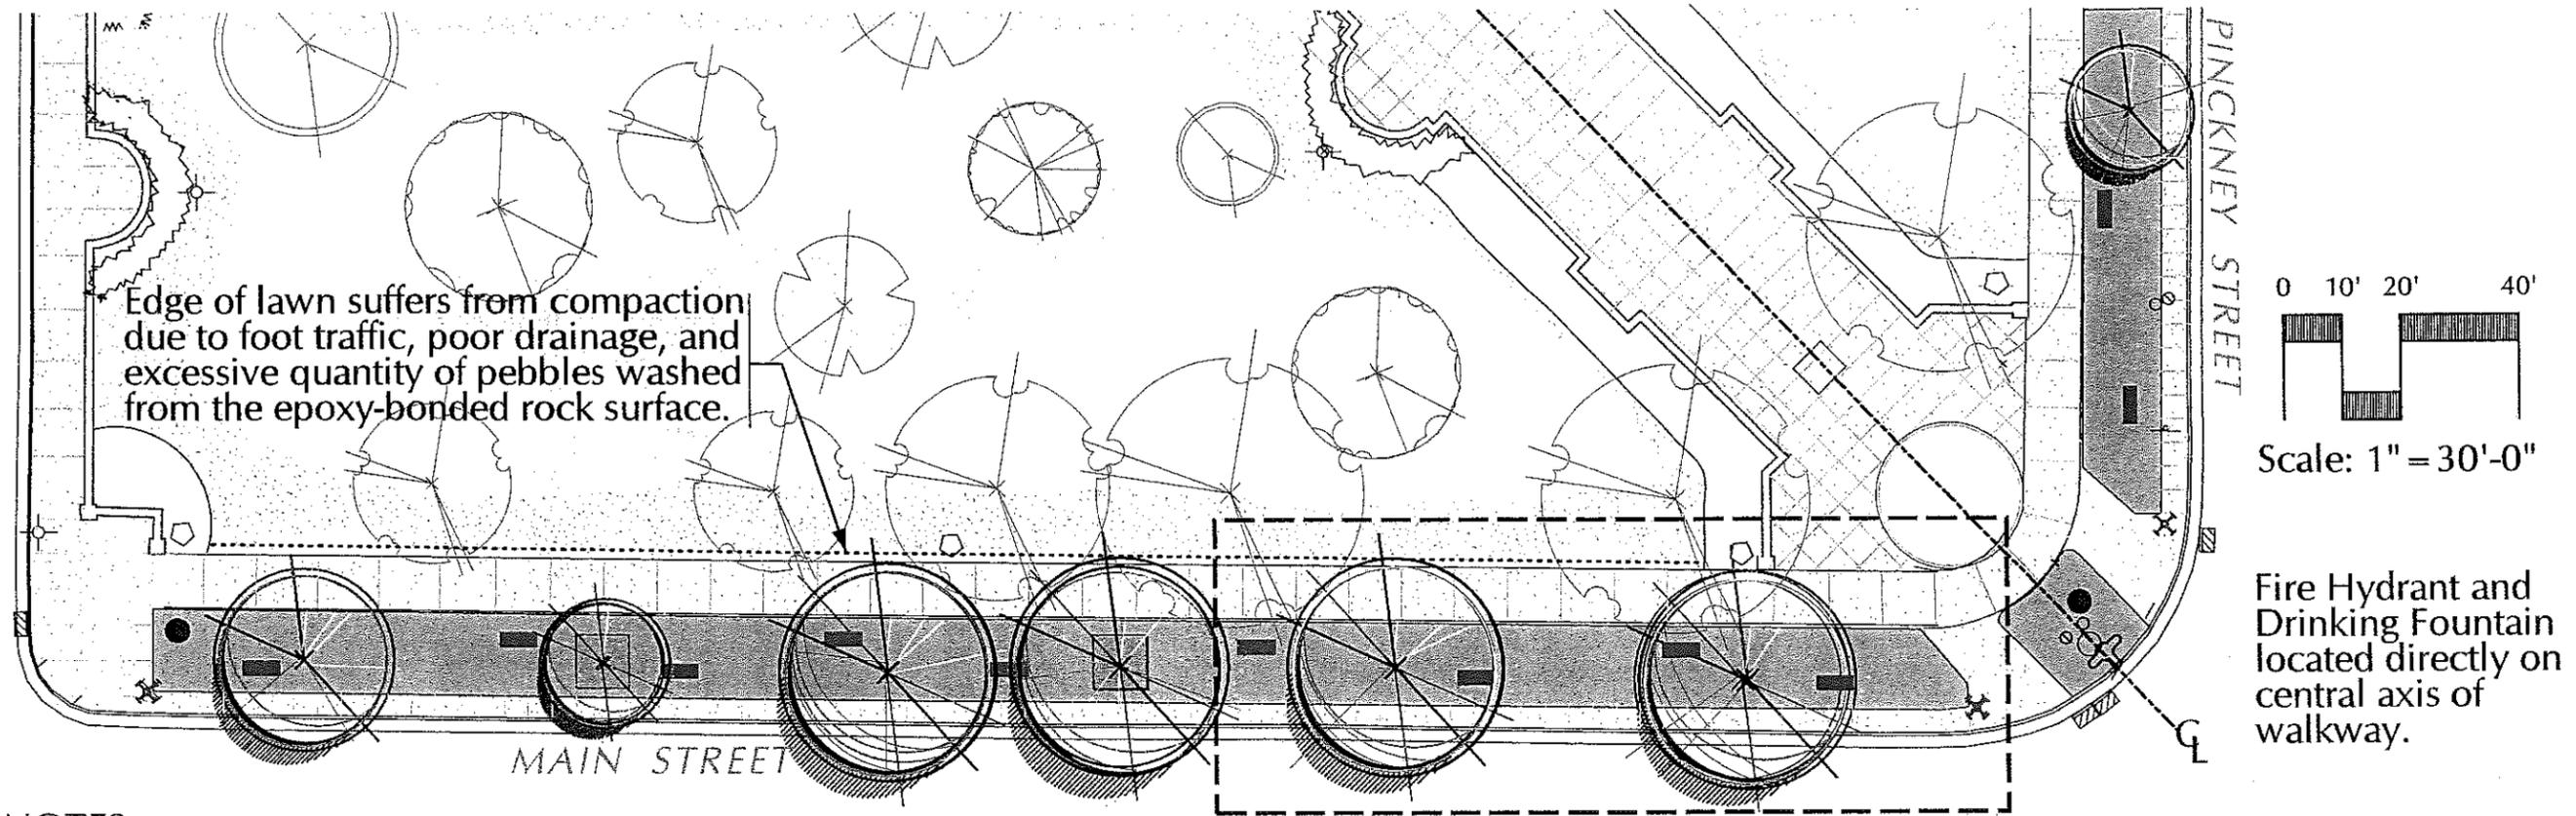
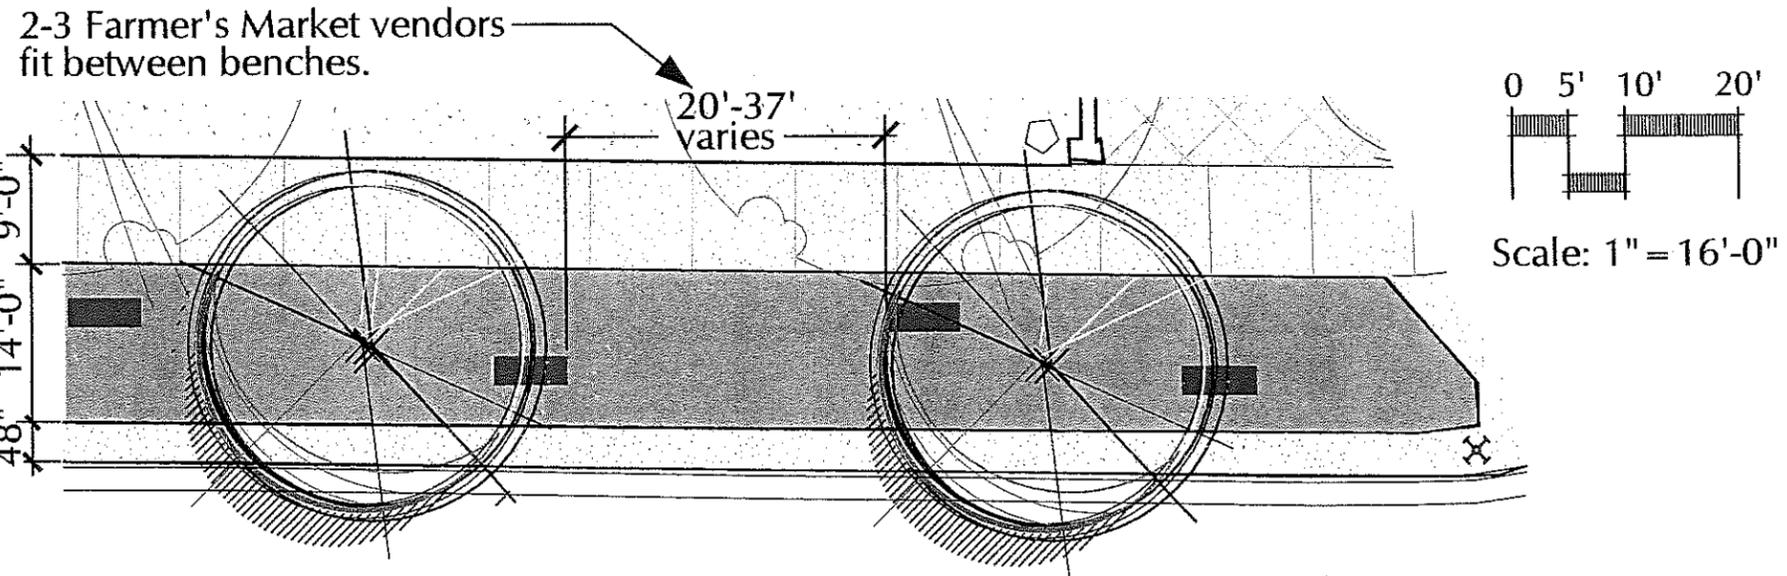
PROMENADE-TYPICAL SECTION (2000)

- Existing sidewalk is 9'-0" wide and has a rose colored aggregate finish.
- Epoxy-bonded rock paving surface shows significant signs of deterioration.
- Tall modern light at lawn has hanging flower basket.
- Temporary fence at edge of lawn is unstable and often fails as a barrier to the pressures of pedestrian traffic during high-use events.

DIAGRAM 5.4 The existing condition of the promenade with a malformed allee and epoxy-coated gravel pavement in the terrace.

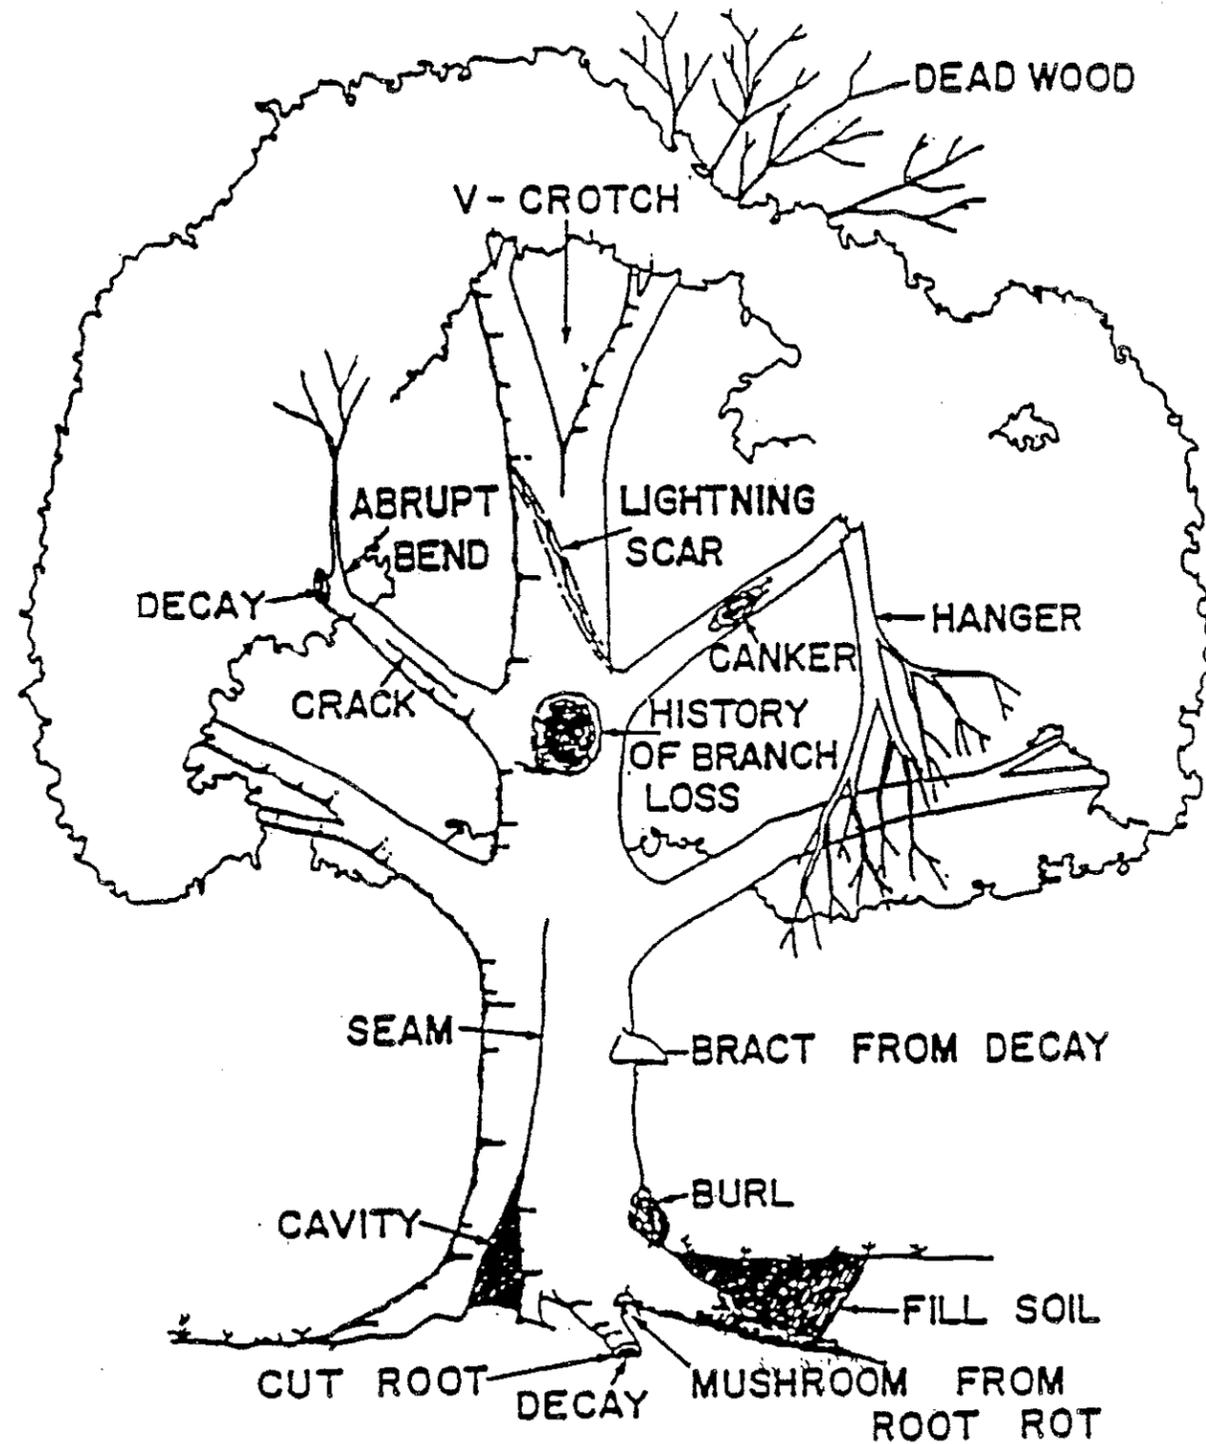
Schematic diagram of defects associated with hazardous trees.

ID	SP	CBH	COMMENTS
1	1	26"	R-lacks flair E side; T-seam; S-N; C-N
2	1	91"	R-restricted; T-seam, burl; S-N; C-N
3	1	36"	R-N; T-N; S-N; C-N
4	1	48"	R-restricted; T-open cavity, canker @ 6'; S-N; C-decline; REMOVE
5	1	72"	R-restricted, girdling root; T-seam to crotch @ 18', crack, cavity, conks; S-seam to crotch @ 24'; REMOVE
6	1	100"	R-restricted; T-canker 16" wide at base, pruning wounds; S-seams; C-deadwood; PRUNE, WATCH
7	1	70"	R-restricted; T-large target canker; S-decay, cavity at crotch @ 12'; C-N; REMOVE
8	1	75"	R-restricted; T-seams w/ exudate, cavity 5" @ 12'; S-seams; C-open, decline, street risk; WATCH
9	1	20"	R-N; T-N; S-N; C-N
10	1	78"	R-N; T-N; S-ridge seam, pruning wound; C-N
11	1	38"	R-N; T-N; S-N; C-N
12	1	87"	R-restricted; T-seams; S-cracks, decay crotch @ 15'; C-hanger; REMOVE
13	1	30"	R-N; T-N; S-N; C-N
14	1	67"	R-N; T-seams; S-decay crotch @ 10' from pruning wounds; C-dangerous deadwood @ 12'; REMOVE
