WHS
Headquarters
Barrier Free
Access Study

Wisconsin
Historical
Society,
Madison

DSF Project
No. **10D2U**

2010

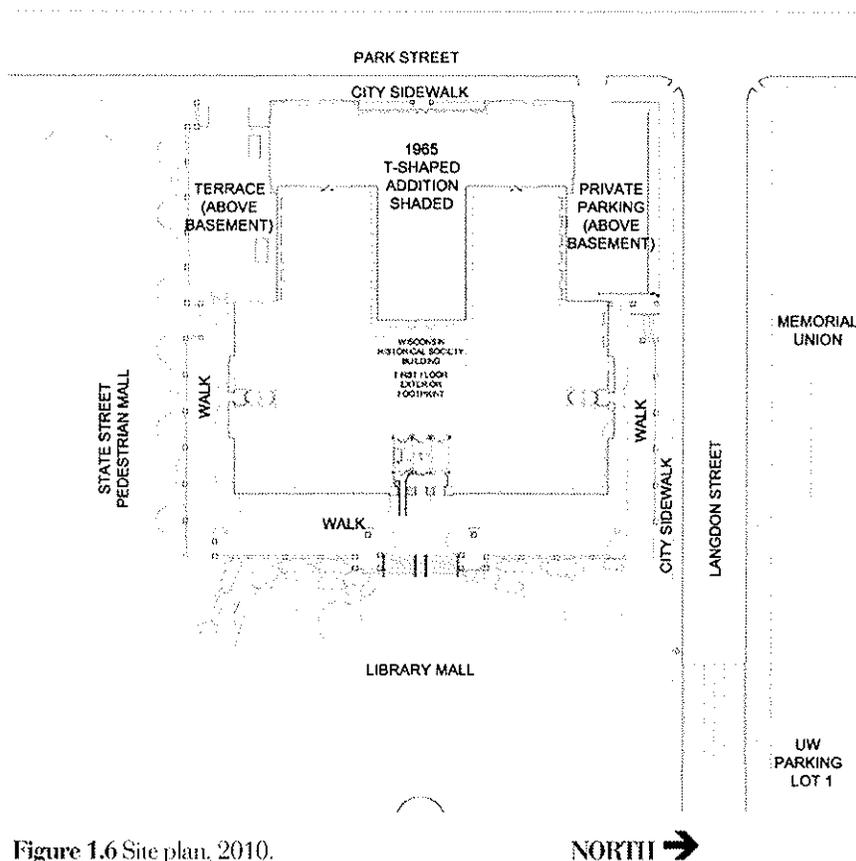
Figure 1.6 Site plan, 2010.

The building sits elevated above library mall and the city sidewalk on three sides, the North, South and East elevations. A secondary level change occurs on the North, South and East elevations and is surrounded by a stone balustrade. For purposes of this report it will be referred to as the "walk." From this level, the building's first floor is approximately 4'-2" higher on the north and 3'-6" higher on the South and East entrances.

The site slopes up towards Park Street where the city sidewalk is within 6 inches of the 1965 addition's first floor. As a result at the fourth side, West elevation, there is a 6" level change between the city sidewalk and first floor at this elevation.

The closest accessible parking lot is at the Memorial Union across Langdon Street. The closest city parking garage is the State Street Campus Ramp on Frances and Lake Streets. The closest street parking is on Langdon Street. Therefore, the closest accessible parking is North and East of the building.

The existing wheelchair accessible entry ramp into the building is located on the East Elevation. There is an accessible drop off area in the North staff parking lot. Currently there are two possible accessible routes; the first accessible route approaches from the North city sidewalk up a ramp to the building walk and around the building's Northeast corner to the East entry. The Historical Society Staff also use this path around the Northeast corner of the building exterior in order to bring wheeled equipment/carts into the building from the North staff parking lot, except they would access the North walk at building down a ramp from parking lot. It is not a favorable route for the staff. The second accessible route approaches from the Southeast at Library Mall to the building walk and around the Southeast corner of building to the East ramp.

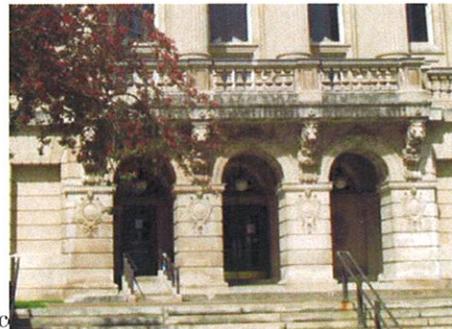
Figure 1.3 (right) East Entrance 2010

constructed above the original marble stairs that stretched the length of the entry vestibule. Thus, approximately a third of the original entry stairs at the center of vestibule are visible and usable for pedestrian entrance. The areas designated for coat rooms are currently landings with half height walls on either side of the central stair.

The existing East accessible entry ramp was designed and installed by BFM in May of 1975. It consists of two sections of ramp; one on the exterior and one in the interior, neither of the ramps meet the current accessibility codes for slope. The exterior concrete ramp connects the walkway at the buildings base to an intermediate landing at the southern loggia masonry arch. Two original granite slabs, loggia marble floor pattern and door heights were altered to accommodate the new floor height. After 35 years of exposure to the elements, the exterior concrete ramp is deteriorating. The interior portion of the ramp connects the intermediate landing to the first floor level in the defunct coat room area.

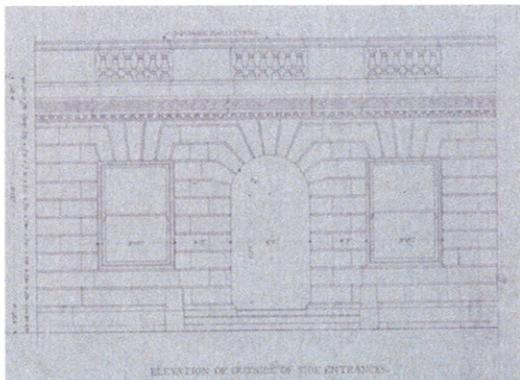
Figure 1.4 (left) South Entrance Elevation (North is similar), 1896. (Courtesy Wisconsin Historical Society)

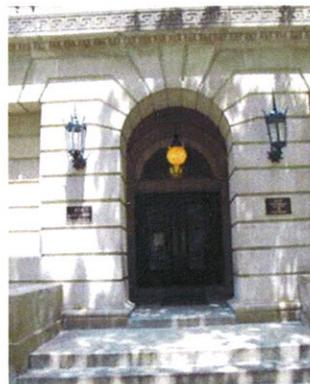
Figure 1.5 (right) South Entrance 2010

The brick terrace, including the balustrade, was part of the 1965 T-shaped addition and was built over new museum exhibit space in the basement. It is thought that the balustrade foundation wall is an extension of the southern basement exterior wall; however, further investigation is needed to confirm. The terrace is an intermediate level between the walk at the building base on the Southeast, East and Northeast and the city sidewalk level at Park Street.
