RE: **Programming Statement**
12G2R.18 – Black Point Historic Preserve Porch Rehabilitation
Lake Geneva, WI

13G2R.18 - Black Point Historic Preserve - Porch Rehabilitation
Department of Administration

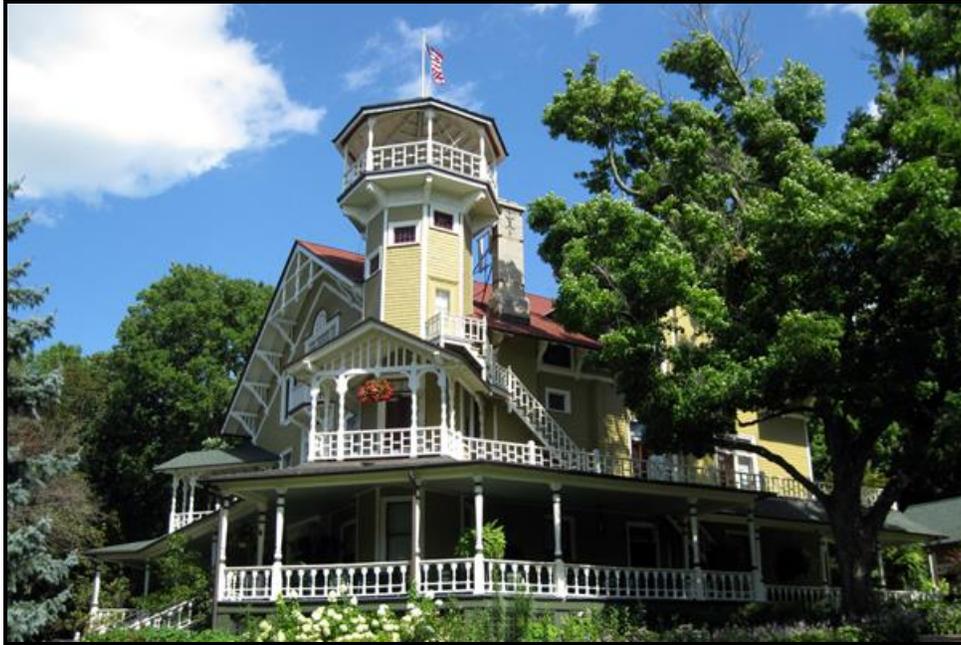
Photo Illustration #1

This project includes reconstruction of a 2,800 square foot porch in order to comply with live load requirements appropriate for assembly occupancies. Reconstruction will include replacement of foundation systems, floor framing systems, decking, and select stair assemblies. Furthermore, all exterior painted ornamental woodwork such as columns, balustrades, and newel posts will be replaced. Peripheral work will include, but may not be limited to: landscape protection/restoration, structure shoring, screen enclosures reconstruction, and stone base/filter fabric installation.

This site is listed with the State and National Registry of Historic Places. Consequently, reconstruction of various architectural components shall be in kind, including material, detailing, and geometry with possible minor structural embellishments. The primary structure, however, will be replaced with modern engineered components appropriate for increased live load.

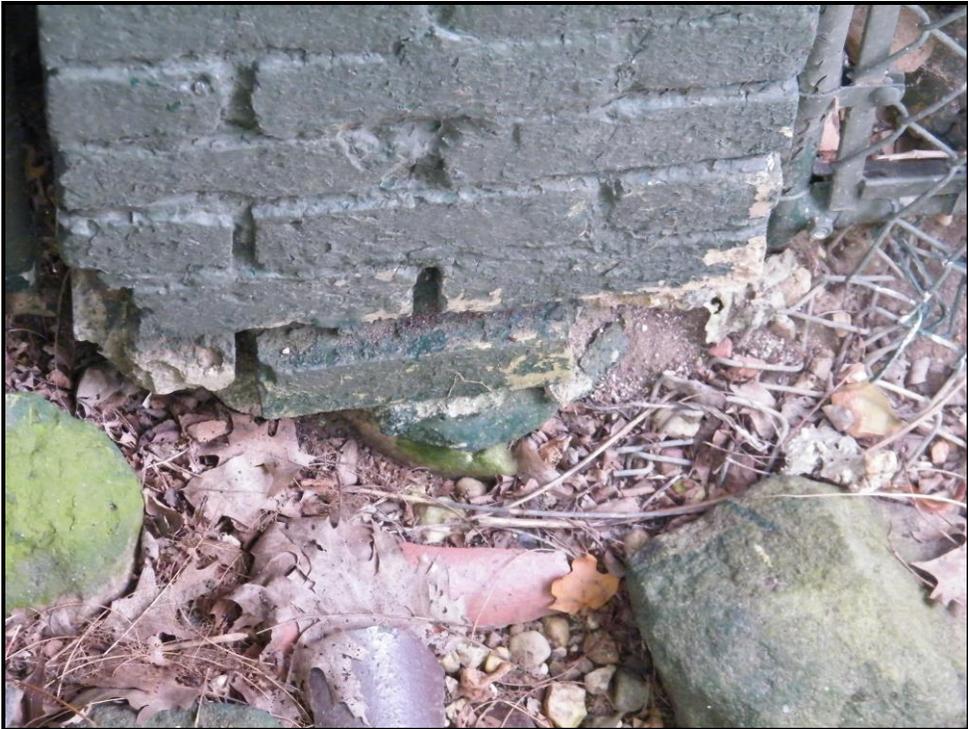
Photo Illustration #3

The original porch, circa 1888, was expanded in 1903. The primary structural components including piers, beams, and joists are in various stages of deterioration. Some remedial repairs and embellishments have been made in response to observations made in a historic structures report (HSR) completed in June of 2009. However, no significant structural embellishments have been completed in order to address live load capacity of the porch floor, an item also identified in the 2009 HSR. Accordingly, these systems are inadequate to accommodate loading associated with assembly occupancies, and intended for

residential occupancies. In 2006, reconstruction of a section of the porch followed structural failure as a result of overloading.

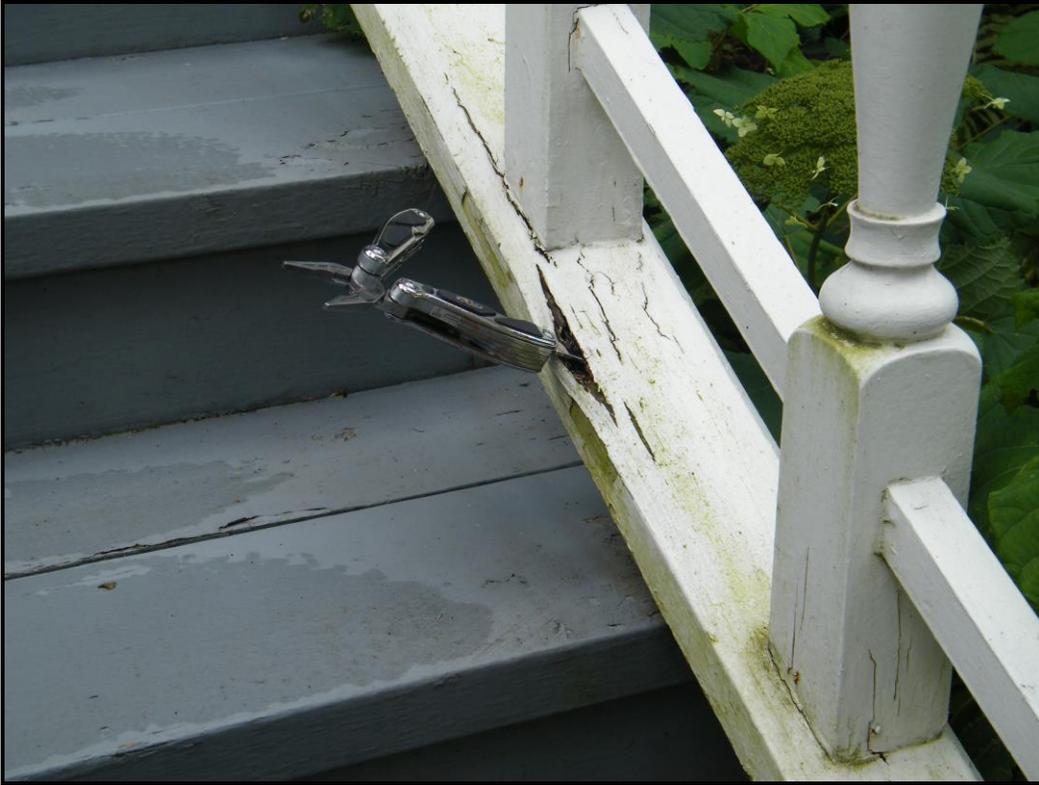
Photo Illustration #9

Architectural components such as columns, balustrade, newels, and fascia are in various stages of deterioration. Reconstruction of the primary structural systems will warrant their complete removal. Select salvage of components, their rehabilitation, and reinstallation is possible, however, not ideal. Significant damage to components during their removal is likely, if not, unavoidable. For example, the tongue of the tongue and groove decking will be destroyed during fastener removal, rendering it inappropriate for reuse. Fastener removal will impact most all components. With exception to the deck fascia, it is important to note, that these architectural components are also structural in nature.

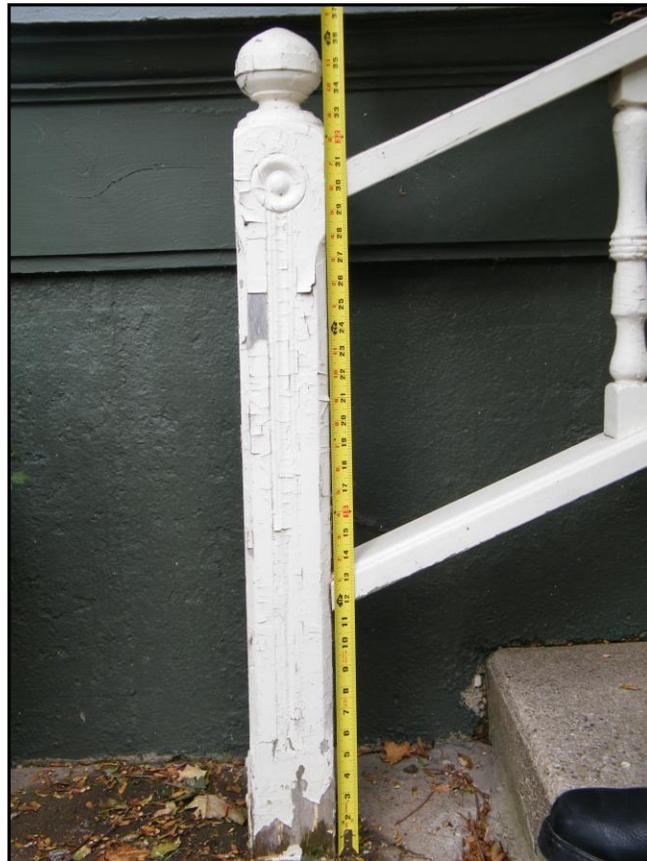
Photo Illustration #14

Removal of numerous layers of lead based paints or coatings is costly for those components *that can* be salvaged. Furthermore, given the investment associated with developing the dies/jigs for the custom elements, mass manufacturing of these components becomes financially beneficial. Consequently, replacement of all components will provide cost savings, while resulting in predictable results in: overall service life, structural performance, and finish retention.
