Devil's Lake Sewer System Evaluation

Devil's Lake State Park

DSF Project No.: 10B30

March 11, 2011

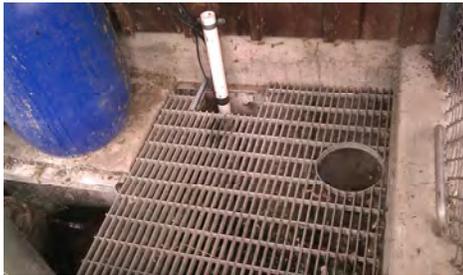
Wetwell

Inside the wetwell there is an overflow pipe (Pipe 109 on the System Map) with an invert three feet below the top of the wet well which diverts flow into the adjacent concrete septic holding tank. There is a valve located in a concrete vault on the overflow pipe immediately west of the wet well to shut off this overflow pipe. Two float switches in the wet well control pump operation. Based on sketches provided by park staff, the off float is 8 feet below the top of the wet well and the on float is 5'-6" below the top of the wet well resulting in a 2.5' operating range for the pumps. This operating range provides a 673 gallon operating volume. The exposed top portions of the wet well concrete appeared to be in good condition. The interior of the wet well was not observed as it was not dewatered for observation at the time of the site visit.

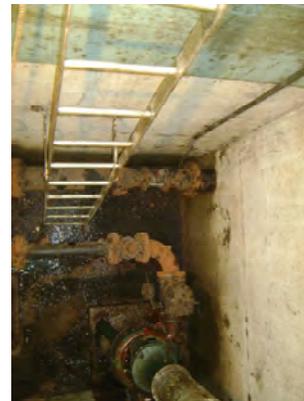
Drywell (east side)

Wisconsin Administrative Code. There are shut off valves (plug valves) on the suction piping and shut-off (plug valves) and check valves downstream of each pump. The finish of most of the piping and valves is deteriorated and rust is visible. It appears that the valves date back to construction of the pump station based on records provided by park staff, LW Allen and Terrytown Plumbing. Therefore, they are well beyond their expected 15-20 year service life.

An aluminum access ladder is used to enter the dry well. The floor of the dry well was moist, and wastewater appeared to be leaking from the seal of Pump #2. There is a ventilation fan in the control room with an intake in the dry well and exhaust duct through the side wall of the control room. However, there was a noticeable sewage smell coming through the access opening to the dry well. A rope is connected to the lever of the check valve on Pump #1 to back flush the pump when clogging occurs. The dry well was lacking an automatic heater, dehumidifier and sump pump as required by paragraph NR110.14(3)(b) & (d) of the Wisconsin Administrative Code.

The improvements should also include replacement of the deteriorated piping and valves with a recommended minimum diameter of six inches. The dry well access ladder should be replaced with one that is compliant with current OSHA standards for fixed ladders. An automatic heater, dehumidifier and sump pump should be added to the dry well per paragraph NR 110.14(3)(b) & (d) of the Wisconsin Administrative Code.

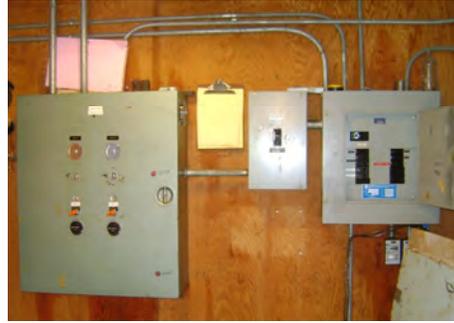
Controls & Electrical Distribution Panel

The control room houses the pump motors and pump controls. Each pump is driven by a 20 hp, 1750 rpm, 230/460 volt, 3-phase motor manufactured by Lincoln Motors. The motors are each controlled by a variable frequency drive (VFD) which ramps the pump up to full speed when the "on" float switch is activated and then ramps them down to shut off when the "off" float switch is activated. There is a control enclosure with a "hand" – "off" - "auto" switch and a run time meter for each pump. The pumping flow rate is indicated by an instantaneous flow digital display and totalized flow indicator connected to the flow meter. The controls are in good condition. The VFDs and magnetic flow meter are the current preferred technologies for pump control and flow measurement respectively.

A automatic telephone dialer, radio conveyed system, or telemetry system should be added to the controls to convey power failure, pump failure and high water level alarm conditions to comply with the requirements of paragraph NR 110.14(3)(i) of the Wisconsin Administrative Code.

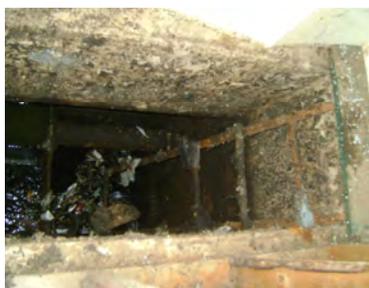
Wetwell/Access Ladder

Below the head works is a 20' x 11' x 11' deep concrete wet well. The head works channel, comminutor and bypass screen sit 6 feet below the top of the wet well. Two gravity pipes (Pipe 106 & Pipe 107 on the **South Shore Sanitary System Map** found in the **Appendix**) discharge into the head works channel. One pipe is from the west and one from the east. There is a 4' tall wall in the wet well which vertically aligns with the outside edge of the head works room. This wall separates the part of the wet well below the head works room from the part that is buried outside. Based on sketches provided by Park staff, normal operating pump on liquid level is set at of 3.95' which provides an approximate wet well operating volume of 6,500 gallons. This operating volume provides a detention time in excess of 30 minutes which is the maximum allowed by current code. There is a ventilation fan in the head works room with an intake in the wet well and exhaust duct through the side wall of the head works room. The exposed top portions of the wet well concrete appeared to be pitted and crumbling. There was a deteriorated permanent fixed ladder into the wet well from the head works room which is not currently allowed per Paragraph NR 110.14((3)(b)3. of the Wisconsin Administrative Code. The interior of the wet well beyond the head works room was not observed as it was not dewatered for observation at the time of the site visit. However, based on conditions of the portions of the wet well visible in the head works room, it is reasonable to assume that the rest of the wet well may be of the same deteriorating condition also in need of repair or replacement.

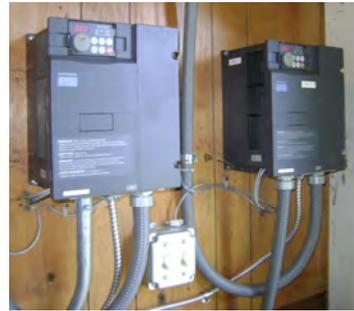
separate boxes instead of one common enclosure, the controls are in good condition. The VFDs and magnetic flow meter are the current preferred technologies for pump control and flow measurement respectively.
